TIMOR DAM SURVEILLANCE REPORT (TYPE 2)

(Inspection: 6th November 2015)

Report Number: DC15219

February, 2016

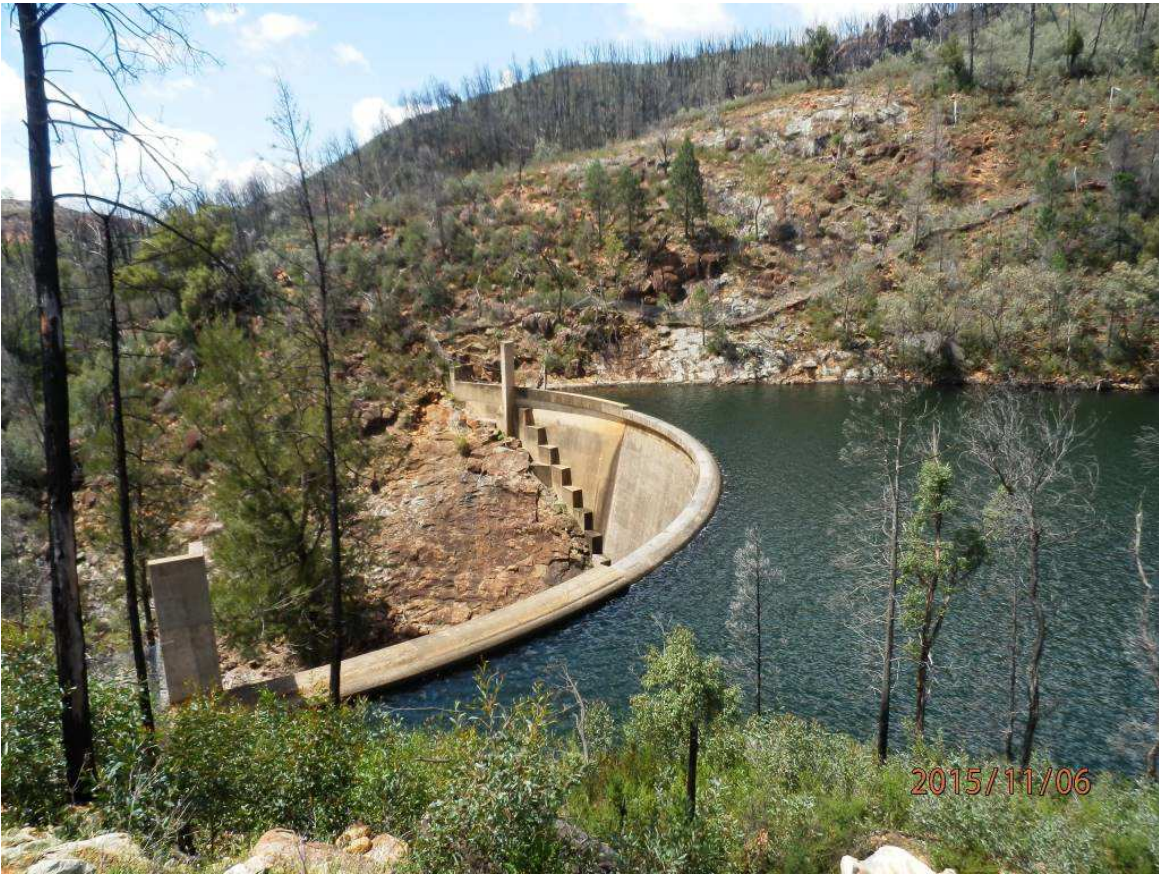
The visible portion of the upstream face of the dam appeared to be in satisfactory condition. (Photos 1 and 5).

Photo 1: General view of the dam from left hand side

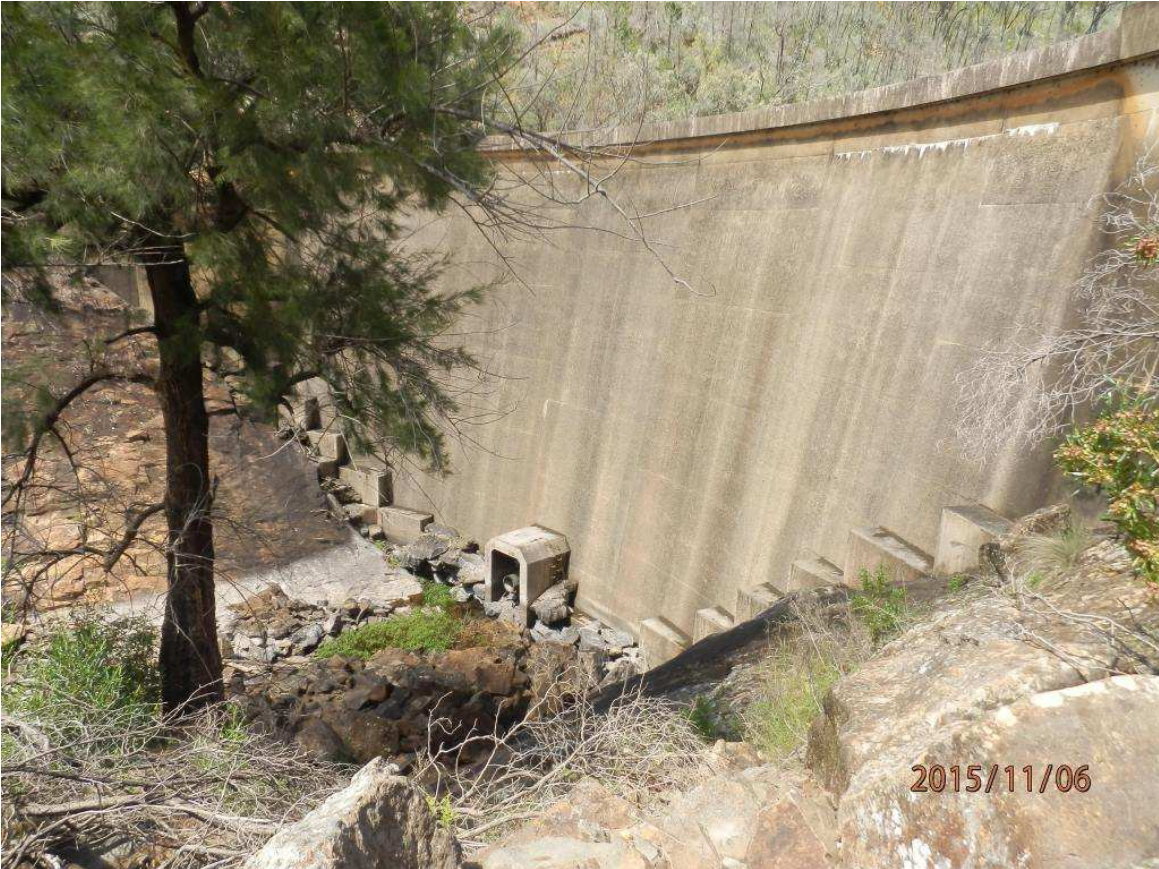
The downstream face of the dam appeared generally in satisfactory condition (Photos 2 to 4). No seepage from the downstream face was observed during the inspection. There was some minor calcification at some of the concrete joints. The concrete appeared to be generally in good condition.

Photo 2: Downstream face

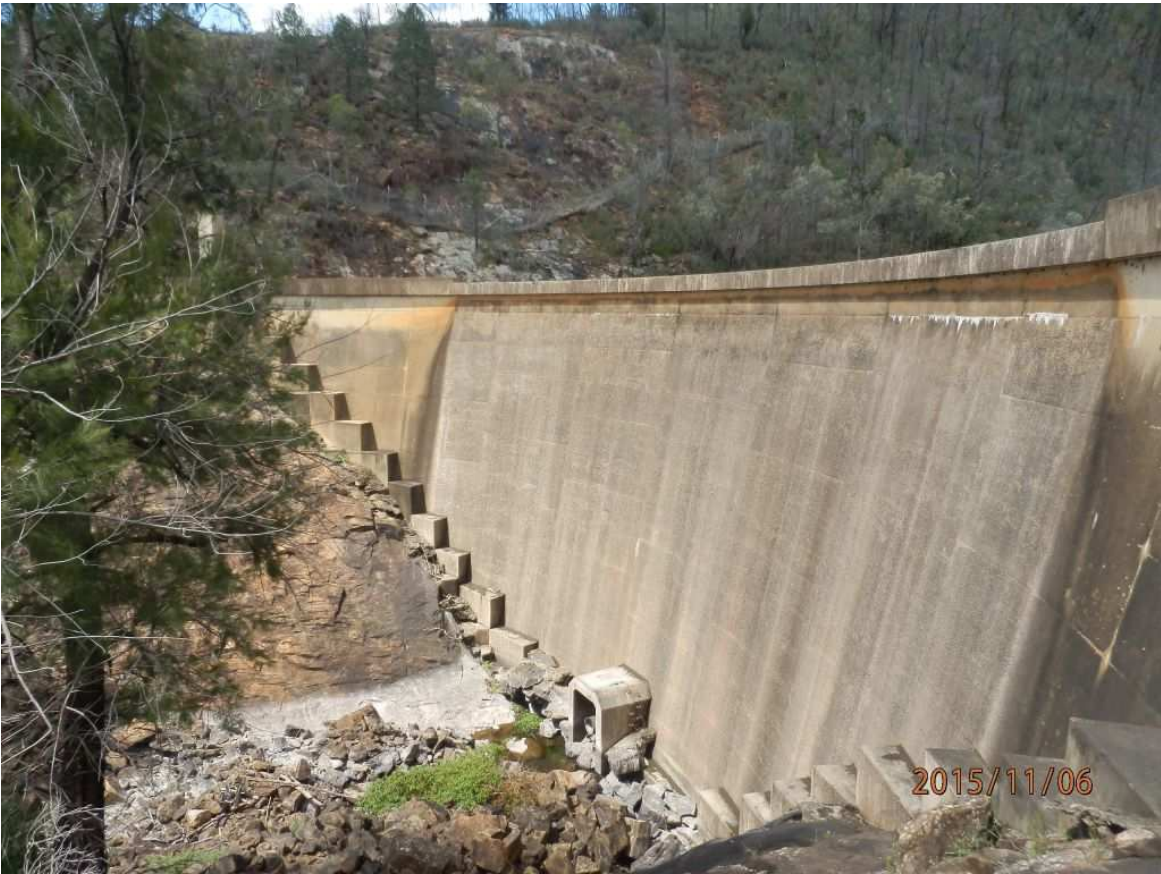
Photo 3: Downstream face

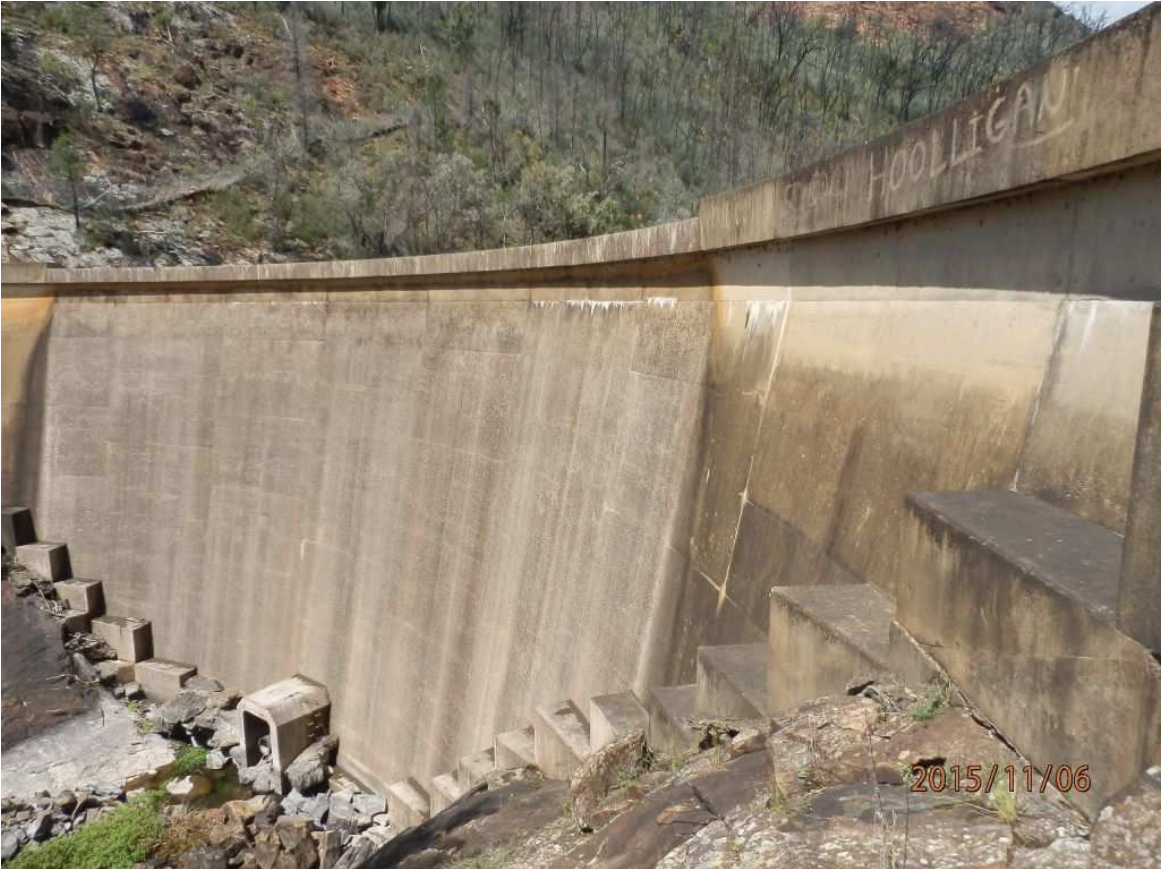
Photo 4: Downstream face

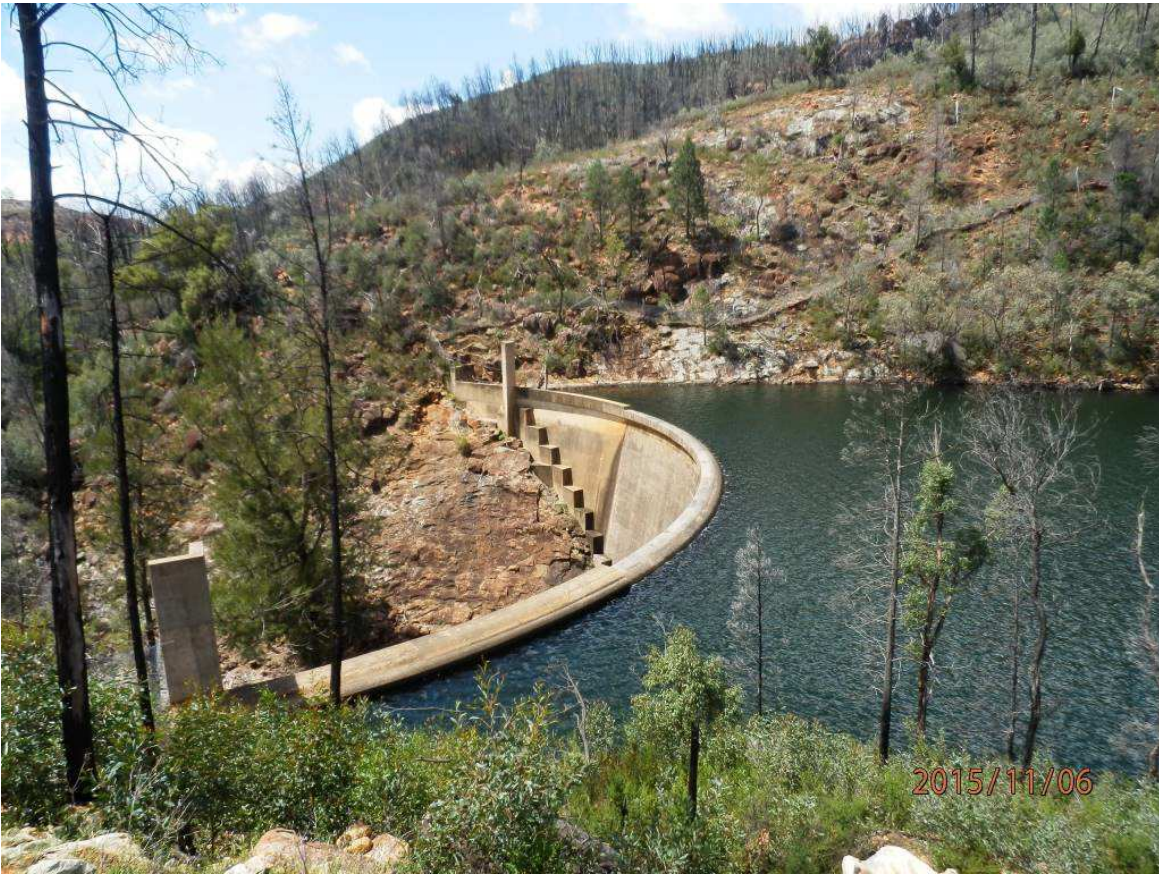
Photo 5: Dam crest (and unsubmerged portion of upstream face)

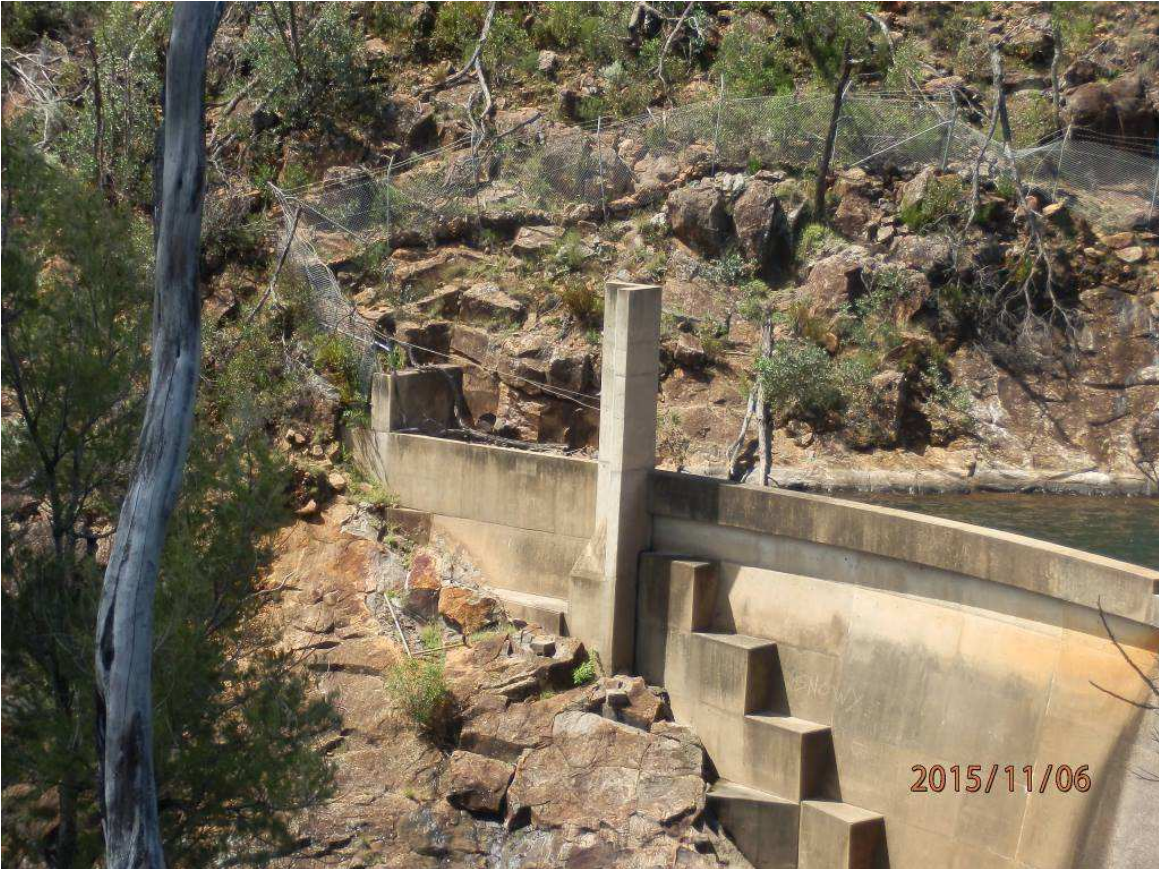
Photo 6: Right abutment

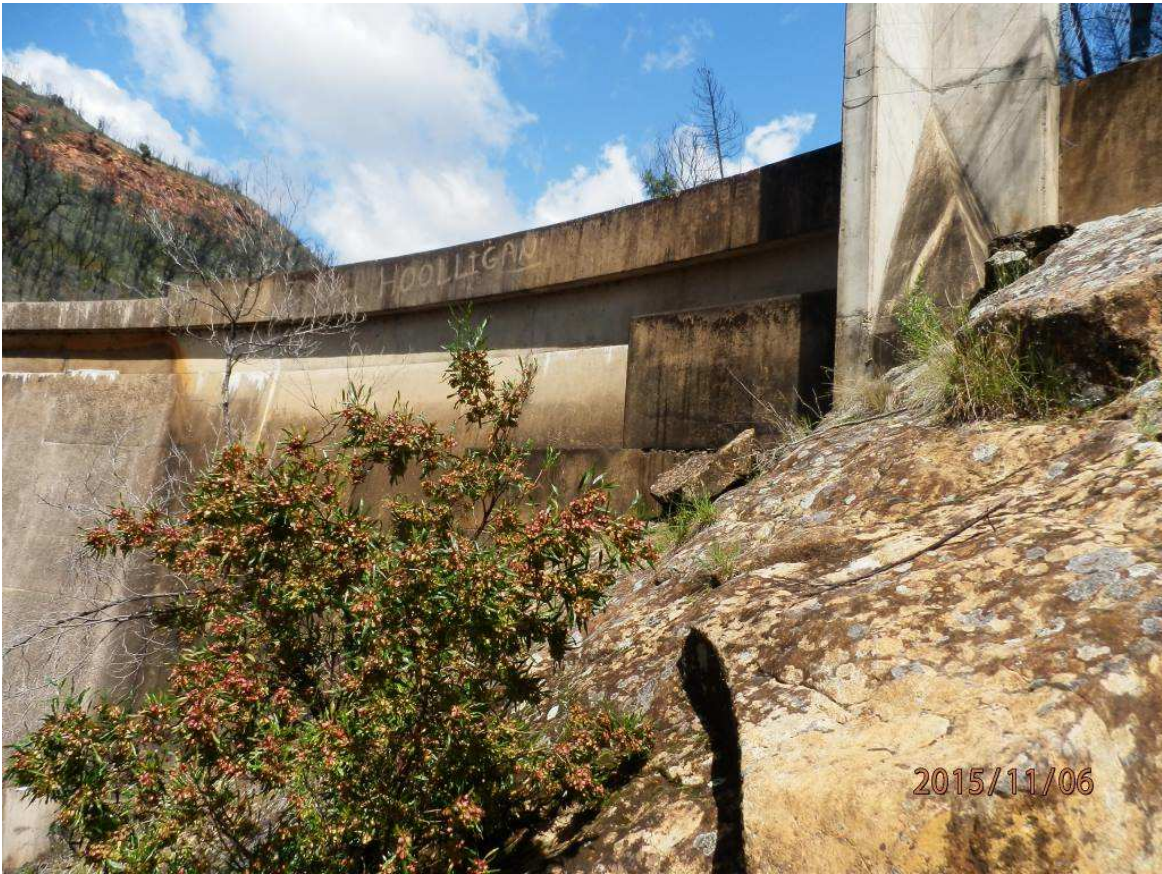
Photo 7: Left abutment

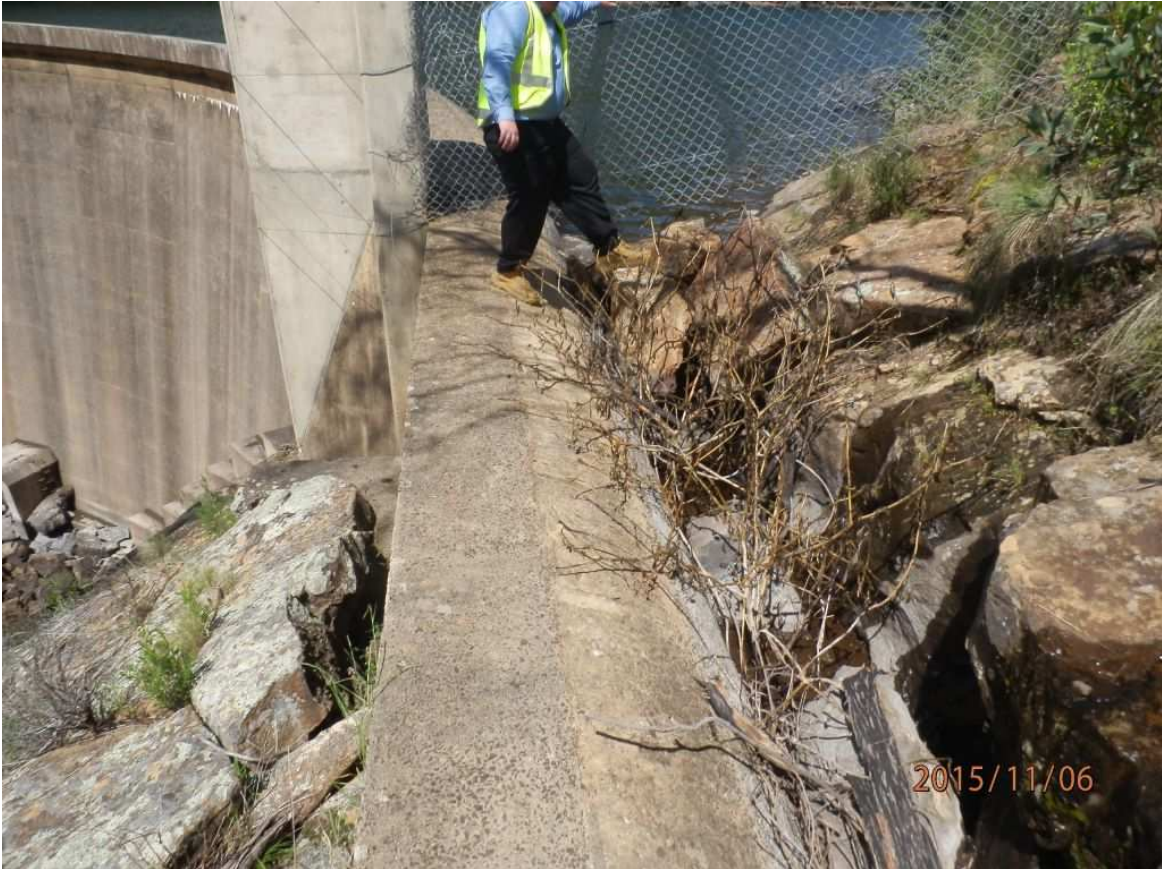
Photo 8: Left abutment

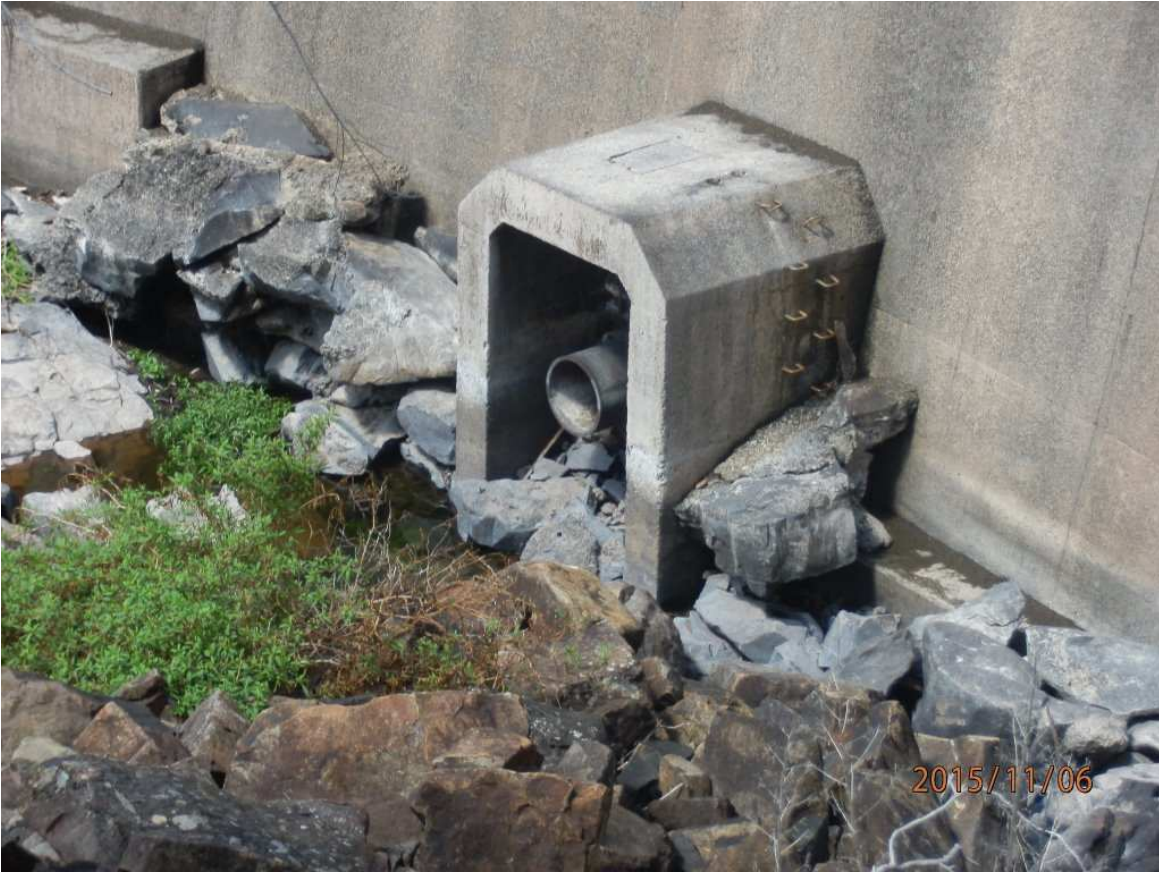
Photo 9: Scour Outlet

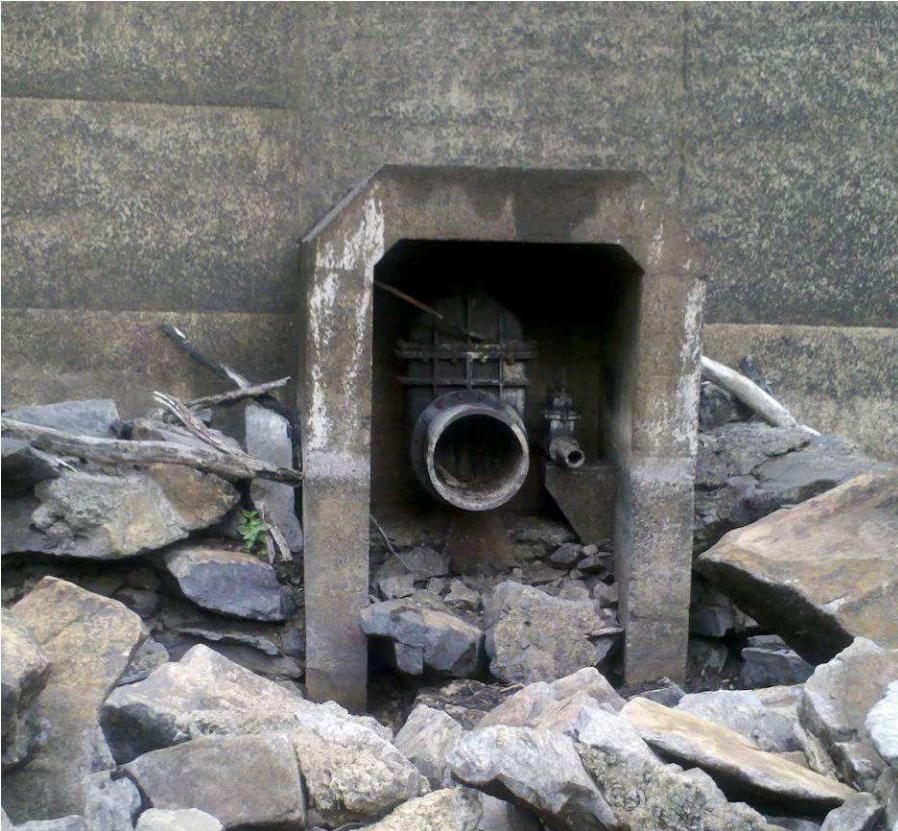
Photo 10: Scour Outlet (photo taken by council staff in June 2014)

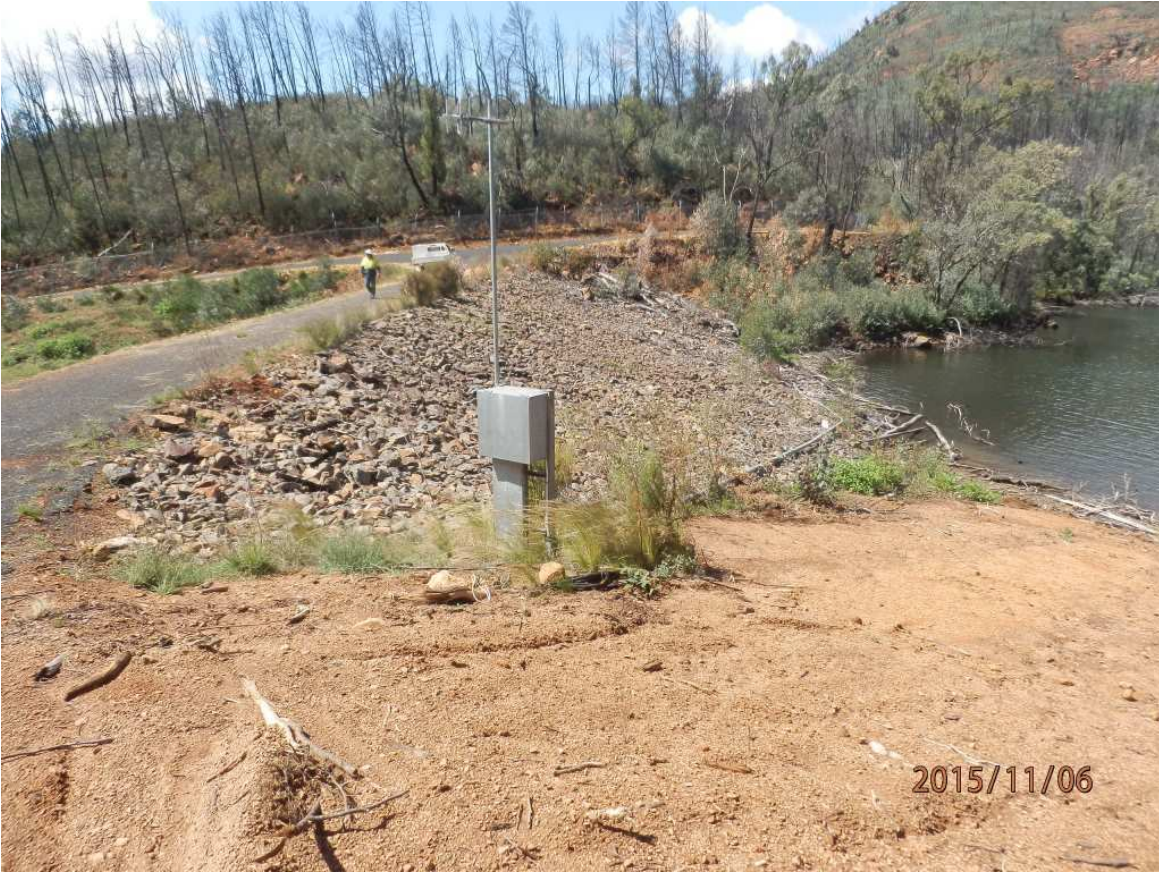
Photo 11: Saddle Dam from left hand side

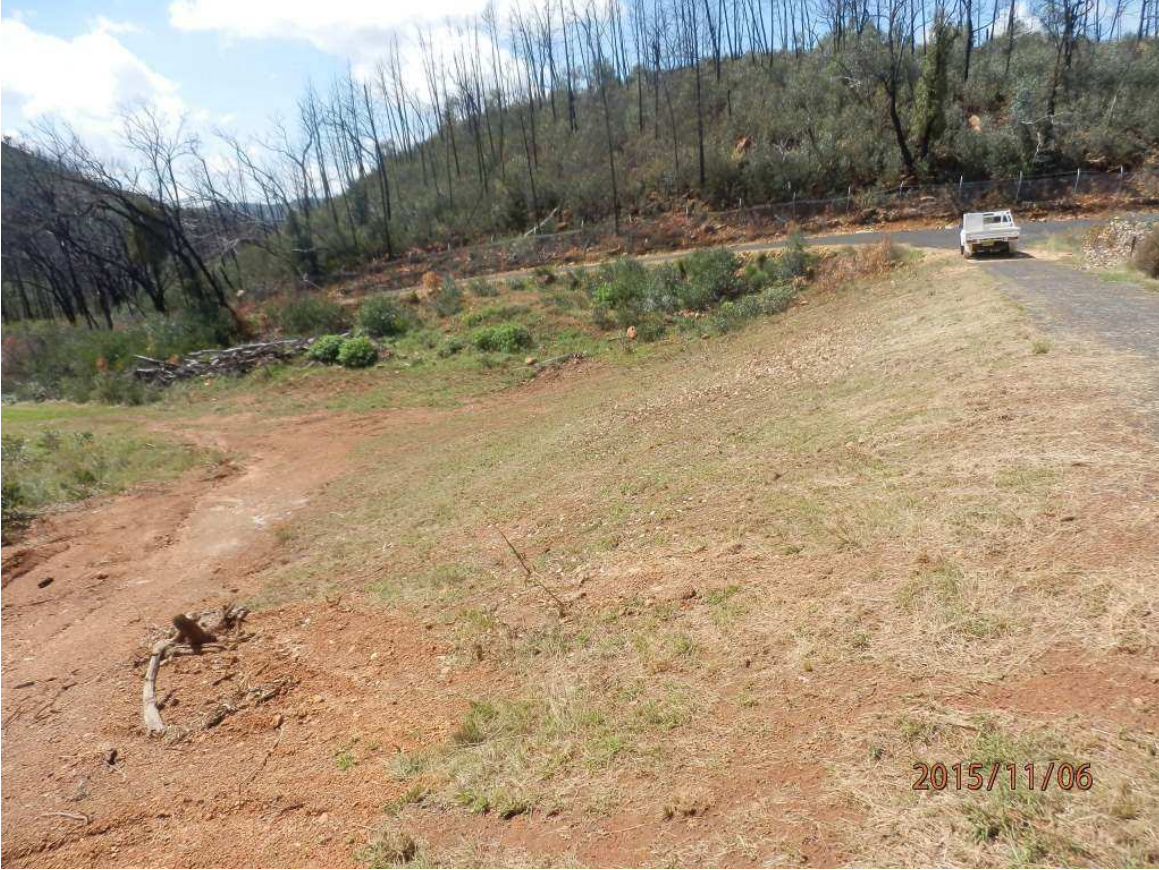
Photo 12: Saddle Dam downstream face

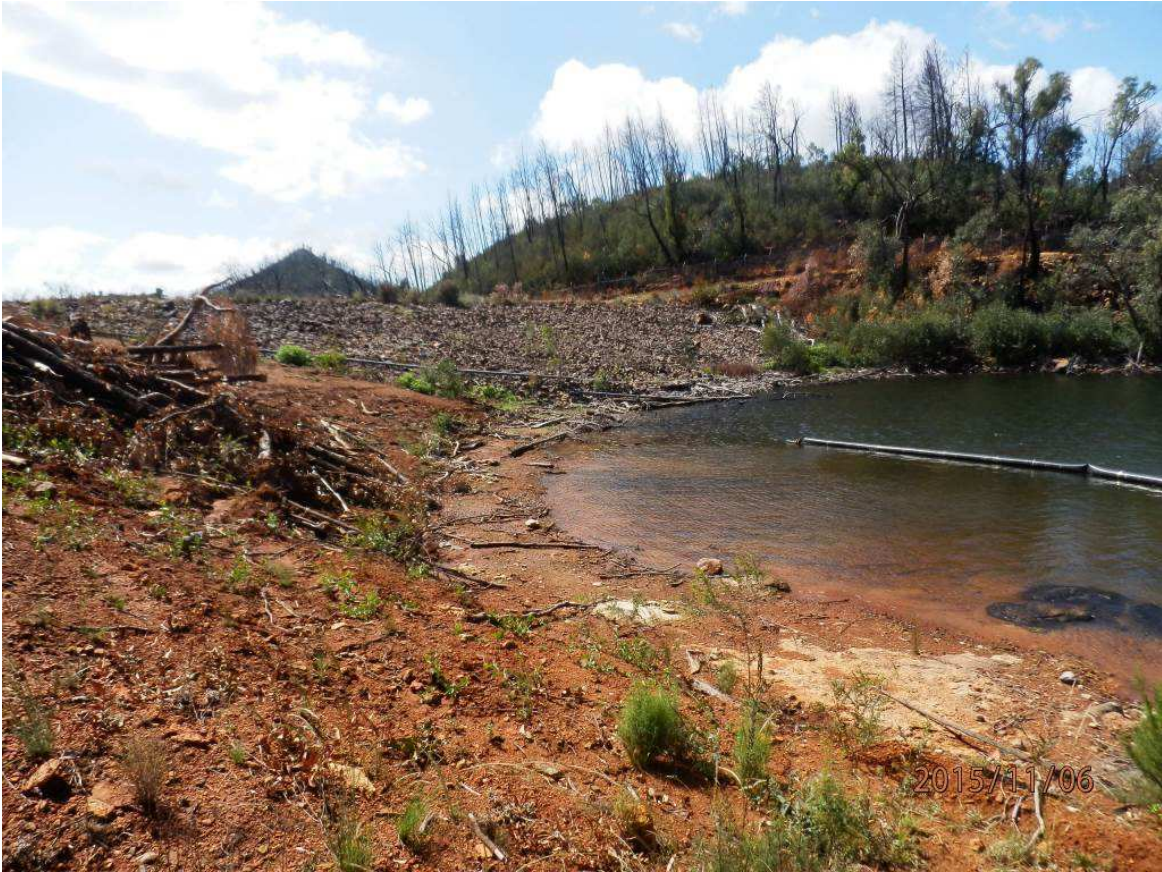
Photo 13: Saddle dam upstream face

4.	Continue to remove debris that collects on the upstream face of the saddle dam.	4
5.	Carry out a comprehensive condition assessment of all mechanical equipment associated with the operation of the dam and appurtenant works and upgrade the outlet system to meet acceptable modern standards.	3

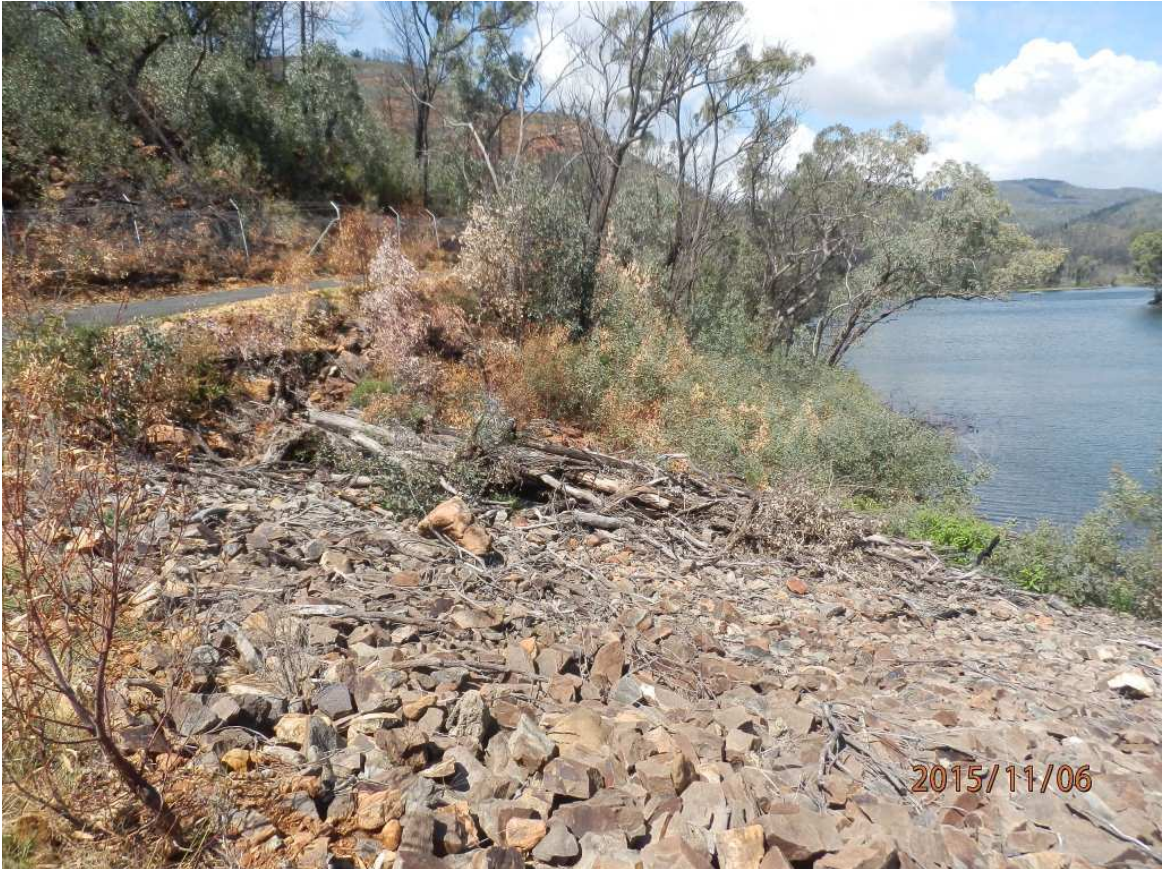
Photo 14: Saddle dam right abutment upstream side

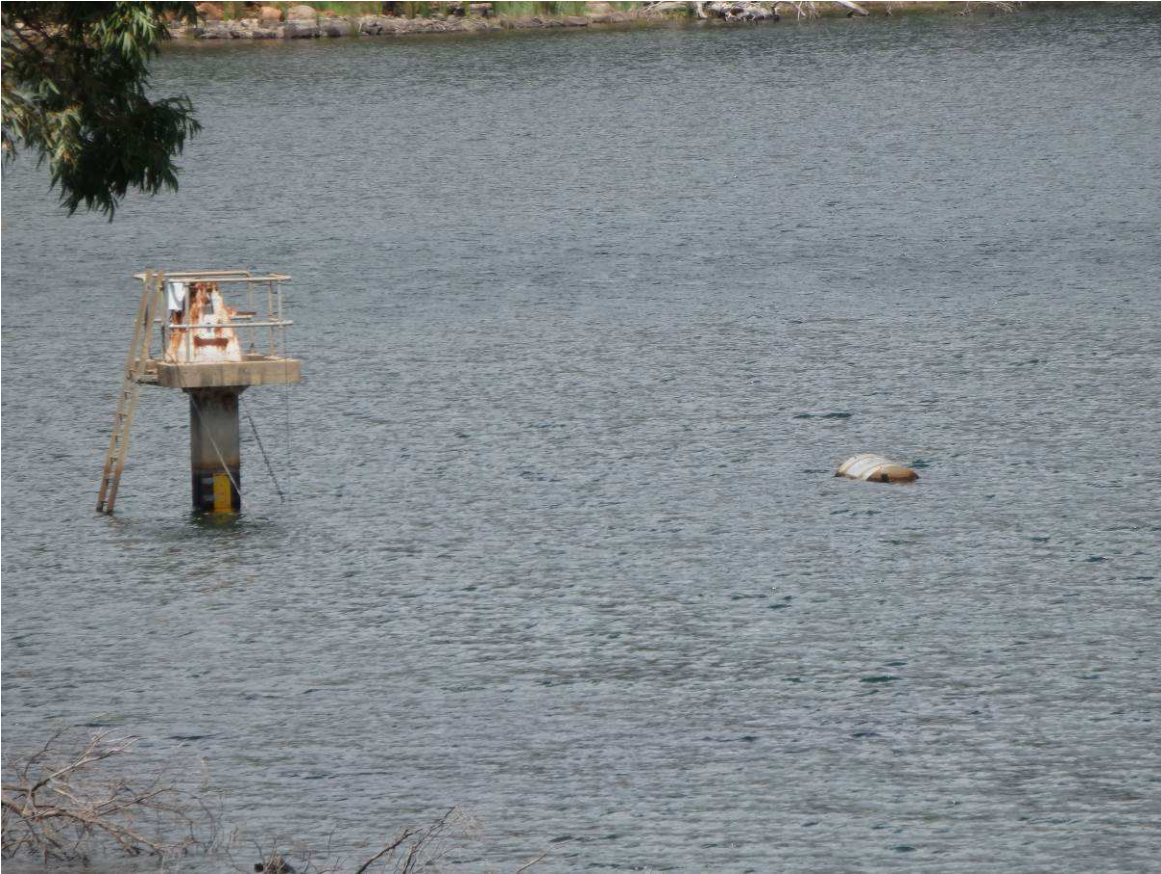
Photo 15: Trunnion for water supply outlet

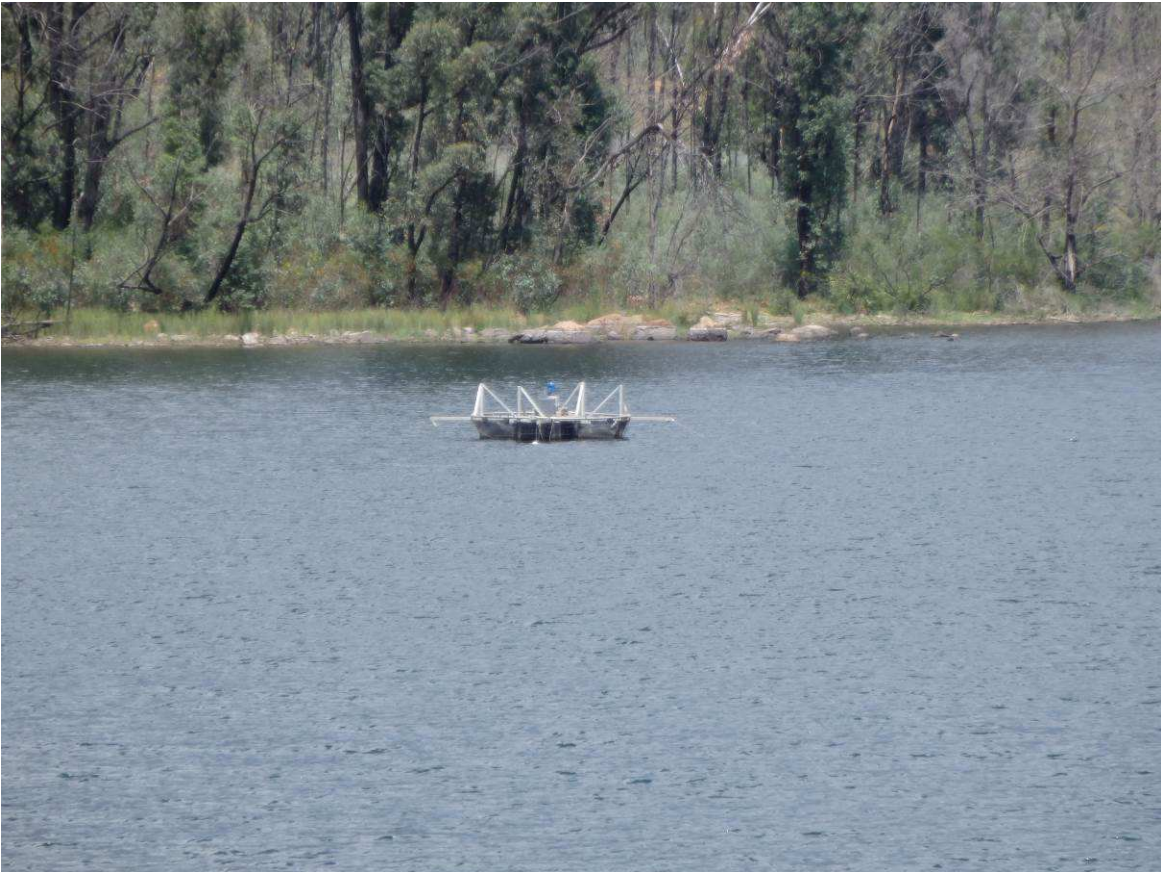
Photo 16: Storage mixer

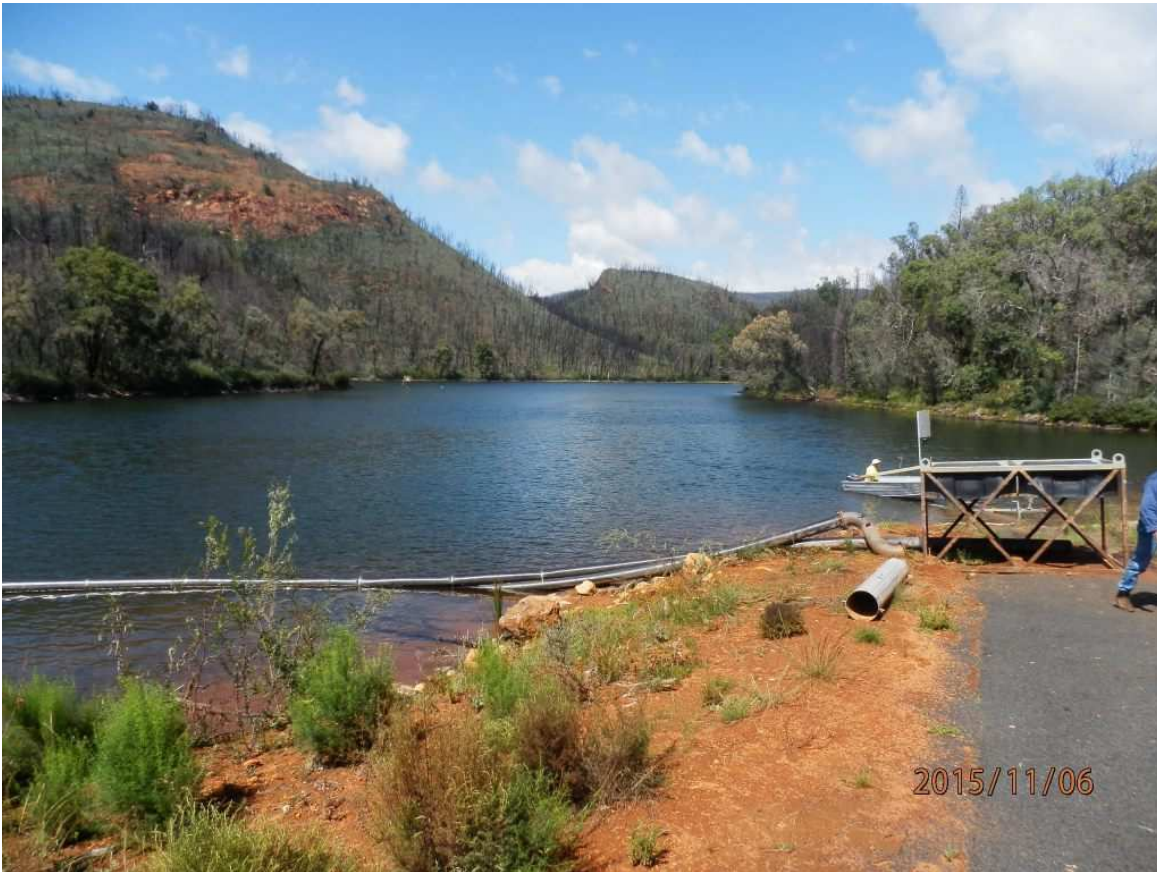
Photo 17: Dead storage line (pump removed for repairs)

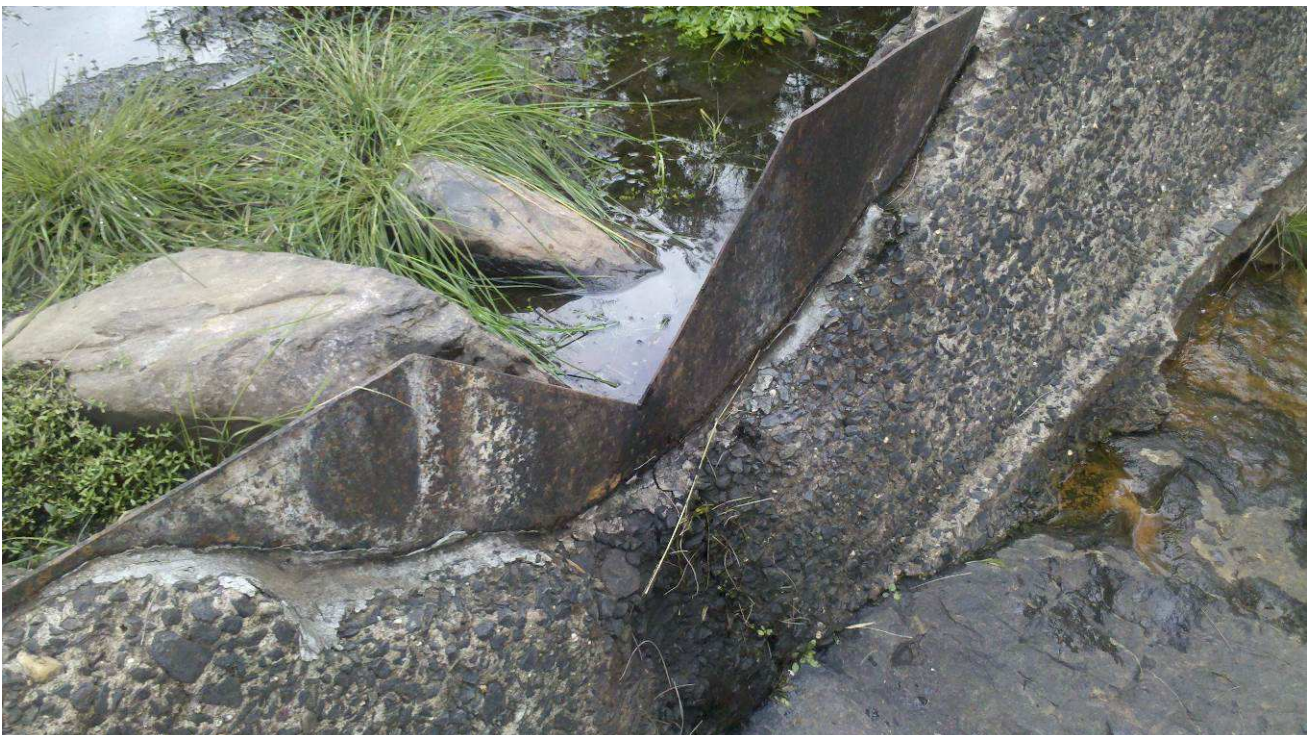
There is a V-notch weir downstream of the dam that measures seepage, however the weir is in disrepair (Refer to Photos 18 and 19 at Appendix D) and is difficult to access safely, therefore seepage has not been measured. The seepage weir should be repaired or replaced and seepage rates recorded on at least a weekly basis in accordance with ANCOLD (2003) (Recommendation 1).

Photo 18: Seepage weir (photo taken by Council staff in June 2014)

Rec. No.	Recommendation	Criticality Rating (See legend below)
1.	Repair or replace the seepage weir and commence seepage monitoring on at least a weekly basis in accordance with ANCOLD (2003).	3

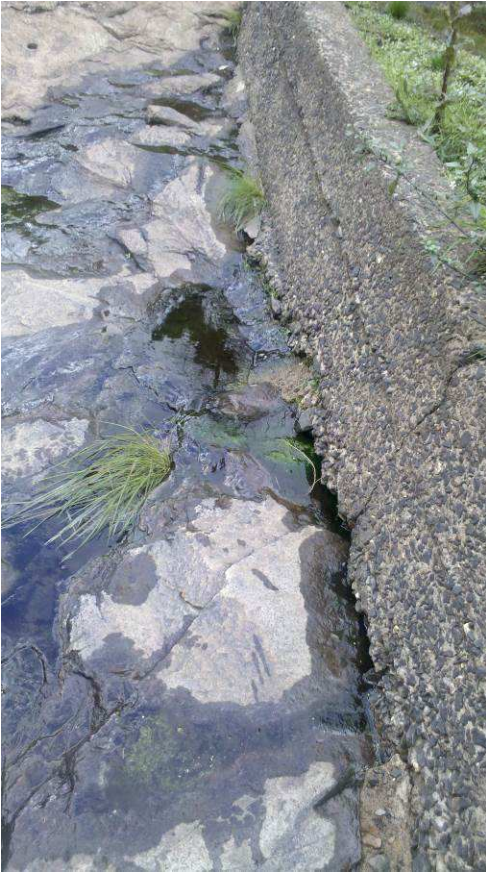
Photo 19: Seepage weir wall with under-seepage (photo taken by Council staff in June 2014)

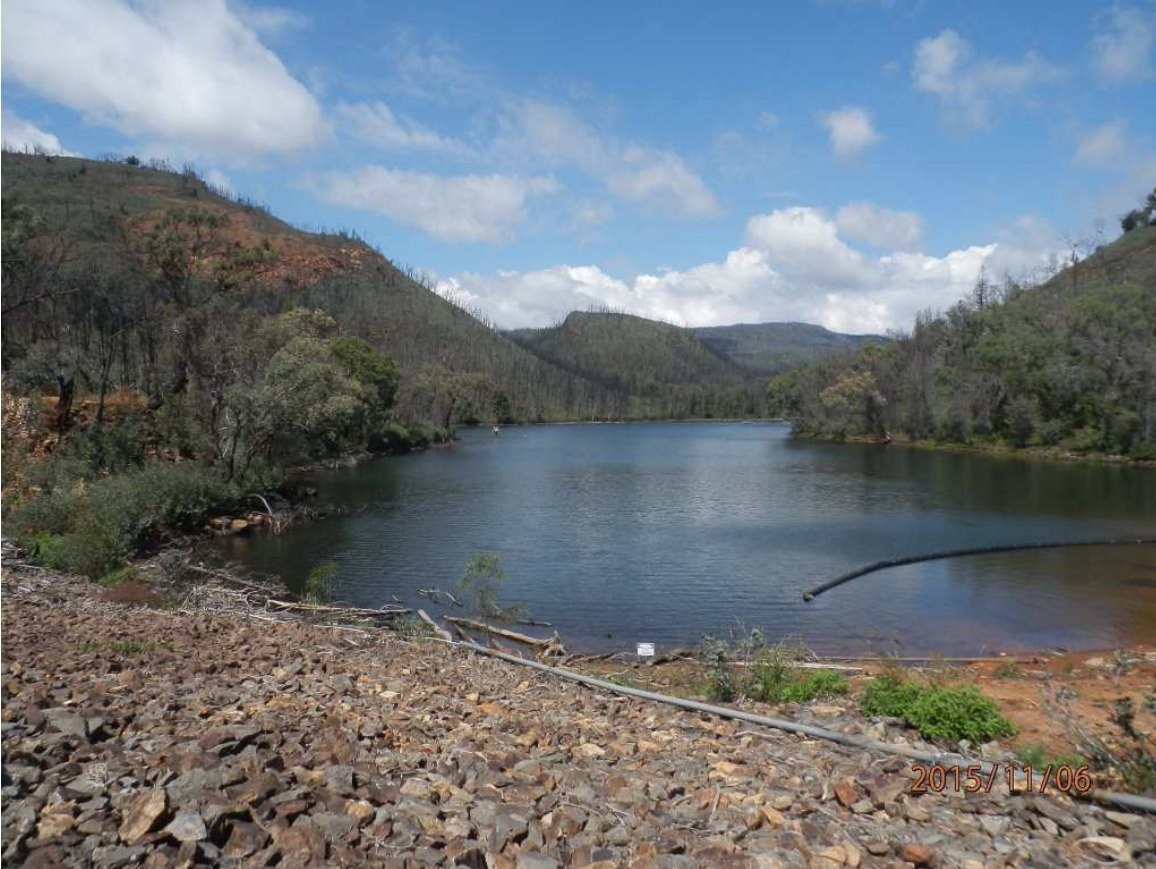
Photo 20: Reservoir storage looking from saddle dam

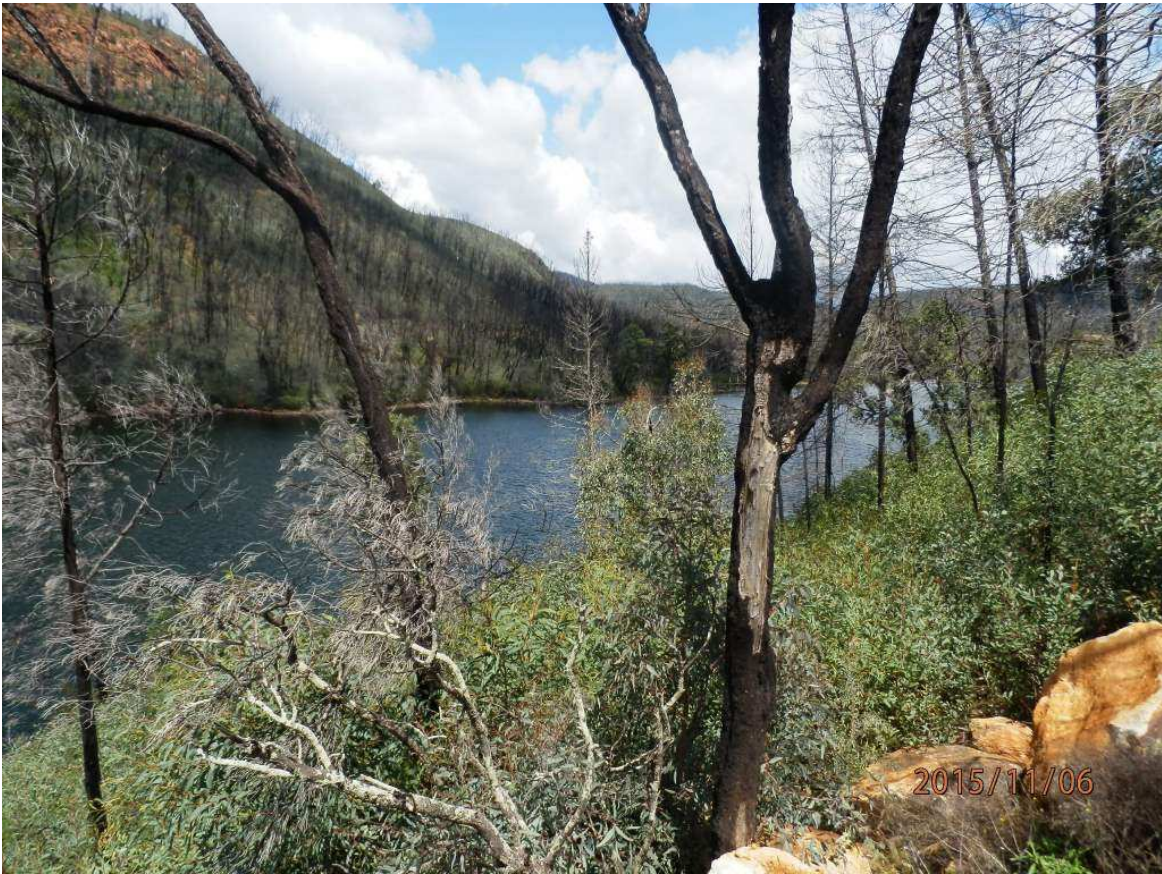
Photo 21: Reservoir storage looking from left hand side of main dam
