Condition Assessment of Existing Ground Water Bores

**Orana Water Utilities Alliance
Warrumbungle Shire Council**

PREPARED BY Access Environmental Planning

January 2021

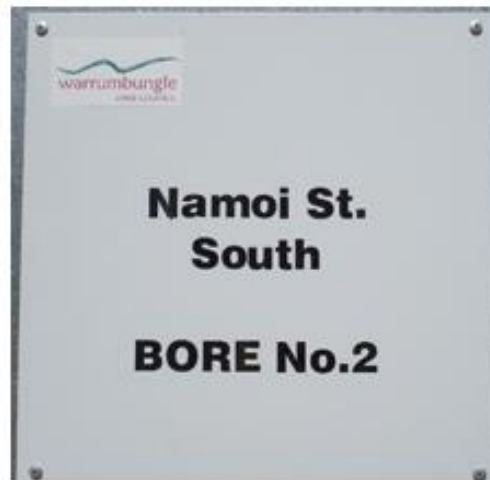
Figure 2 - Coonabarabran Namoi Street South Bore

Condition of casing well cap and slab	Good condition
Well age	82 years old, high risk
Well type	Low to moderate risk
Screen material	Assume slotted, high risk
Bore material	Moderate/high risk
Pump depth setting	20-30 meters
Bore cementing	No record
Water quality	No record
Iron level	No record
Salinity Level	No record
Relationship of pump depth setting and screen level to Iron Hydroxide potential	Moderately high risk, pump is in slotted casing area
Comments	Not enough records, the bore us accessing sandstone
Conclusion	Moderate/high risk

Bore is high risk due to age and the mild steel casing. Recommend a Camera inspection and pump test to monitor bore performance.

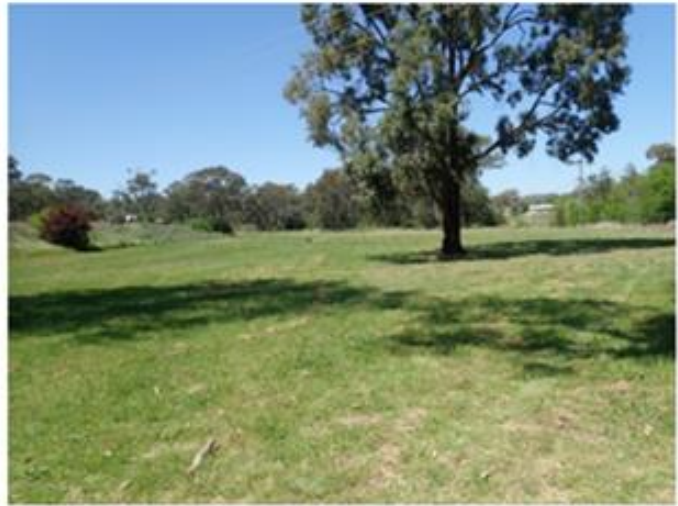
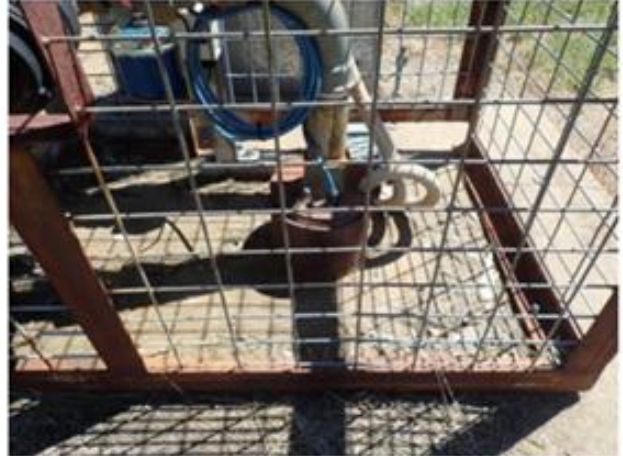
Figure 4 - Coonabarabran Namio St North Bore 4

Bore 4 – Namoi St North This bore is located further north on Namoi Street on Lot 1, DP 1085566 Coonabarabran. This bore does not yield much water and pumps a small amount of sand. Due to this it is used as a backup water supply.

Estimate of specific capacity of the well. Flow rate vs drawdown	NA
Site details including accessibility	Power is underground
Additional comments

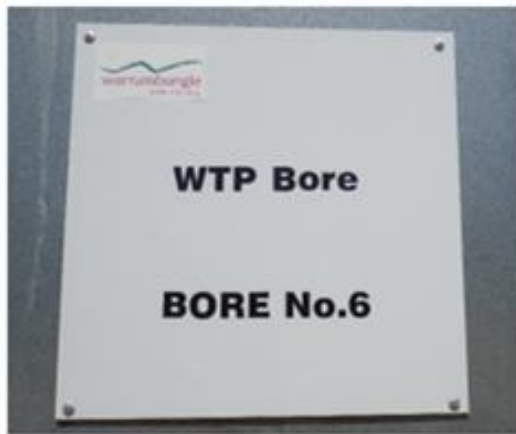
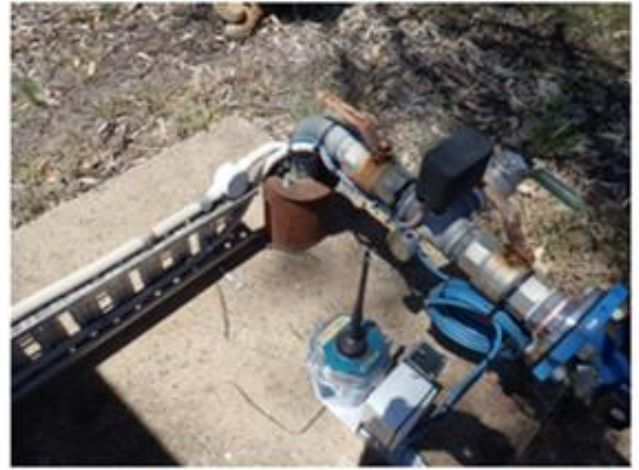
Figure 5 - Coonabarabran Water Plant Bore

The water plant is located on Timor Rd, 1.4 km west of the Coonabarabran town centre. It is the major water supply for Coonabarabran. This bore has had minimal issues after the pump replacement in 2015. There is limited information available on this bore.

Site details including accessibility	No overhead powerlines
Additional comments	Bore not in shed

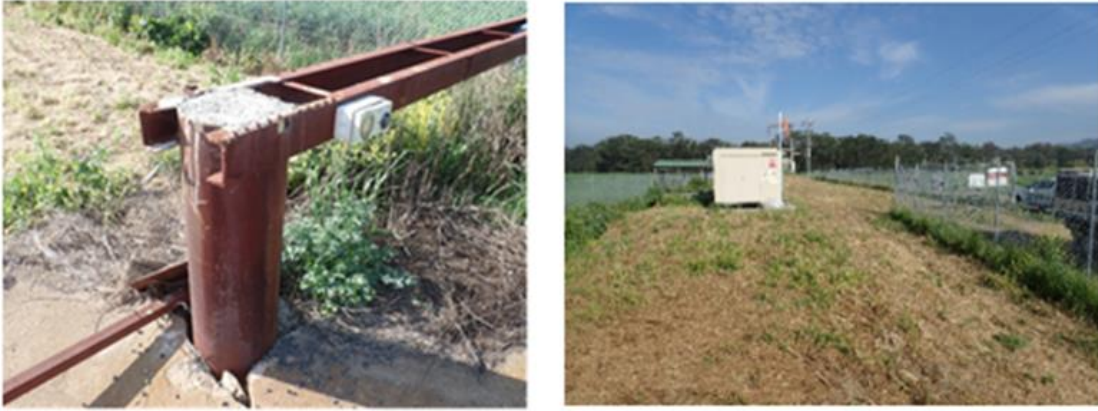
Figure 6 - Coolah Old Bore

GPS Coordinates	Latitude: -31.81175000 Longitude: 149.74324000
Date of Inspection	07/10/2020
Original Form A or Drill log or Bore Sketch	Capped / decommissioned
Pump-test data available. Stage and constant test	NA
Water Quality Data	NA
Camera or previous geophysical investigations	NA
Any maintenance issues in the past	NA
Any records of pumping sand or turbid water	NA
Any monitoring program, maintenance checks, frequency	NA
Any records of pumping problems	NA
Type of pump	NA
Pump depth setting	NA
Type of pump column and diameter	300mm (12")
Cleanliness of pump column when pulled. Any red or brown ochre colour?	NA
Details of pump and pump column diameter fittings	NA
Any signs of pumping sand from bore	NA
Any examples of old pump column left near the bore indicating possible iron or corrosion issues with pump column	NA
Estimate of specific capacity of the well. Flow rate vs drawdown	NA
Site details including accessibility	Good accessibility to site. No overhead powerlines

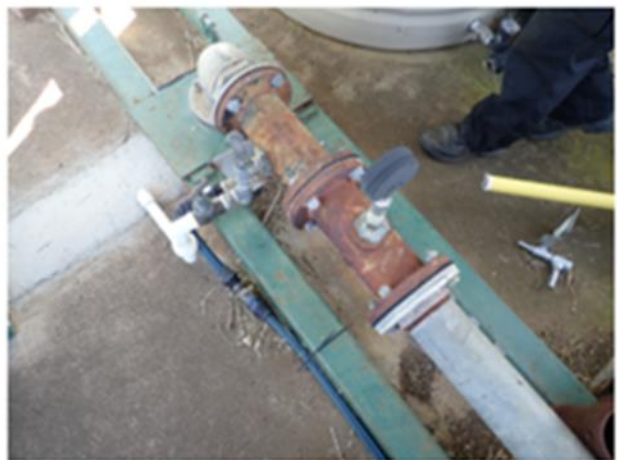
Condition of casing, well cap and slab	Unknown
Well age	24 years, low/moderate risk
Well type	Low risk
Screen type	Slotted casing, low/moderate risk
Bore material	Mild steel, moderate/high risk
Pump depth setting	NA
Bore cementing	No
Gravel pack or natural pack	Gravel pack, sedimentary rock
Water quality	No record
Iron level	No record
Salinity level	No record
Relationship between pump depth setting and screen level on Iron Hydroxide potential	No record
Comments	Not enough information to make a full risk assessment. A camera inspection is suggested
Conclusion	Low/moderate risk

The bore is a low to moderate risk as it is cased in sedimentary rock. Unclear what is in the annulus if any material. A camera inspection is recommended and a stage test to record bore performance should be considered.

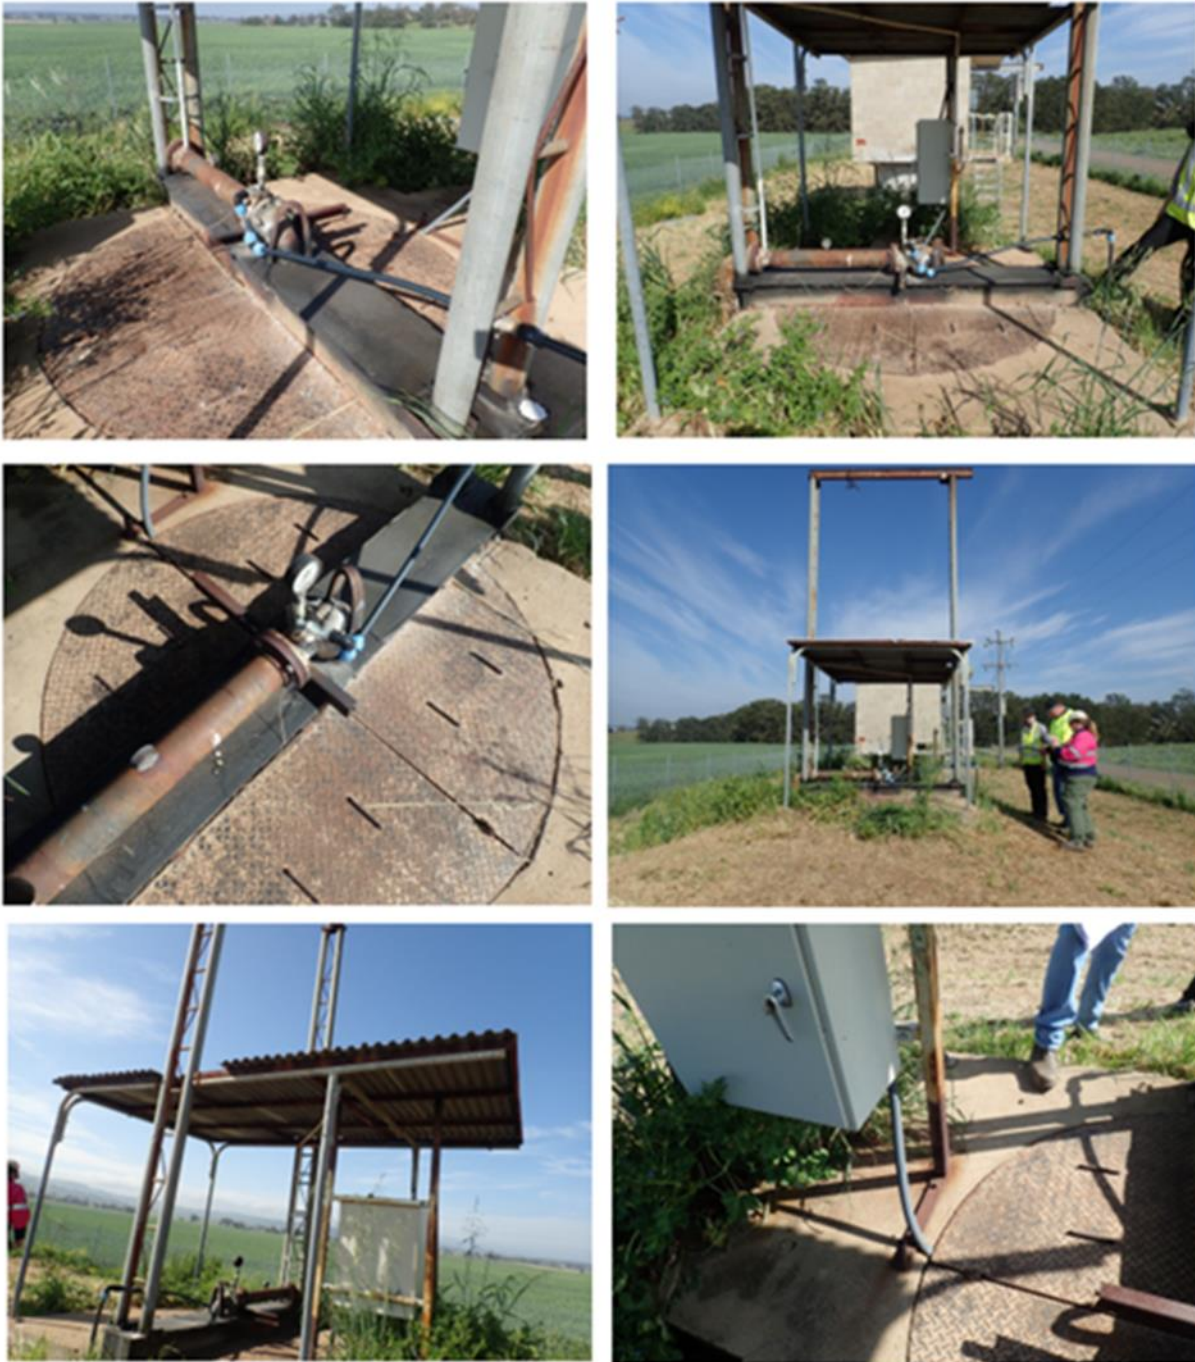
Figure 7 - Coolah Back -up Well

Site details including accessibility	5 m water table
Additional comments	9 m to sandstone

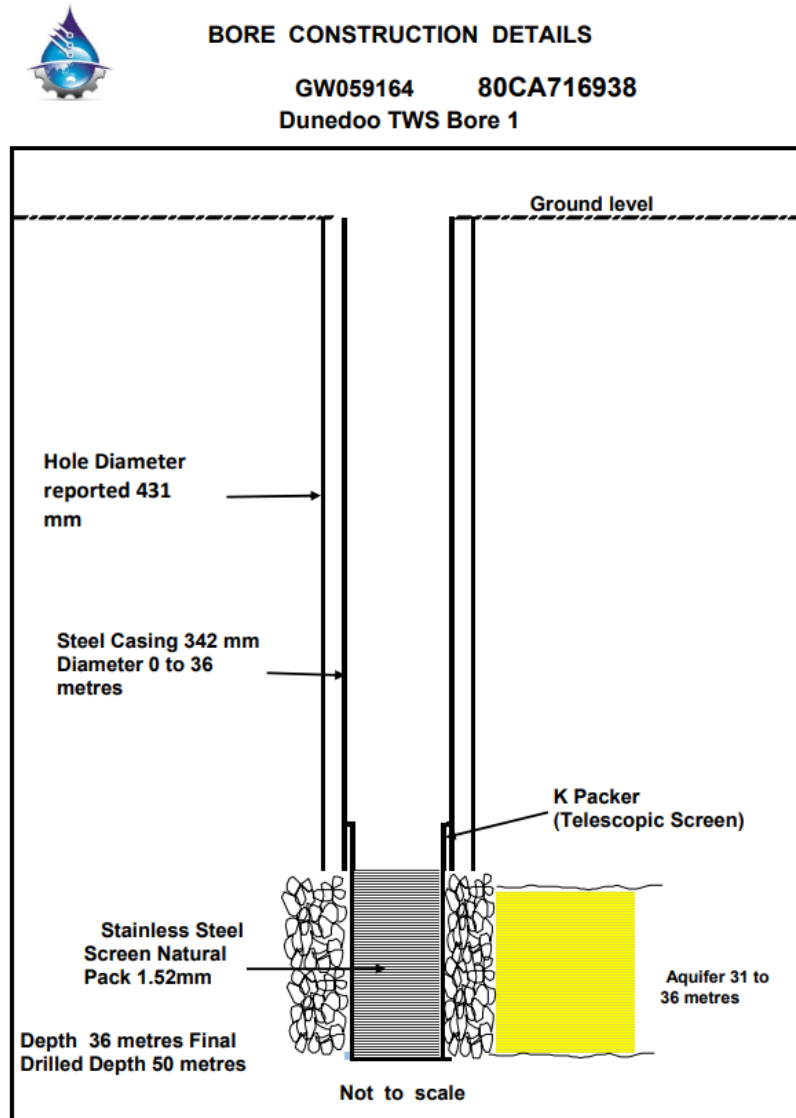
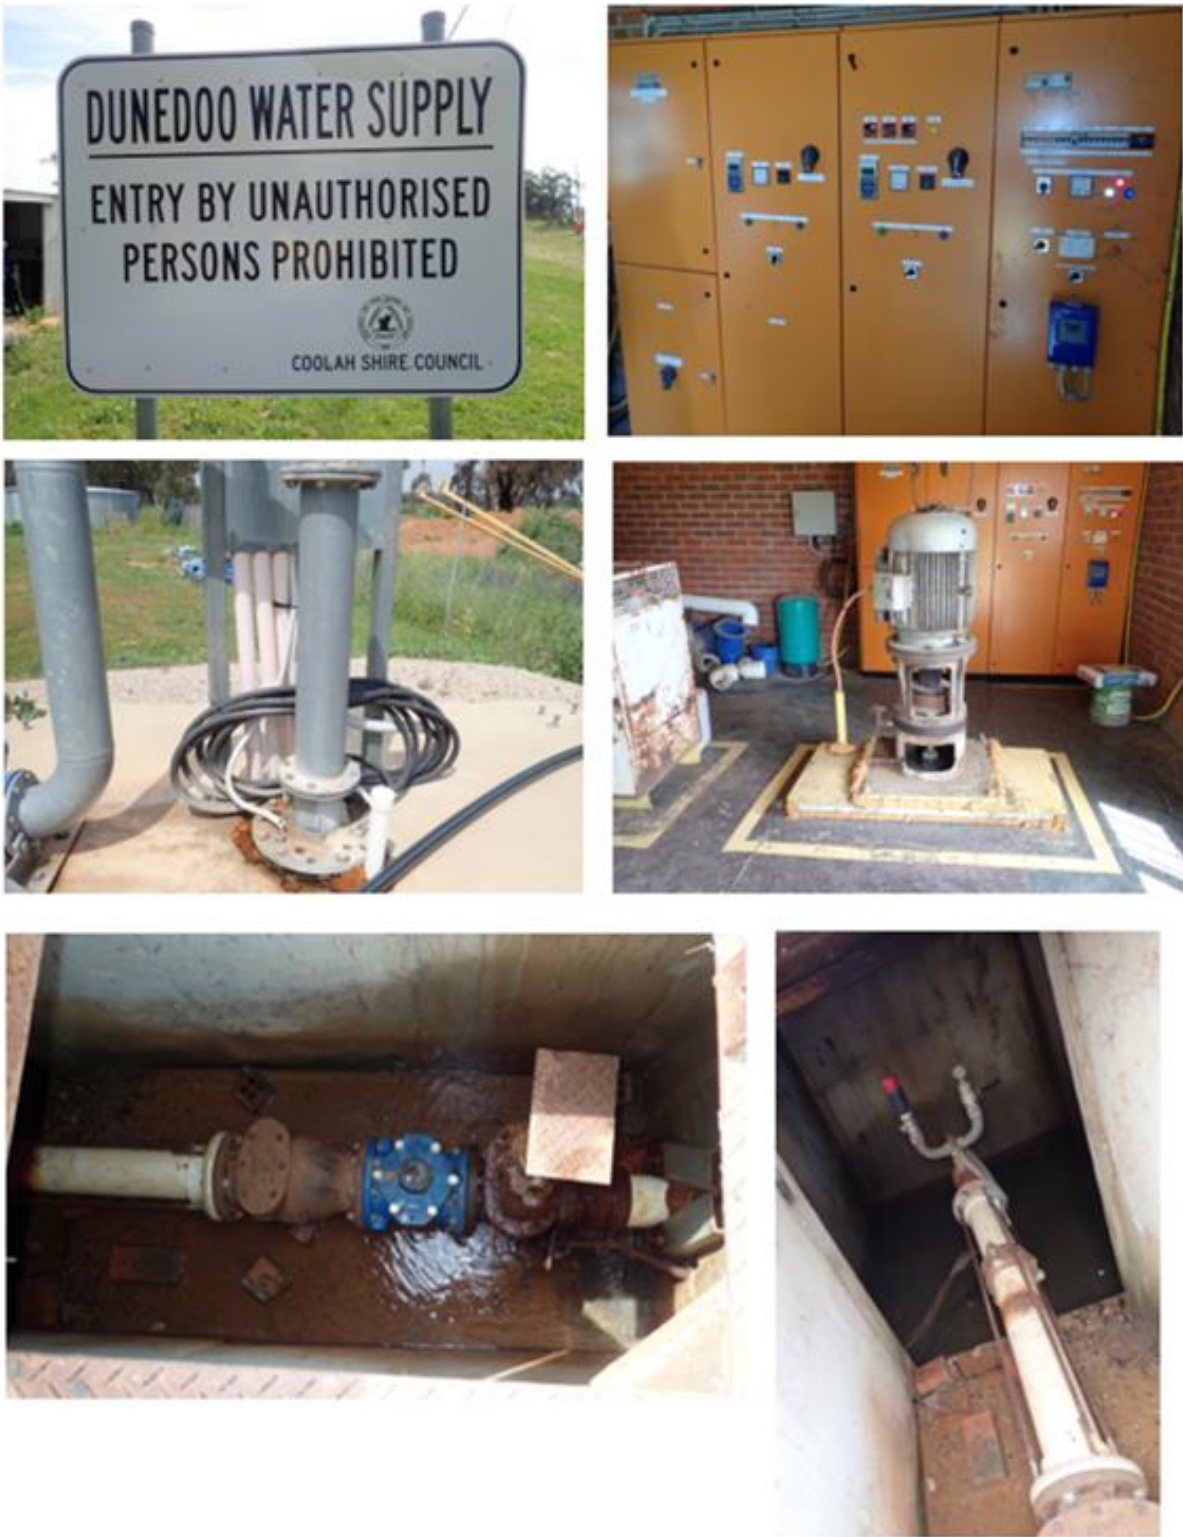
Figure 9 - Dunedoo Town Water Bore

Condition of casing, well cap and slab	Bore is in a pit, corrosion of surface casing could be an issue
Well age	37 years, moderate risk
Well type	Low risk
Screen type	Telescopic screen, low/moderate risk
Bore material	Mild steel, moderate/high risk
Pump depth setting	No record
Bore cementing	No
Gravel pack or natural pack	Natural pack, moderate/high risk
Water quality	No record
Iron level	No record
Salinity level	No record
Relationship of pump depth setting and screen level to iron hydroxide potential	No record
Comments	There is a presence of a white material on the pump column (possibly calcium)
Conclusion	Moderate risk

The bore is at moderate risk and due to its old age and a camera inspection is recommended, possibly in conjunction with a stage pump test, with retention of annual records to monitor bore performance over the long term.

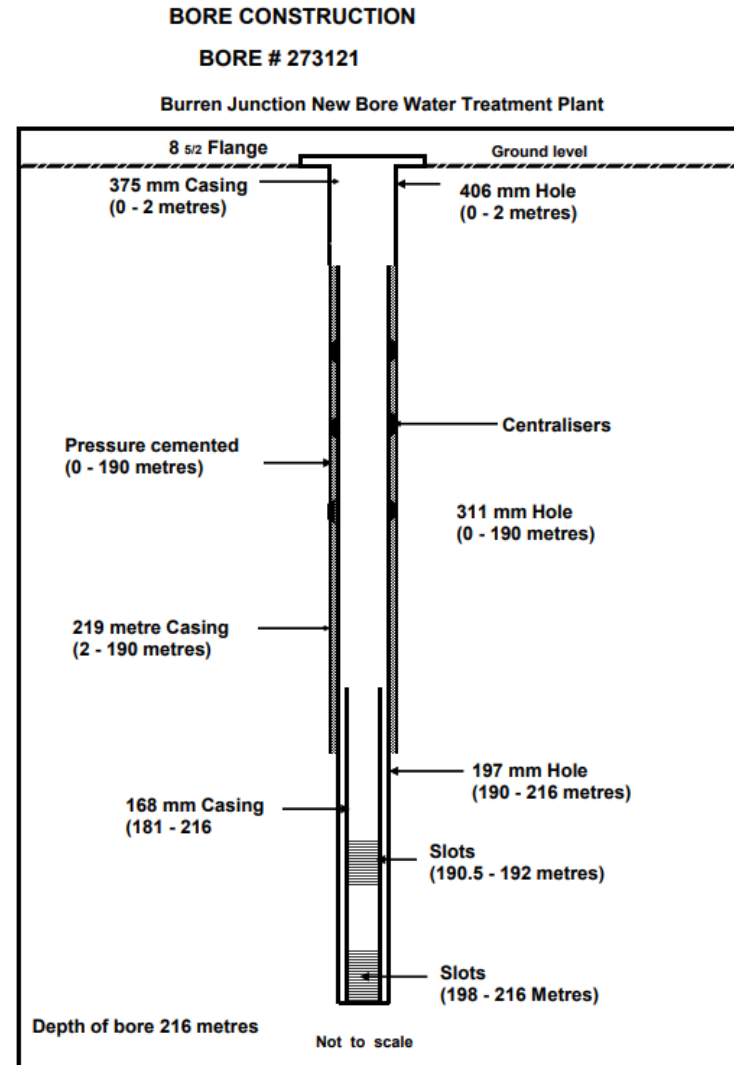
Figure 10 - Baradine Main Supply Bore

Condition of casing, well cap and slab	Low risk
Well age	11 years
Bore Reconditioned	No
Well Design	Low risk, cemented to 180 m and sub artesian
Screen material	Slotted casing, low risk
Bore material	Mild steel, low risk, cemented
Dissimilar metals	No
Bore cementing	Cemented to 180 m, surface casing, low risk
Water quality	No record
Iron level	No record, high in iron and manganese
Salinity level	No record
Relationship of pump depth setting and screen level to iron hydroxide potential	No record
Comments	Bore is only 11 years old, good design, low risk
Conclusion	Low risk

Camera inspection recommended to ensure iron and manganese fouling is not occurring in the bore.
