WARRUMBUNGLA SHIRE COUNCIL BARADINE BACK-UP BORE ASSESSMENT REPORT 14/12/2022

BARADINE BACK-UP BORE

Report No: WARRSC14122022
Date: 14/12/2022
Revision: 01
Author: Luke Woods
Project Manager: Luke Woods
File Name: Warrumbungle Shire Council – Baradine Back - Up Bore Assessment Report
14/12/2022

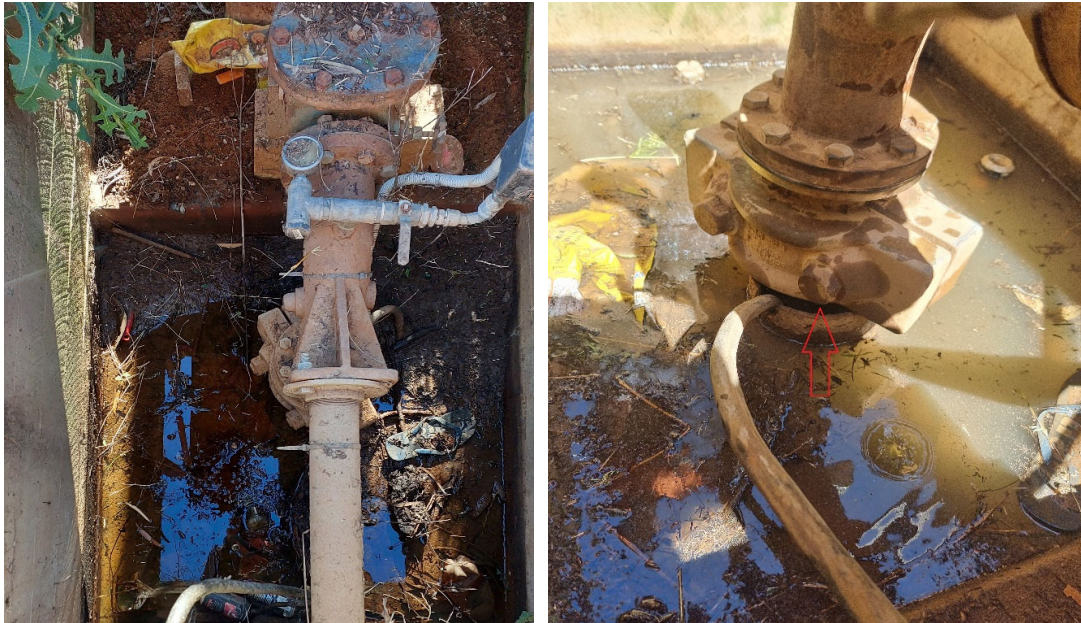
- Bore headworks noted to be of poor design which would fail to meet the NSW health guidelines for groundwater. Bore headworks noted to be unsealed and open at ground level, which would be allowing biological contaminants to enter the bore.

- Rising main noted to be suspended at the top of the bore casing with a mild steel clamp, the clamp was noted to be resting on the top of the casing with no form sealing and a large gap present.

Unsealed headworks as viewed from surface.

- Corrective works undertaken on the headworks to meet the NSW health guidelines for ground water. This will need to include IP68 rated electrical glands and redesign of the bore cap to allow a weatherproof seal to the top of the bore casing.

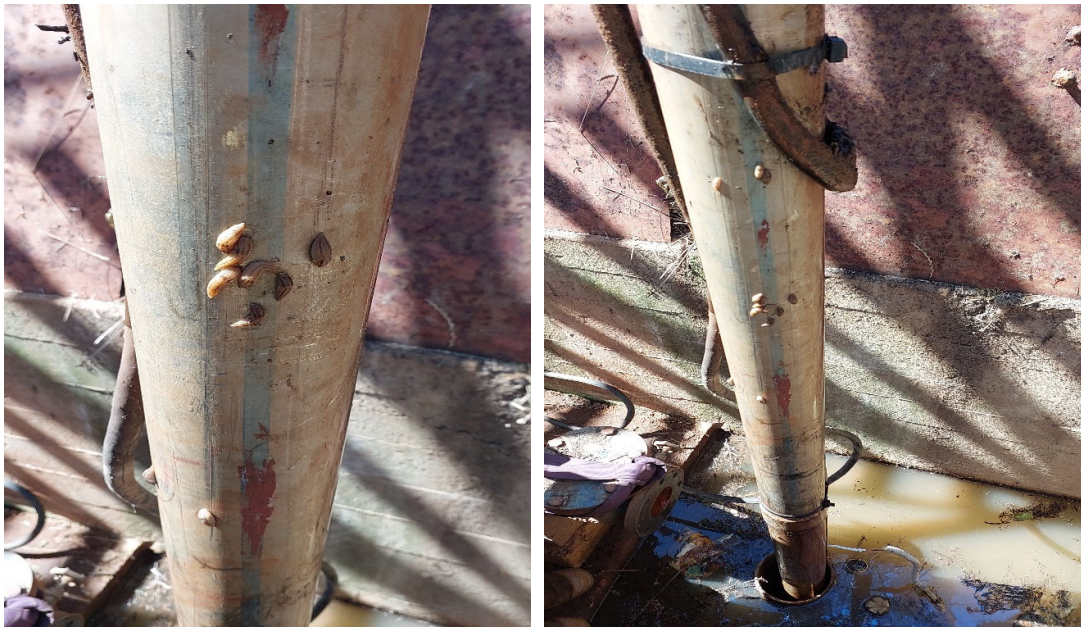
- Upon extraction of the pump Biological contamination was noted at the on the pump column, contamination noted to be slugs.
- Rising main construction noted to be 115mm stainless steel column in 3m lengths with threaded couplings. Column noted to have been welded at each coupling across its full depth.

Condition of pumping equipment showing biological contamination.

- Upgrading the pump rising main from the stainless-steel column to a 4inch 102mm Flexibore 250 crusader hose for ease of future maintenance.
- Disinfection and cleaning of the bore pump prior to reinstallation.

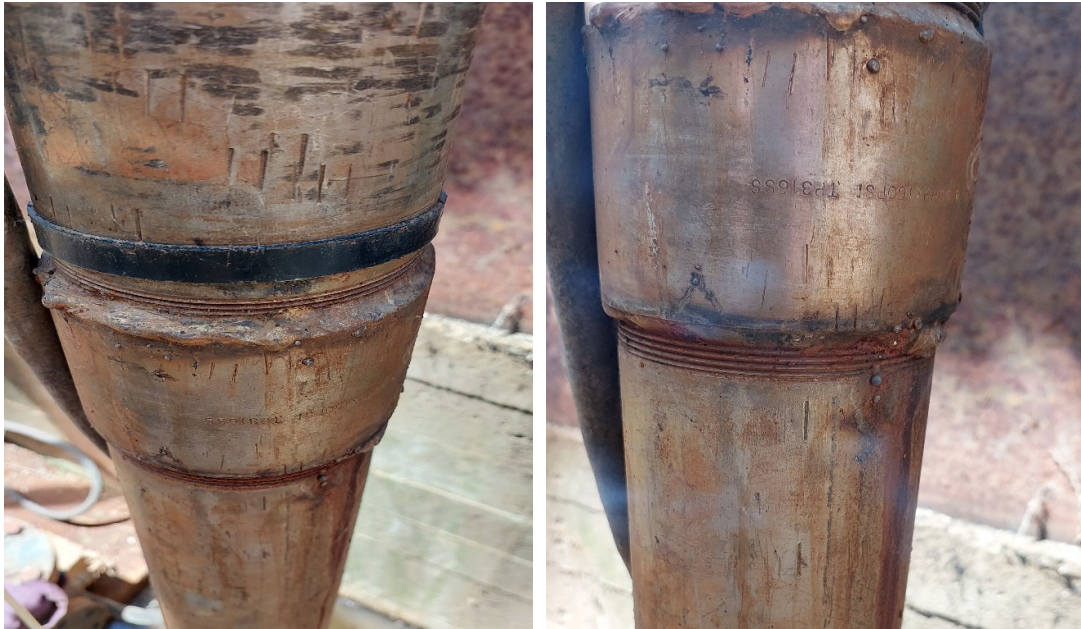
Condition of pumping equipment showing welded couplings.

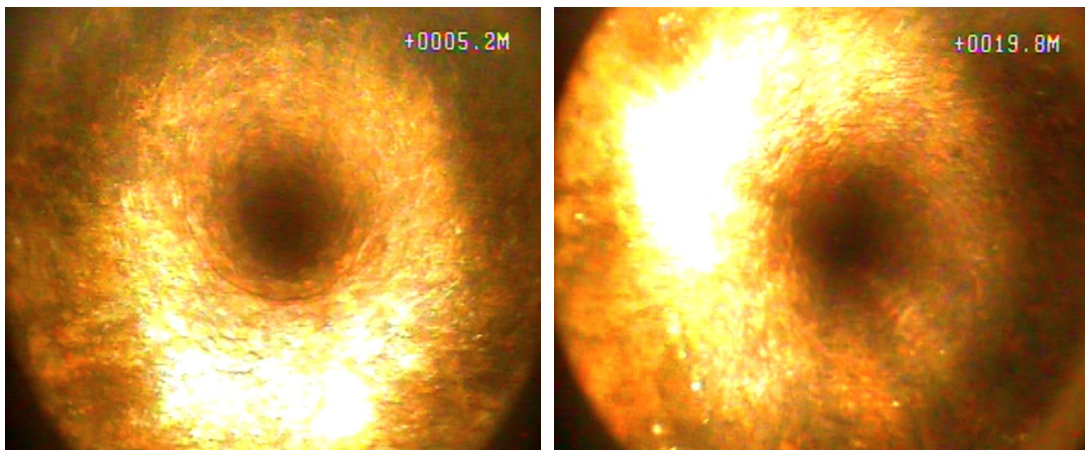
- The Pump set depth was noted to be approximately 60m.
- Substantial pitting and corrosion noted through mild steel casing wall above standing water table, this indicates that the apparent metal loss has been severe and the casing wall will be extremely thin.

Bore at 5.20m and 19.80m showing condition of mild steel casing above the standing water level.

- Stainless steel swage relining operations to be undertaken over the full depth of the bore with stainless steel screens installed over the slotted mild steel section and stainless-steel casing over the mild steel section. This will effectively create a full stainless steel bore design.

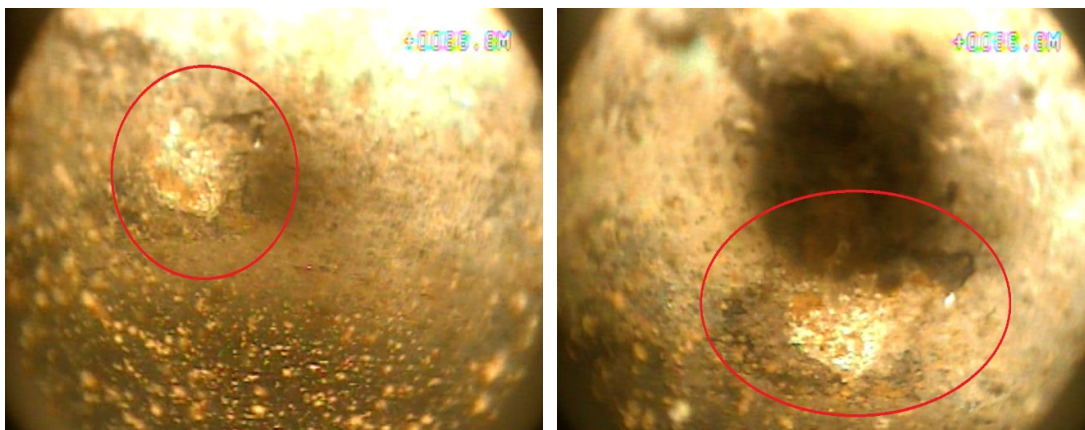
Significant corrosion / hole noted through mild steel casing wall at 86.80m.

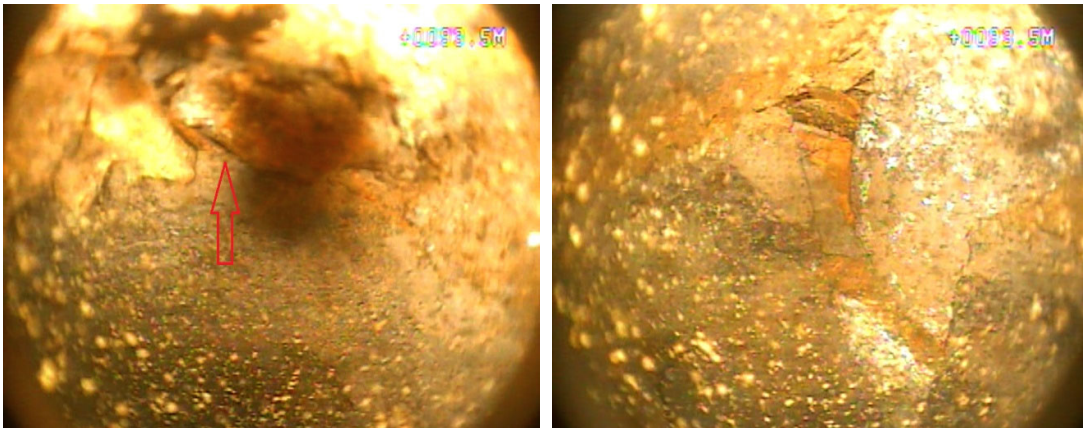
J Latch step noted at 93.50m.

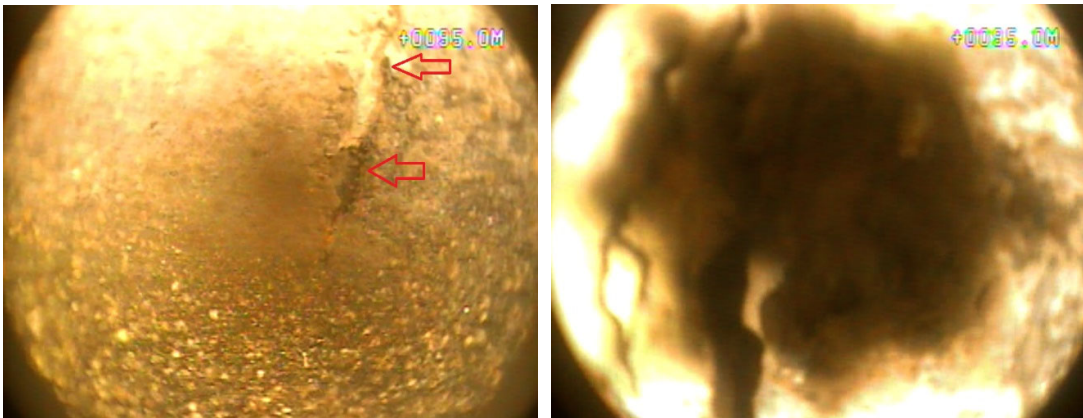
Slotted section noted to commence at 95.00m, slotted apertures noted to be significantly corroded and enlarged.

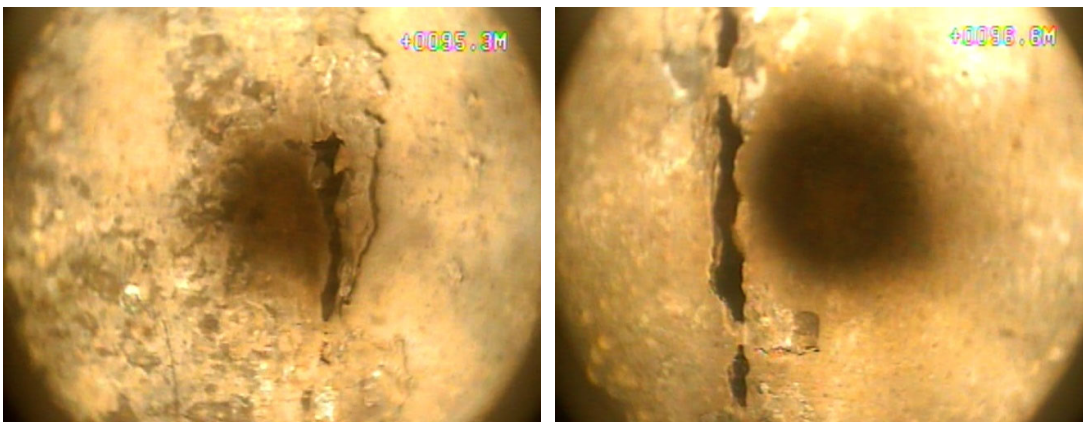
Slotted section at 95.30m and 96.60m showing corrosion around apertures.

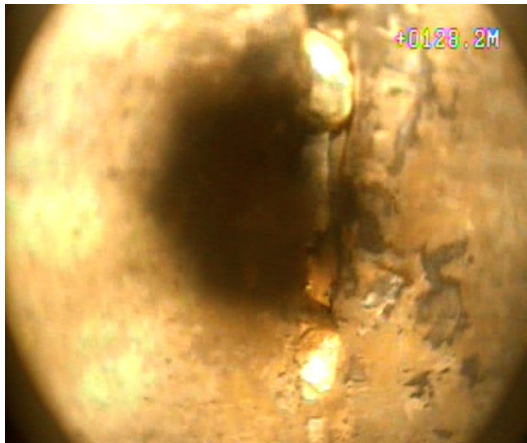
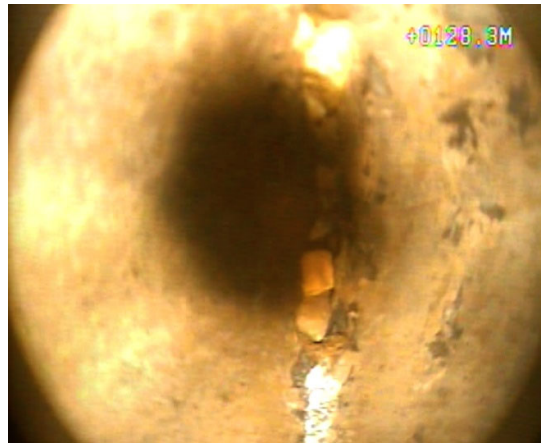
Slotted aperture at 128.30m noted to be heavily corroded with gravel ingress into bore occurring.

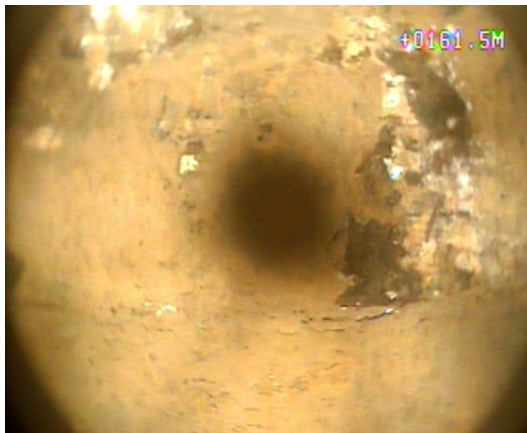
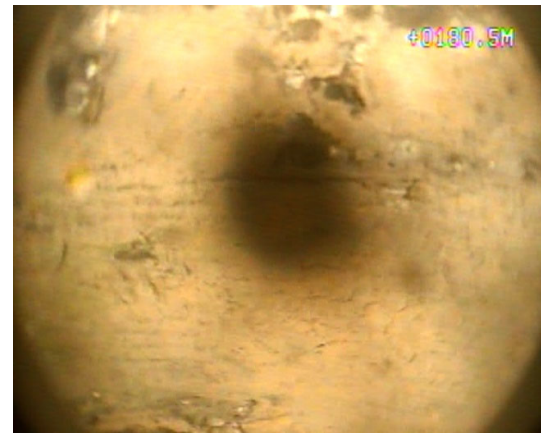
- Significant corrosion and partial separation noted on mild steel threaded join at 148.70m.
- Significant corrosion and partial separation noted on mild steel threaded join at 161.50m

- Significant corrosion and partial separation noted on mild steel threaded join at 180.50m
- Slotted section noted to have significant growth and encrustation present over the slotted apertures.

Threaded joints at 161.50m and 180.50m showing corrosion present.

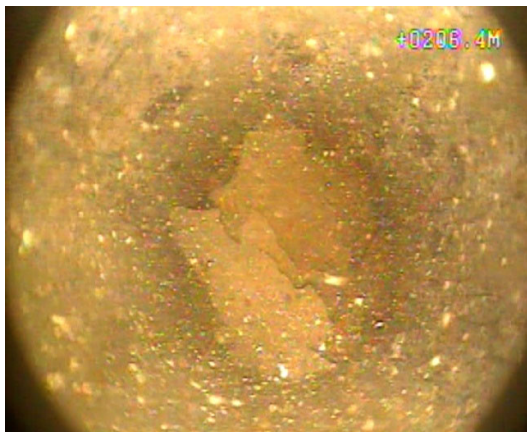
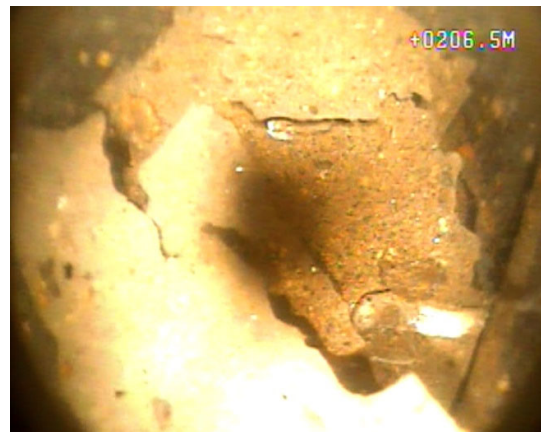
- Bottom depth encountered was 206.60m and the construction depth specified in the Groundworks report is 220.90m indicating that there is 14.30m of debris / fill present in the bottom of the bore.

Bottom of bore encountered at 206.50m.

The encountered bottom depth was 206.60m and the construction depth specified in the groundworks report is 220.90m indicating that the bore has 14.30m of fill and debris present in the bottom.

- Removal of the bore pump to allow the corrective works to be undertaken.
- Removal of the fill noted in the bottom of the bore and reopening the bore back to its original constructed depth via bailing operations.
