WARRUMBUNGLE SHIRE COUNCIL BARADINE MAIN BORE ASSESSMENT REPORT 15/12/2022

Report No: WARRSC15122022
Date: 15/12/2022
Revision: 01
Author: Luke Woods
Project Manager: Luke Woods
File Name: Warrumbungle Shire Council – Baradine Main Bore Assessment Report
15/12/2022

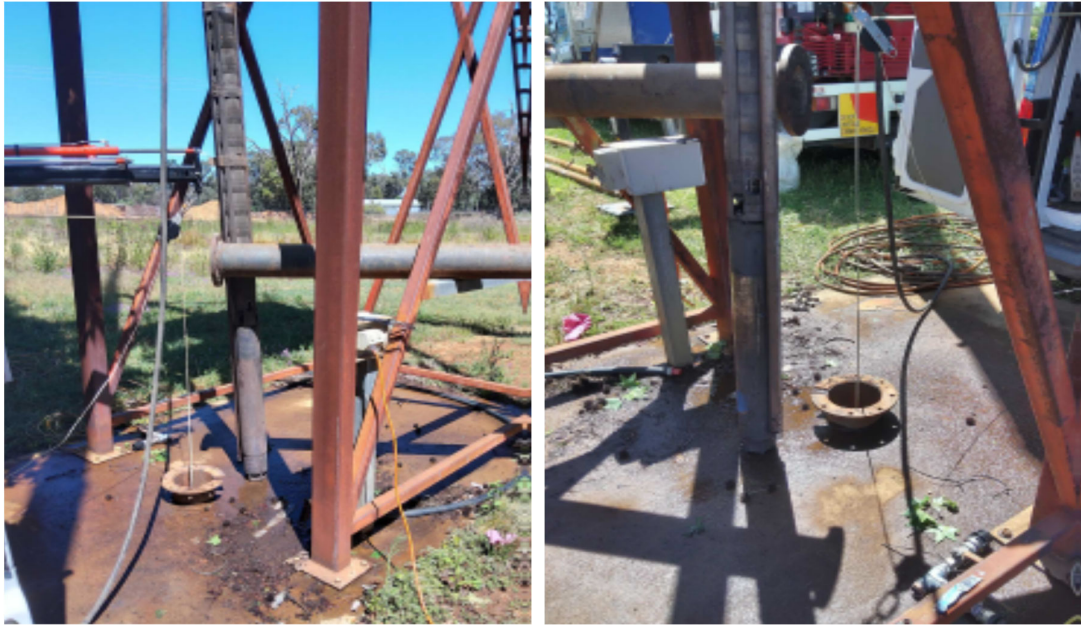
- Bore headworks noted to be of poor design which would fail to meet the NSW health guidelines for groundwater. Bore headworks noted to be unsealed and open at ground level, which would be allowing biological contaminants to enter the bore.

- Rising main noted to be suspended at the top of the bore casing with a mild steel clamp, the clamp was noted to be resting on the top of the casing with no form sealing and a large gap present.

Condition of pumping equipment.

- Corrective works undertaken on the headworks to meet the NSW health guidelines for ground water. This will need to include IP68 rated electrical glands and redesign of the bore cap to allow a weatherproof seal to the top of the bore casing.

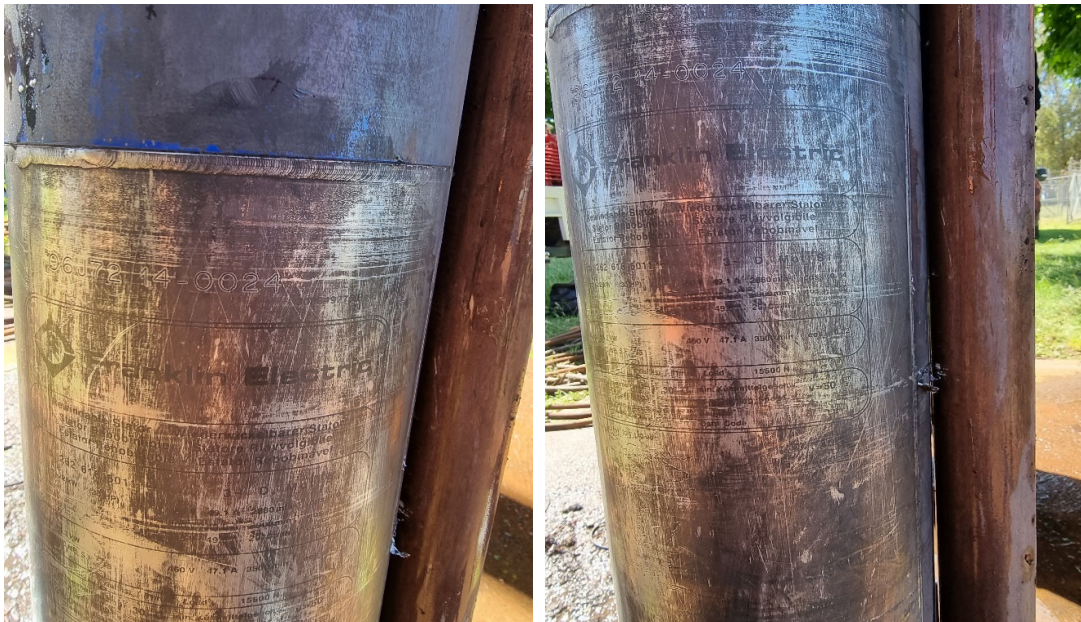
Identification plates as noted on submersible pump.

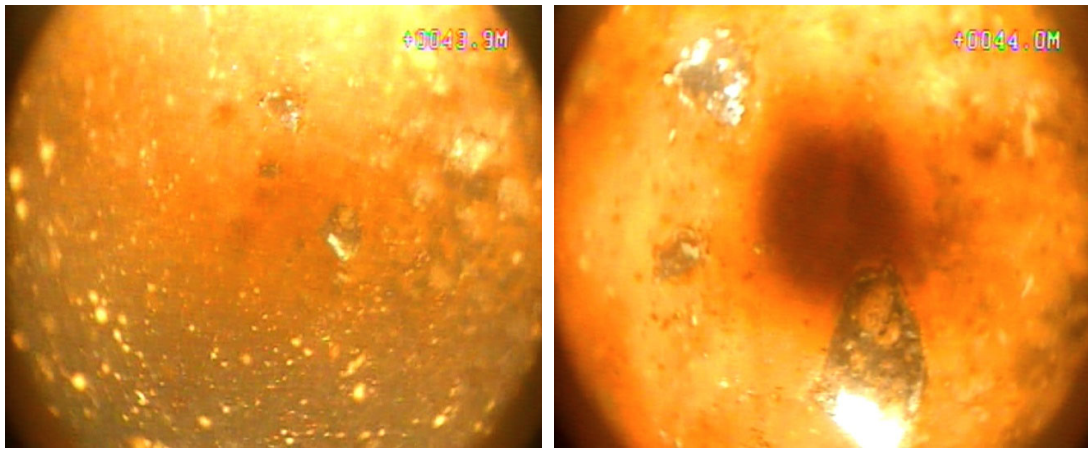
- Significant levels of iron related bacteria growth noted to be present on the mild steel casing wall.
- Numerous areas of corrosion noted.
- J-Lacth step noted at 181.30m, bore construction noted to step down at this depth from 206.00mm inside diameter to 158.00mm inside diameter.

Bore at 43.90m and 44.00m showing iron related bacteria growth.

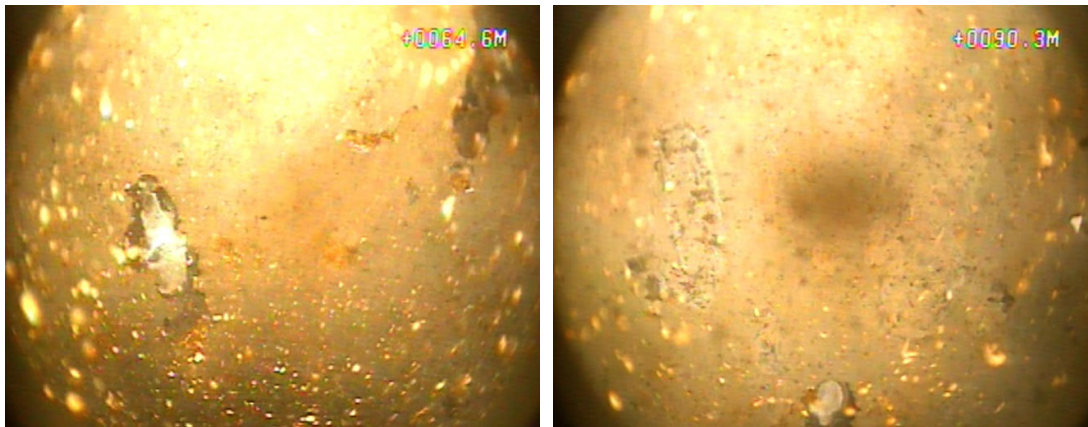
Bore at 64.60m and 90.30m showing the condition of the mild steel casing.

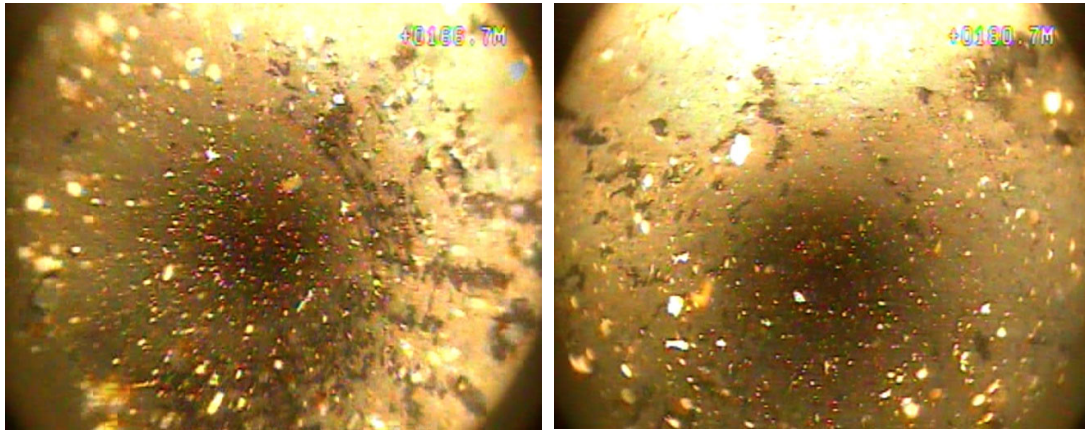
Bore at 166.70m and 180.70m showing the condition of the mild steel casing and corrosion occurring.

During the camera inspection implemented on the 15/12/2022 the overall structural condition of the bore was noted to be extremely poor. Numerous areas of significant corrosion were noted through the mild steel casing wall. This indicates that the mild steel casing has reached the end of its useful lifespan.

- Stainless steel swage relining operations to be undertaken over the full depth of the bore with stainless steel screens installed over the slotted mild steel section and stainless-steel casing over the mild steel section. This will effectively create a full stainless steel bore design.

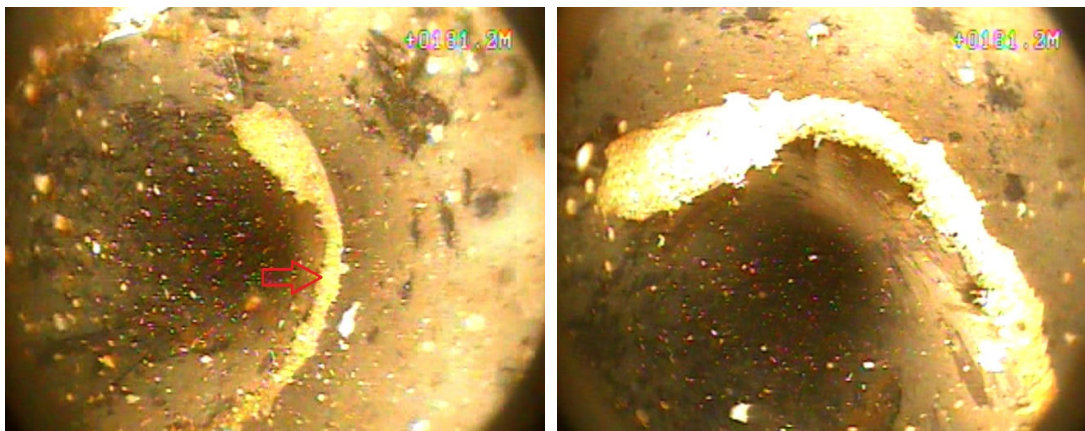
J Latch step noted at 181.30m.

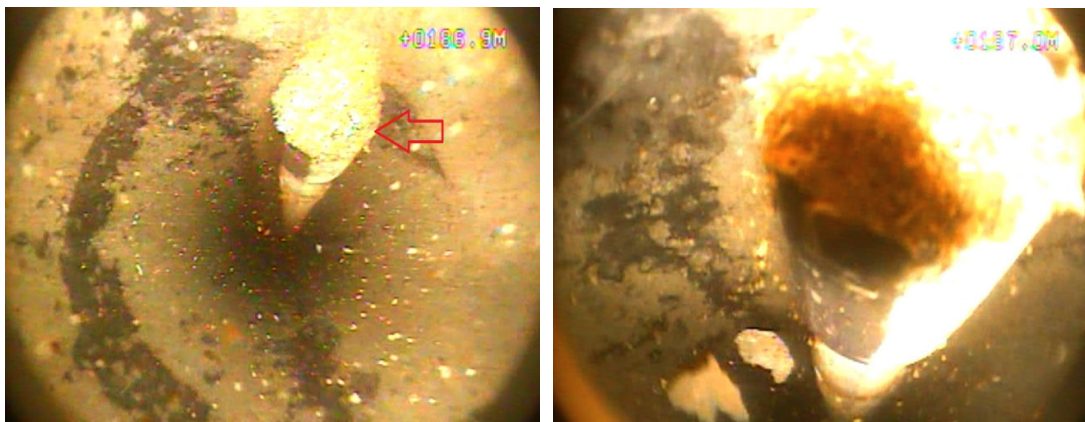
Foreign object noted in bore at 187.00m, object appears to be small diameter PVC pipe.

- Removal of the bore pump to allow the corrective works to be undertaken.
- Retrieval of the foreign object via fishing operations.
- Removal of the fill noted in the bottom of the bore and reopening the bore back to its original constructed depth via bailing operations.

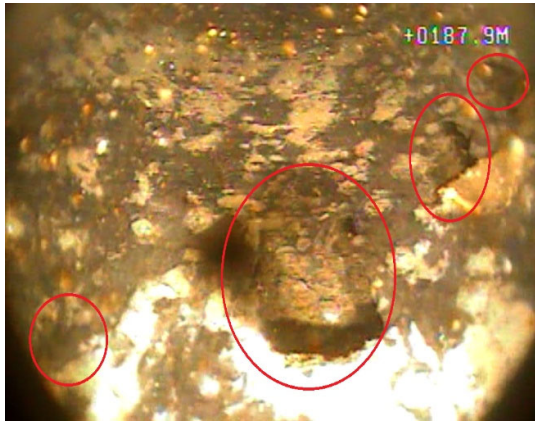
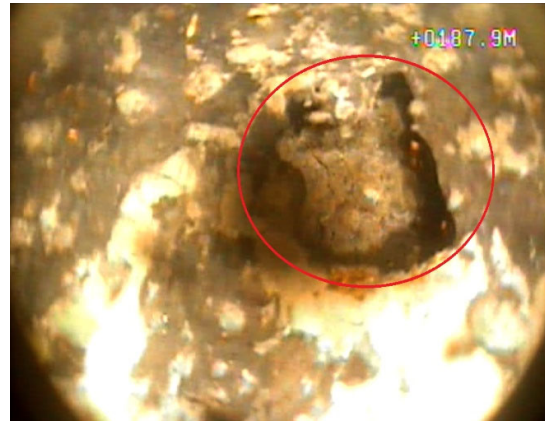
Large hole noted through mild steel casing wall at 187.90m.

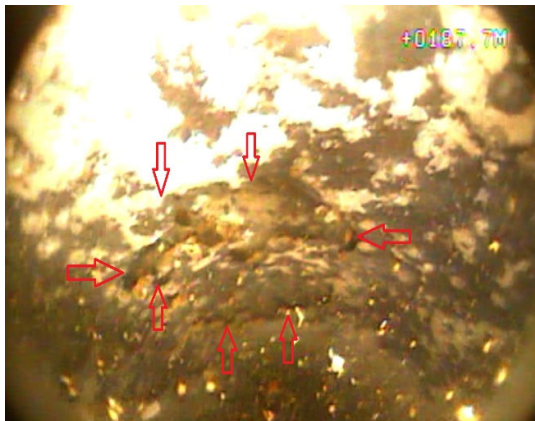
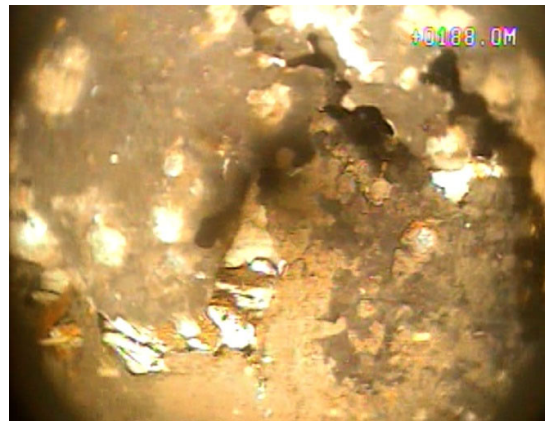
Large hole noted through mild steel casing wall at 188.00m.

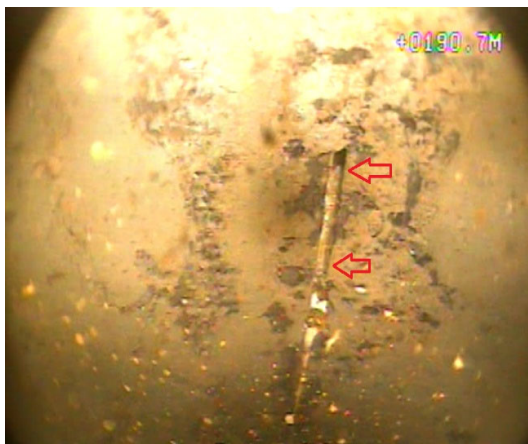
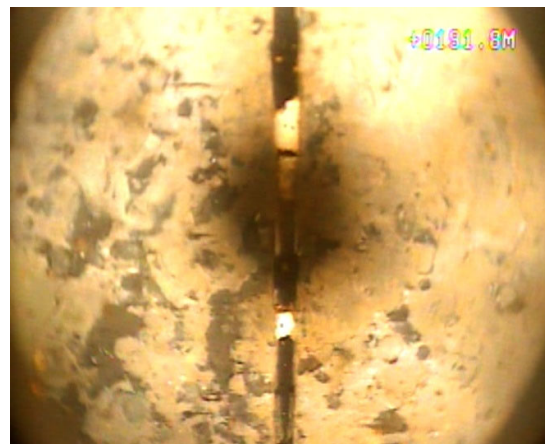
Slotted section at 190.70m and 191.80m.

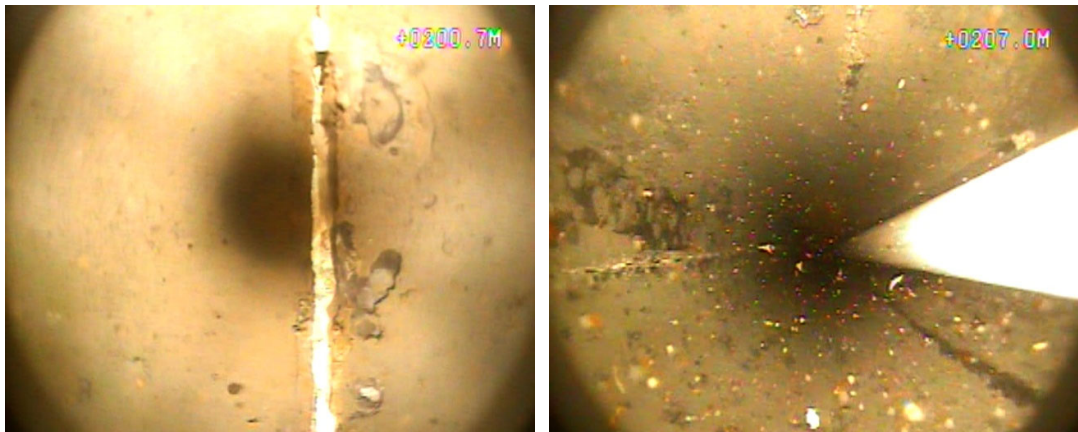
Slotted section at 200.70m and 207.00m.

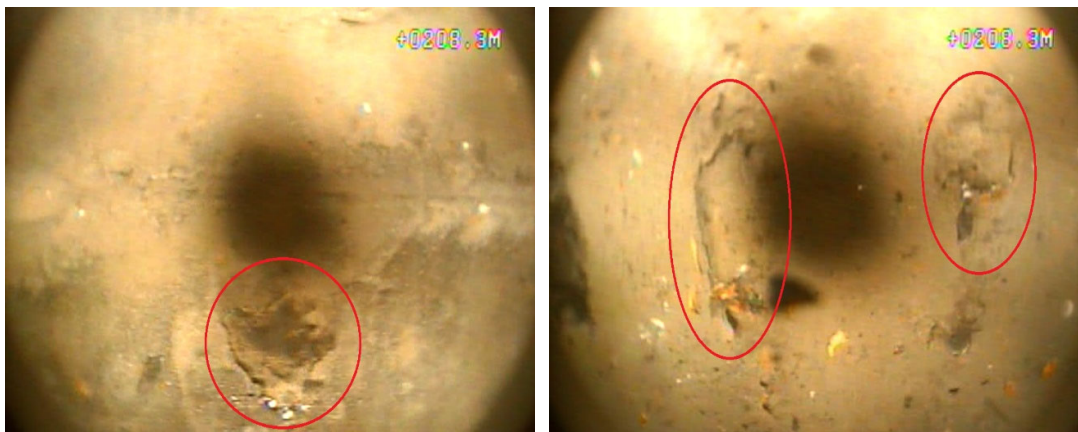
Corrosion and holes noted through mild steel weld join at 208.30m.

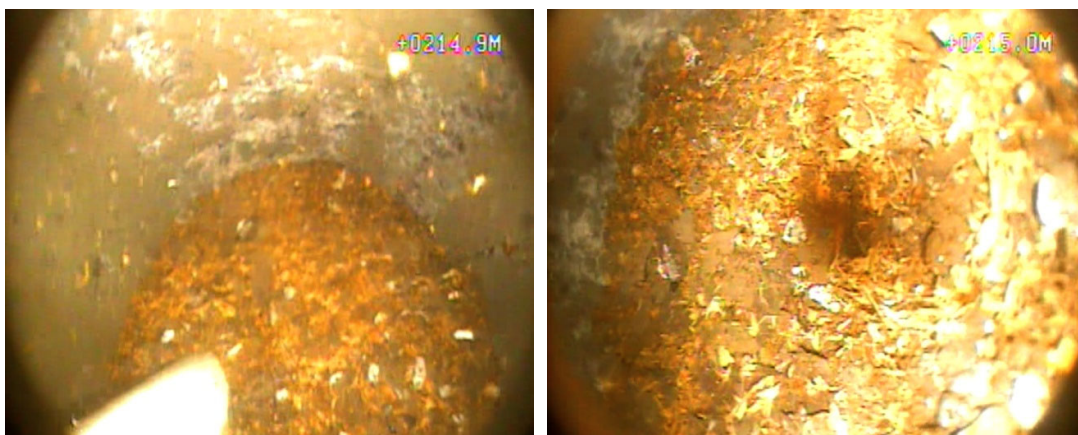
Bottom of bore encountered at 215.00m.

The encountered bottom depth was 215.00m and the construction depth specified in the groundworks report is 216.00m indicating that the bore has 1.00m of fill and debris present in the bottom.
