WARRUMBUNGLE SHIRE COUNCIL BUGALDIE BORE ASSESSMENT REPORT 06/12/2022

Warrumbungle Shire Council – Bugaldie Bore

Assessment Report 06/12/2022

Report No: WARRSC06122022
Date: 06/12/2022
Revision: 01
Author: Luke Woods
Project Manager: Luke Woods
File Name: Warrumbungle Shire Council – Bugaldie Bore Assessment Report 06/12/2022

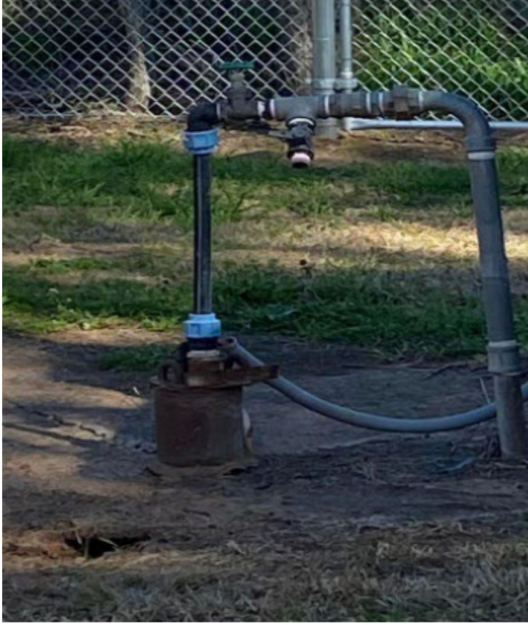
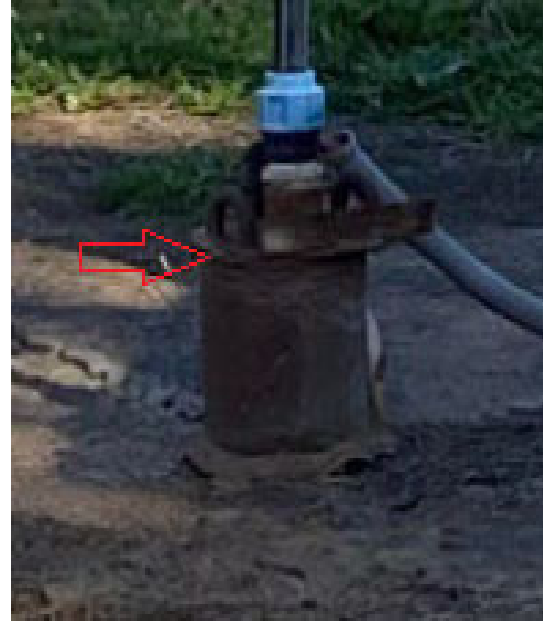
- Bore headworks noted to be of poor design which would fail to meet the NSW health guidelines for groundwater. Bore headworks noted to be unsealed and open at ground level, which would be allowing biological contaminants to enter the bore.

Unsealed headworks as viewed from surface.

- Corrective works undertaken on the headworks to meet the NSW health guidelines for ground water. This will need to include IP68 rated electrical glands and redesign of the bore cap to allow a weatherproof seal to the top of the bore casing.

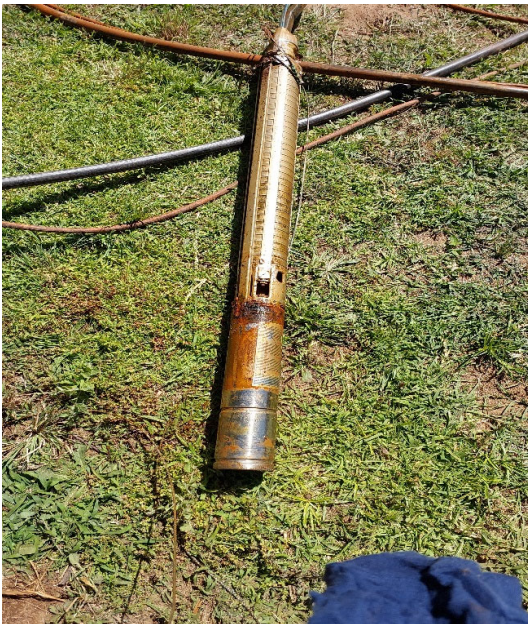
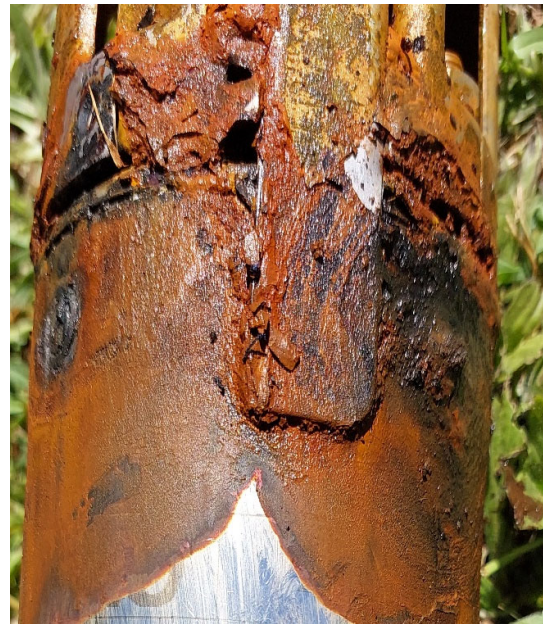
- Submersible pump and poly rising main were noted to have moderate growth levels present.
- Substantial pitting and corrosion noted through mild steel casing wall above standing water table, this indicates that the apparent metal loss has been severe and the casing wall will be extremely thin.

Condition of pumping equipment showing Iron Bacteria.

- Disinfection and cleaning of the bore pump prior to reinstallation.

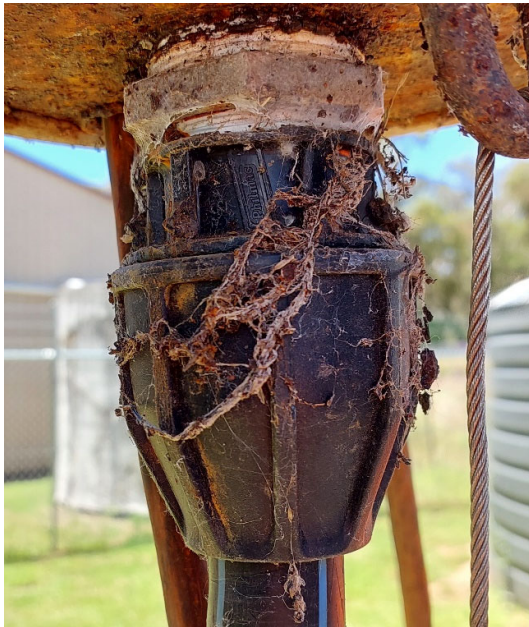
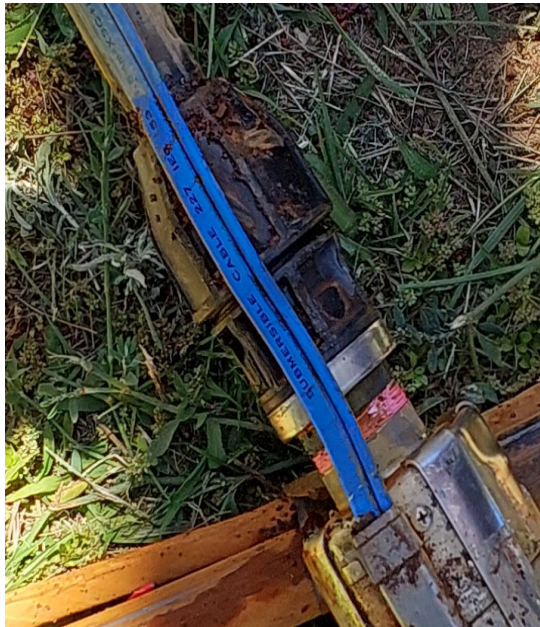
- The Poly fittings on the poly rising main were noted to be of the rural low pressure type with a pressure rating of 115 PSI.
- The Pump set depth was noted to be approximately 90m.

Rural poly fittings as noted on bore cap and pump outlet.

- Replacing the electrical submersible pump power cable.
- Replacing the rural poly pipe fittings for blue line poly pipe fittings with a pressure rating of 180 PSI.

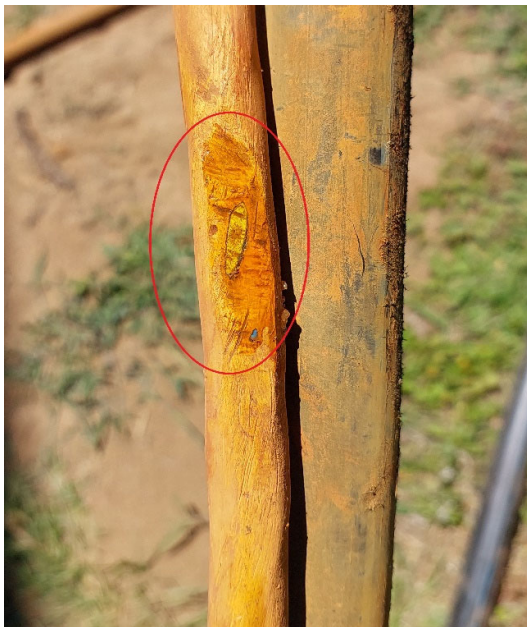
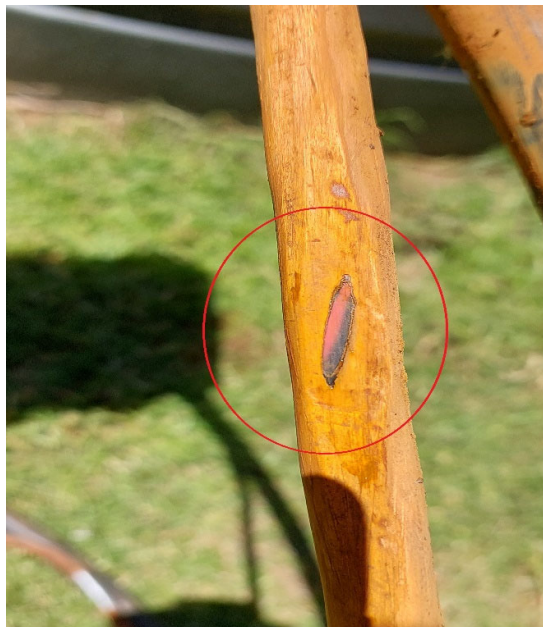
- The submersible electrical power cable was noted to be of an inadequate design lacking the rubber outer sheath. Numerous rub marks were noted over the length of the power cable.

Damaged submersible pump electrical cable.

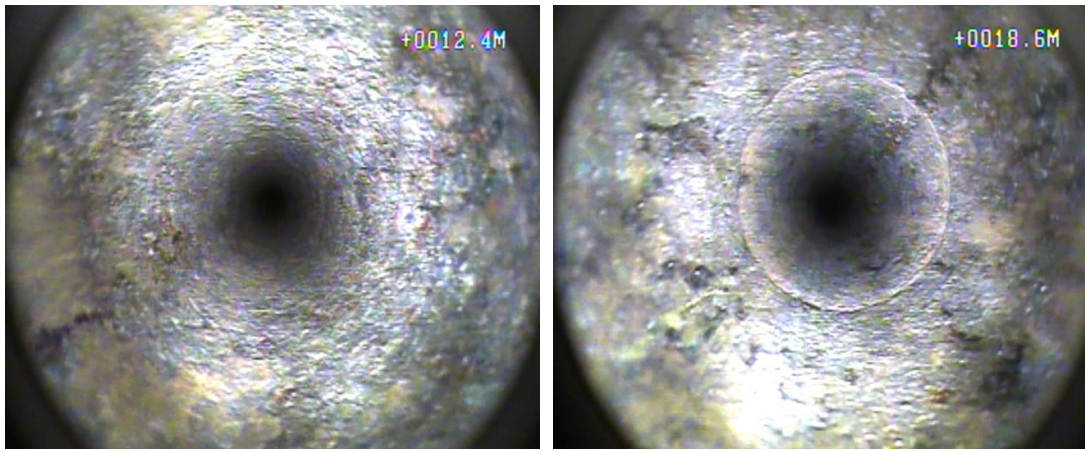
Bore at 12.40m and 18.60m showing condition of mild steel casing above the standing water level and corrosion around the mild steel threaded joints.

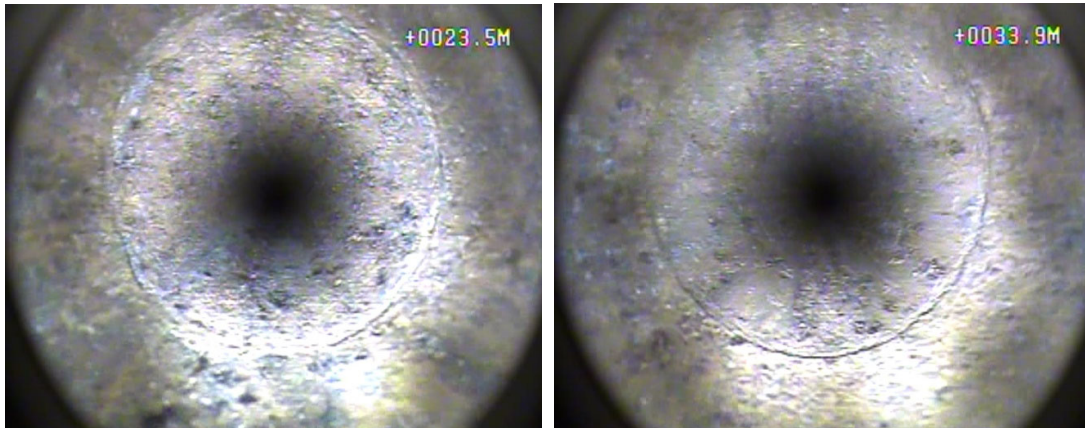
Bore at 23.50m and 33.90m showing condition of mild steel casing above the standing water level and corrosion around the mild steel threaded joints.

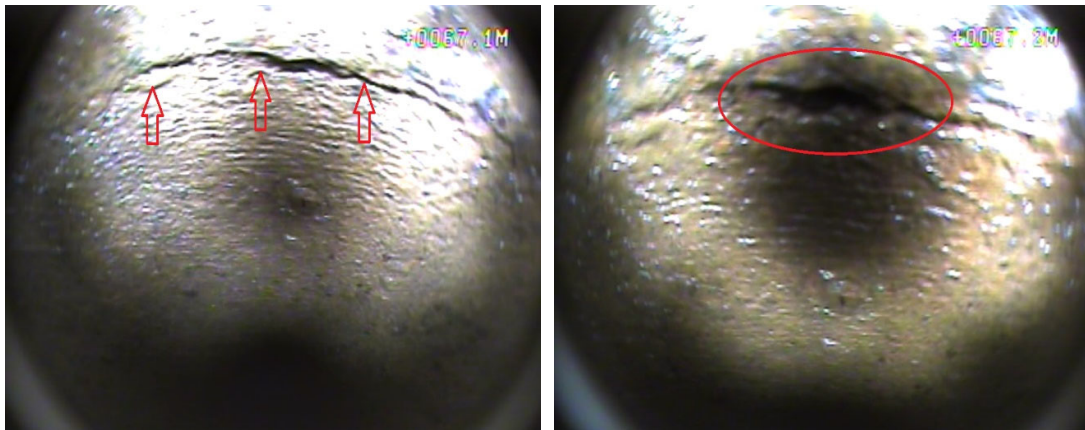
- Bore construction noted to consist of threaded mild steel casing.
- Hole noted through mild steel threaded join at 67.20m.
- Large particles noted to be suspended in the water column and the water column was noted to have high turbidity levels present, visibility was noted to be very poor.

Bore at 67.20m showing corrosion and hole through mild steel threaded joint.

- Stainless steel swage relining operations to be undertaken over the full depth of the bore with stainless steel screens installed over the uncased section and stainless-steel casing over the mild steel section. This will effectively create a full stainless steel bore design.

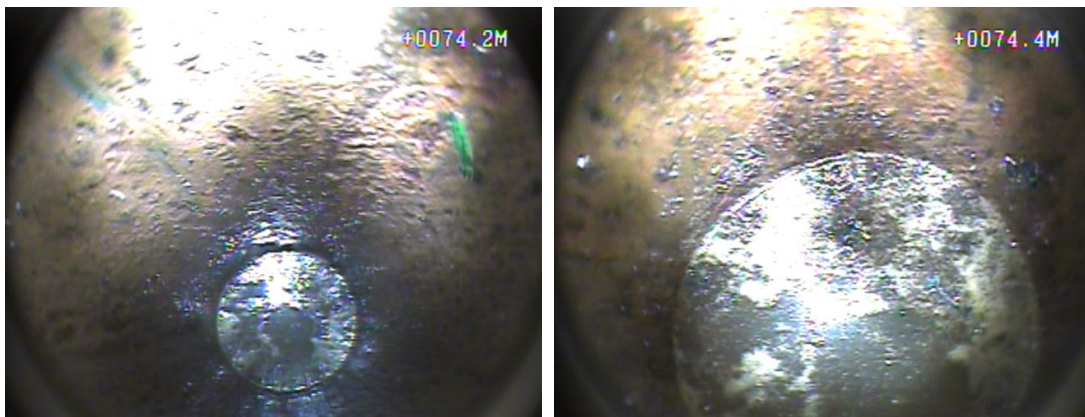
Bore at 74.20m showing condition of mild steel casing and the standing water level at 74.40m.

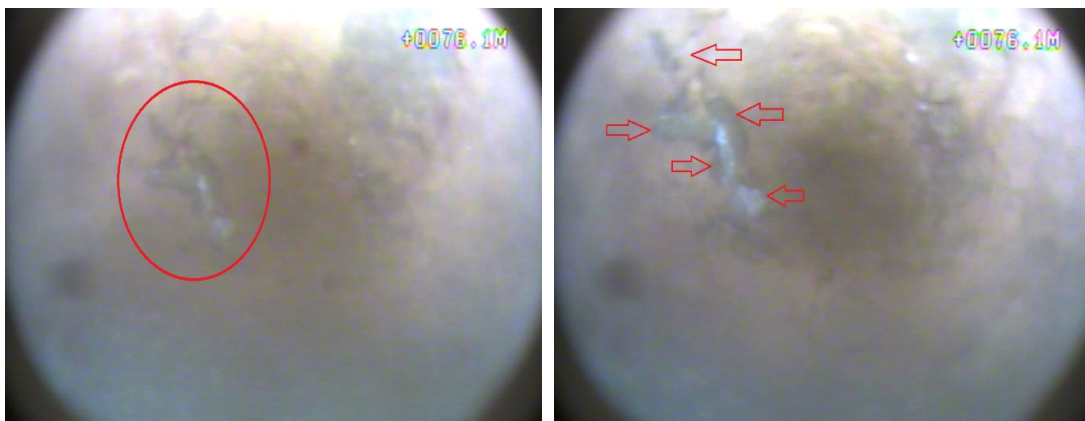
- Corrosion and possible hole through mild steel casing wall at 76.10m.
- Significant corrosion and holes noted through mild steel casing wall between 83.30m and 83.40m.

Corrosion and possible hole through mild steel casing wall at 76.10m.

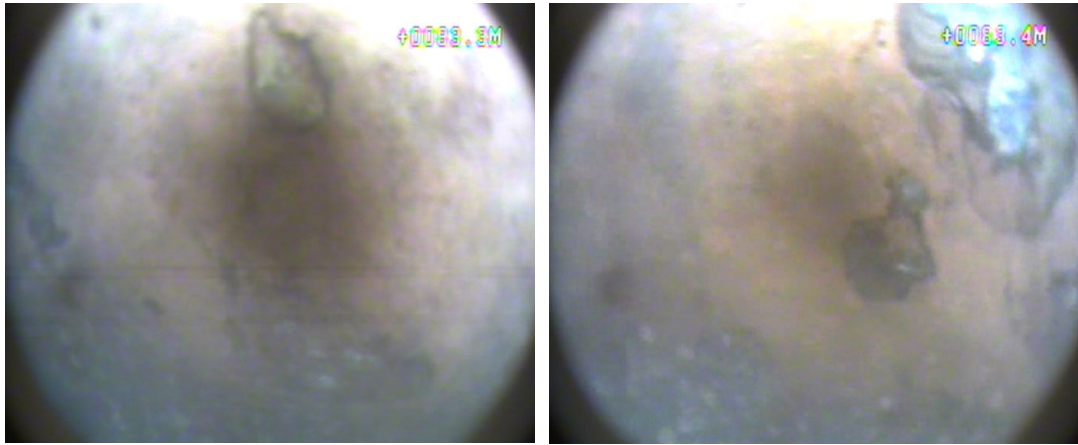
Significant corrosion and holes noted through mild steel casing wall between 83.30m and 83.40m.

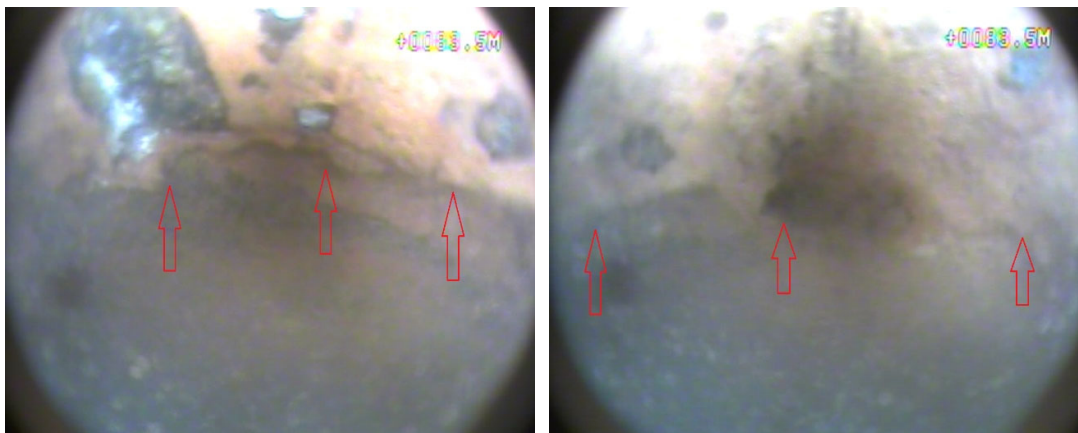
Termination of mild steel casing at 83.50m.

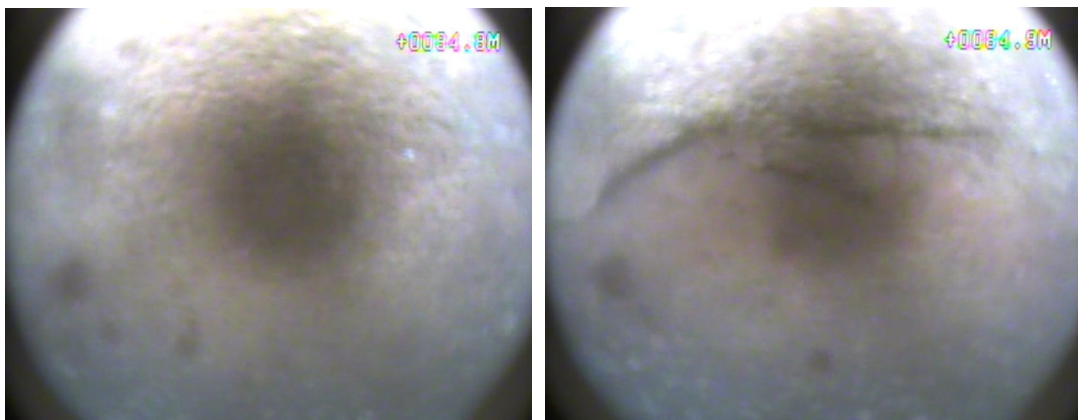
Open hole section of bore at 84.80m & 84.90m.

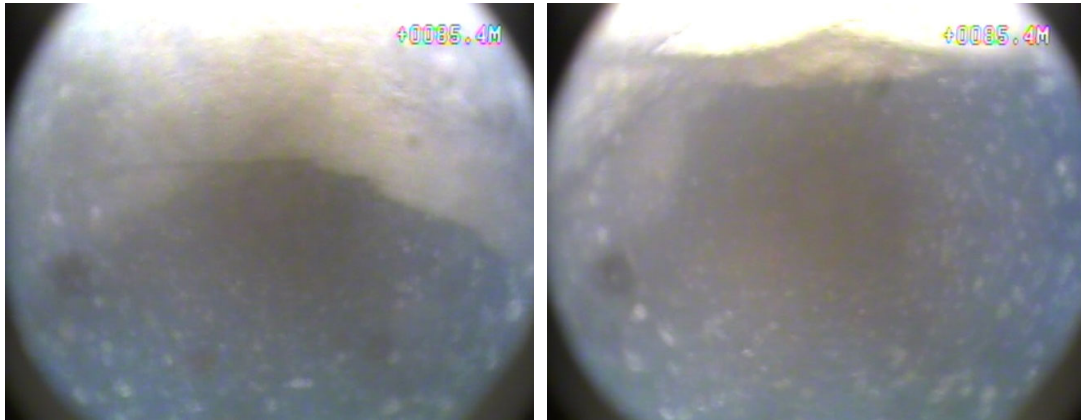
Open hole section of bore at 85.40m, showing large cavity.

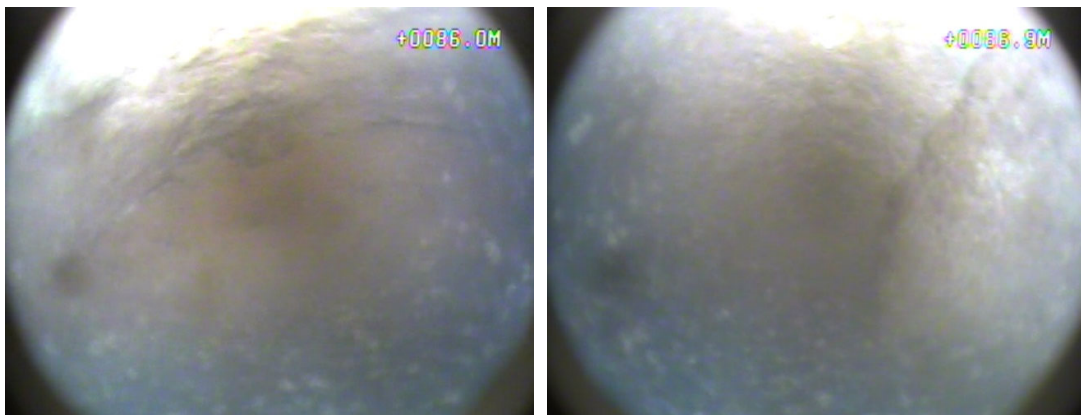
- Large cavity noted through open section of the bore from 85.40m, loose gravels and rocks noted.
- Open hole section of bore at 86.00m & 86.90m was noted to have rough formation and slight ledges which could be causing the rubbing issues on the electrical cable and poly riser.

Open hole section of bore at 86.00m & 86.90m, showing rough formation and slight ledges.

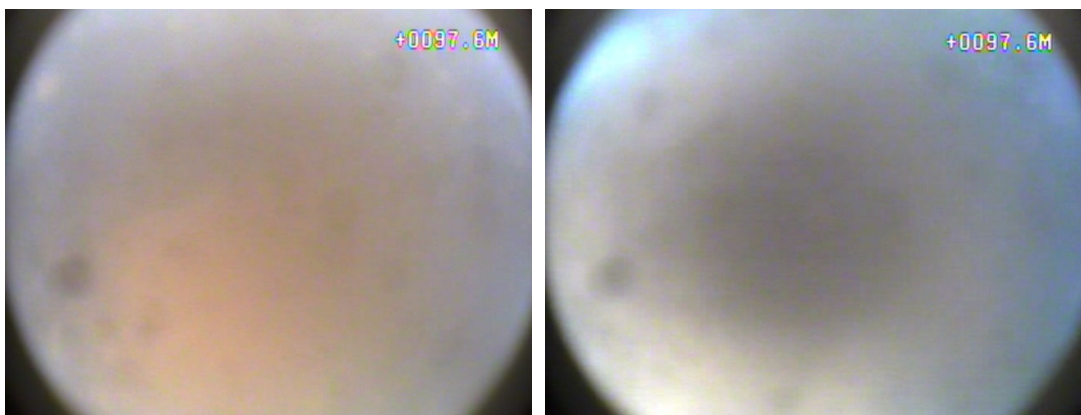
Bottom of bore encountered at 97.60m.

- Removal of the bore pump to allow the corrective works to be undertaken.
- Removal of any fill in the bottom of the bore and reopening the bore back to its original constructed depth.
