# WARRUMBUNGLE SHIRE COUNCIL COONABARABRAN BORE 2 ASSESSMENT REPORT 05/12/2022

Warrumbungle Shire Council – Coonabarabran

Bore 2 Assessment Report 05/12/2022

Report No: WARRSC05122022  
Date: 05/12/2022  
Revision: 01  
Author: Luke Woods  
Project Manager: Luke Woods  
File Name: Warrumbungle Shire Council – Coonabarabran Bore 2 Assessment Report  
05/12/2022

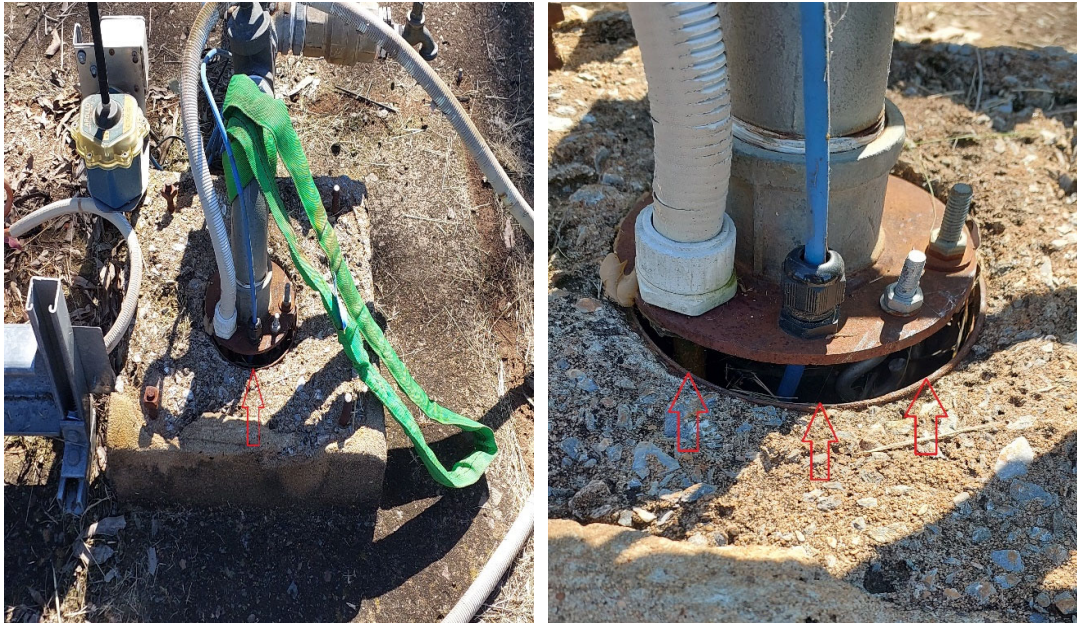
- Bore headworks noted to be of poor design which would fail to meet the NSW health guidelines for groundwater. Bore headworks noted to be unsealed and open at ground level, which is allowing surface water run off and biological contaminants to enter the bore.

Unsealed headworks as viewed from surface.

- Corrective works undertaken on the headworks to meet the NSW health guidelines for ground water. This will need to include IP68 rated electrical glands and redesign of the bore cap to allow a weatherproof seal to the top of the bore casing.

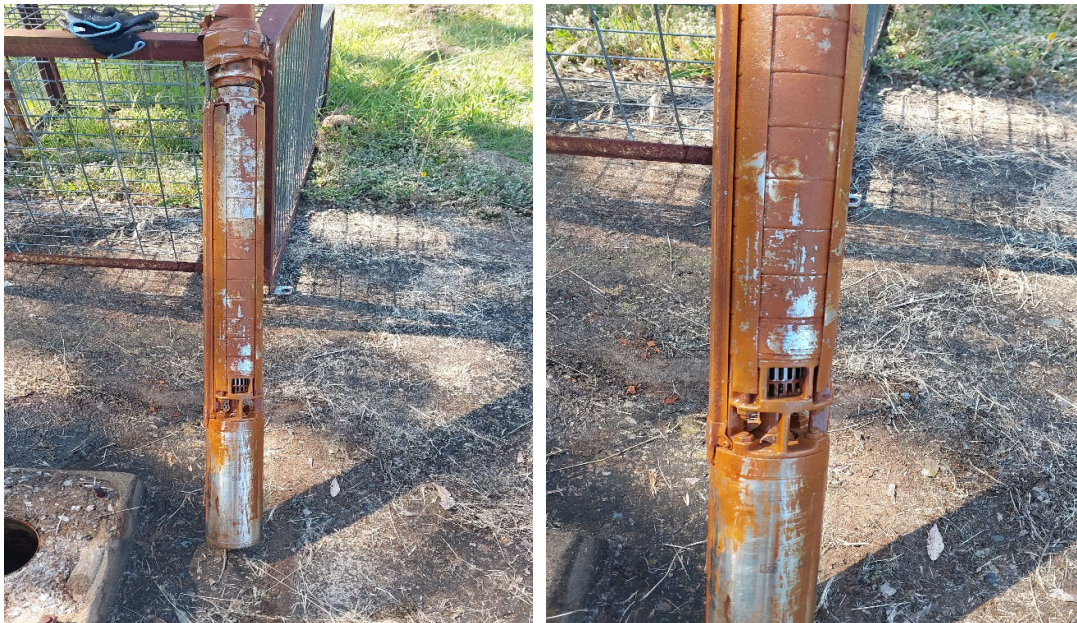
- Upon extraction of the submersible pump and poly pipe rising main was noted to be in reasonable condition.
- Submersible pump was noted to have moderate growth levels present on the pump body.

Condition of pumping equipment showing Iron Bacteria.

- Disinfection and cleaning of the bore pump prior to reinstallation.

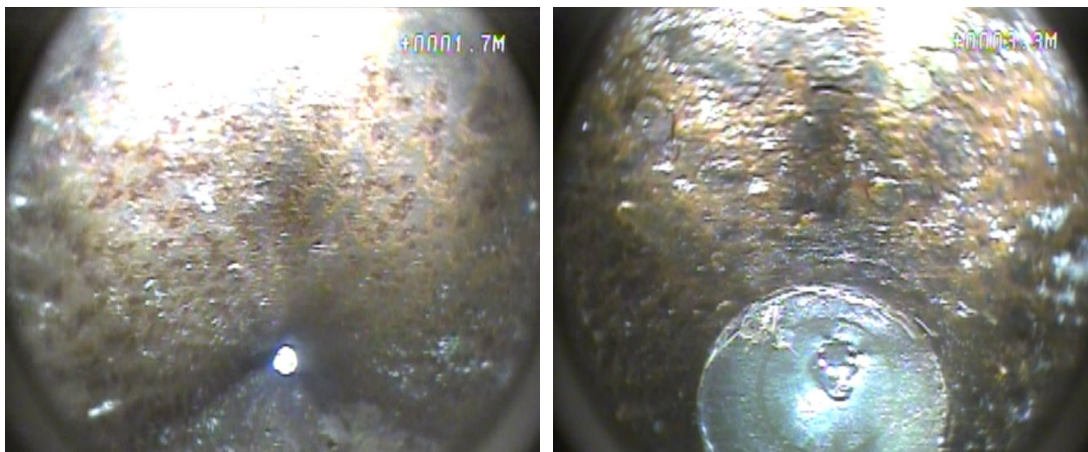
- Substantial pitting and corrosion noted through mild steel casing wall above standing water table, this indicates that the apparent metal loss has been severe and the casing wall will be extremely thin.

Bore at 1.70m and 3.30m showing condition of mild steel casing above the standing water level.

- Stainless steel swage relining operations to be undertaken over the full depth of the bore with stainless steel screens installed over the uncased section and stainless-steel casing over the mild steel section. This will effectively create a full stainless steel bore design.

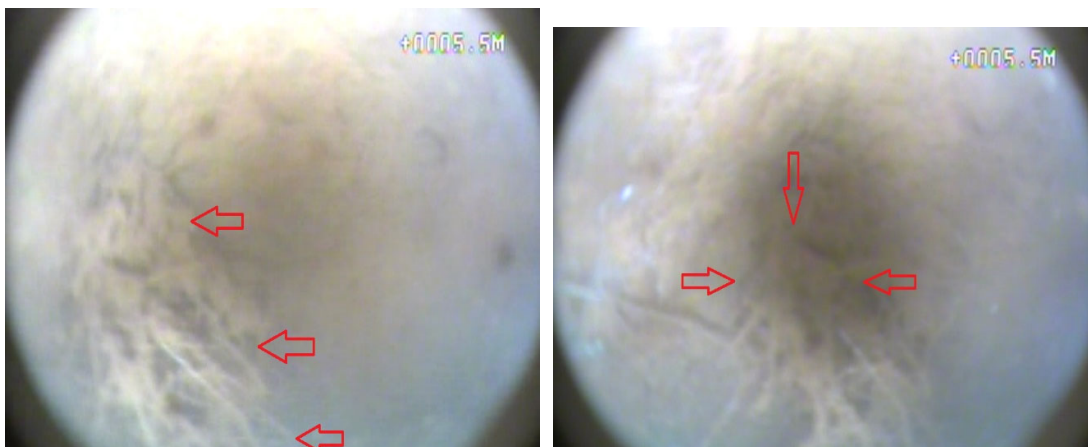
- Tree roots noted to have penetrated through the casing wall between 5.50m and 6.00m, hole visible.
- Tree roots noted to have penetrated through the casing wall at 6.60m, hole visible.

Tree roots noted to have penetrated through the casing wall between 5.50m and 6.00m.

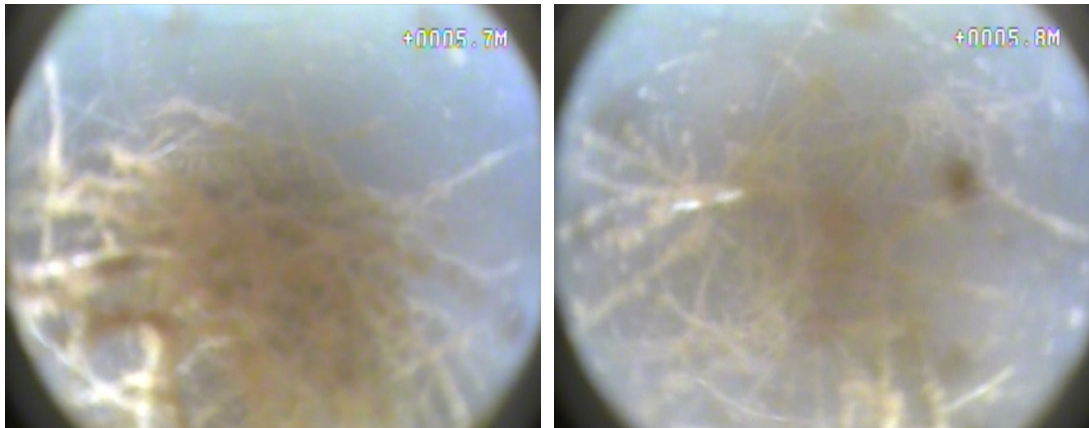
Tree roots noted to have penetrated through the casing wall between 5.50m and 6.00m.

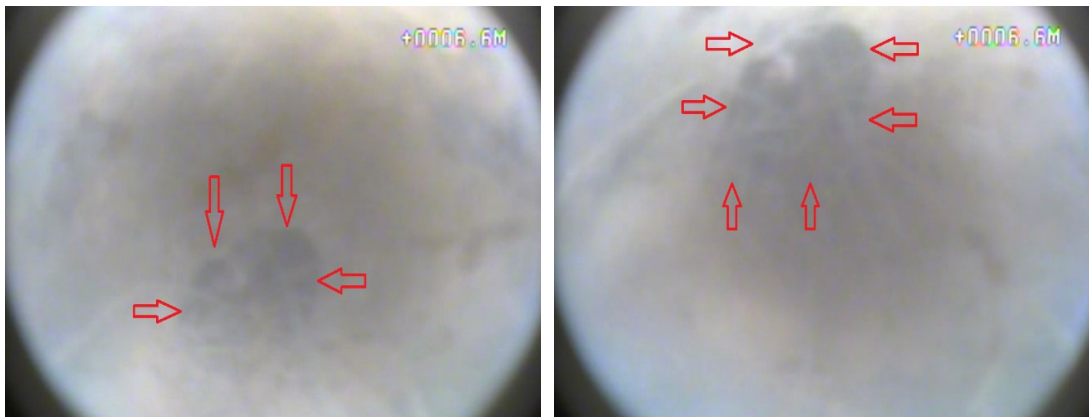
Tree roots noted to have penetrated through the casing wall between at 6.60m.

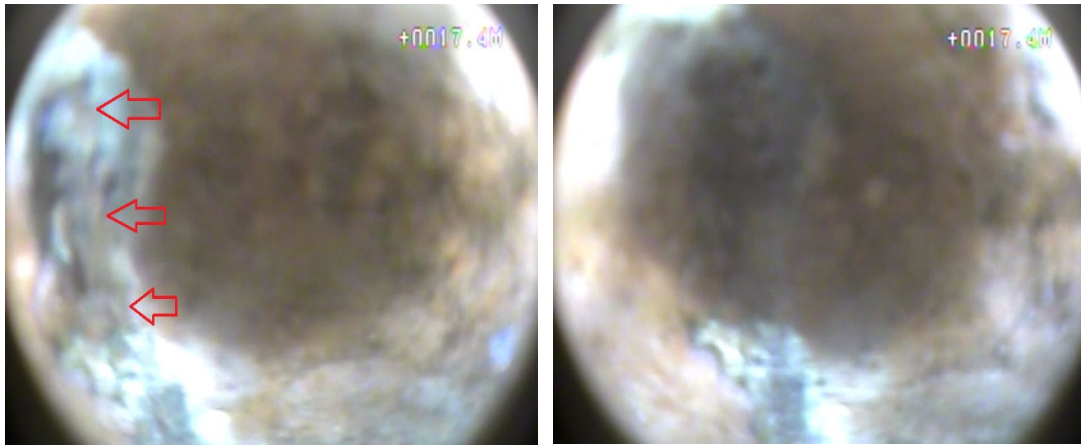
- Possible hole noted through mild steel casing wall at 14.60m.
- Corrosion and hole noted through mild steel casing wall at 17.40m.
- Significant corrosion and hole noted through mild steel casing wall at 19.40m.

Corrosion and hole noted through mild steel casing wall at 17.40m.

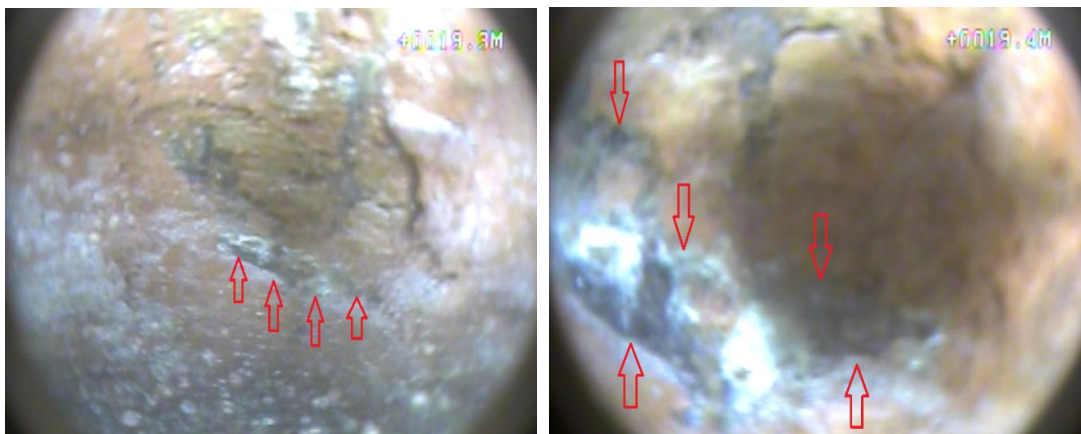
Significant corrosion and hole noted through mild steel casing wall at 19.40m.

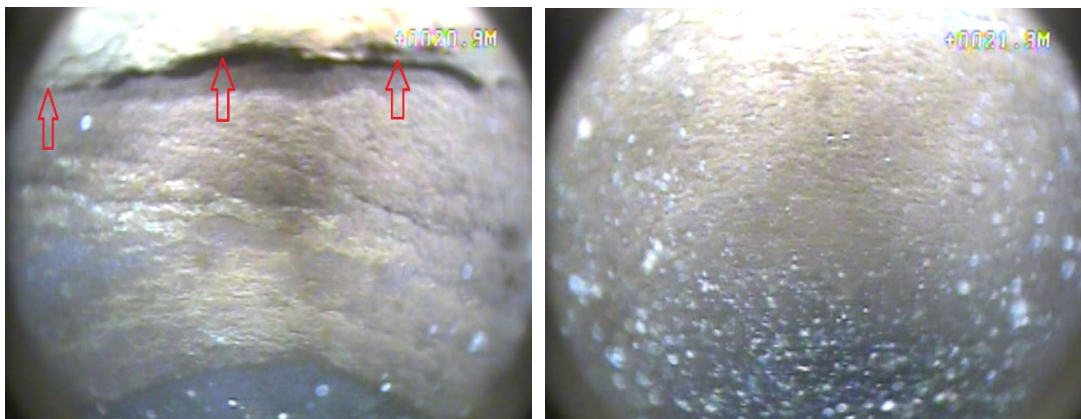
- Bore construction noted to be of mild steel casing from 0.00m to 20.90m, bore casing then terminates at 20.90m and the remainder of the bore is open through rock.

Termination of mild steel casing at 20.90m and open hole section at 21.30m.

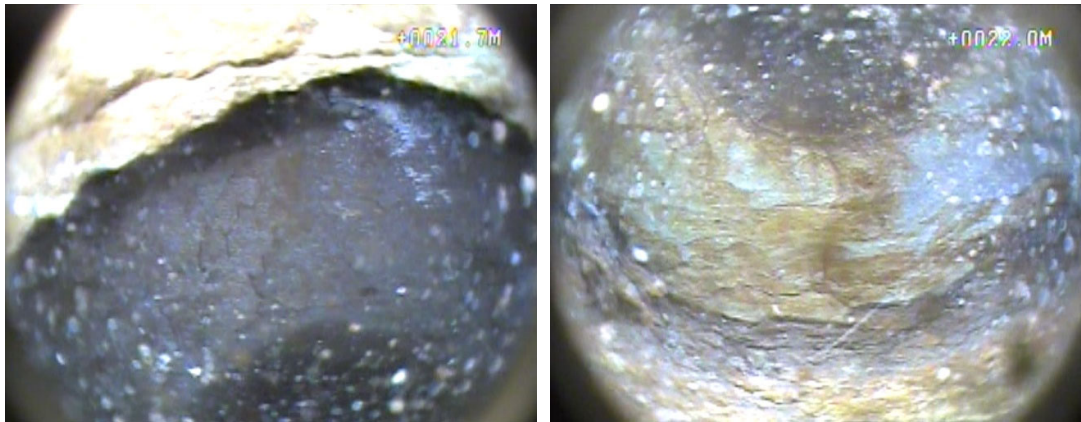
- Large cavity noted through open section of the bore from 21.70m to 22.00m, lose gravels and rocks noted.
- Large cavity noted through open section of the bore from 22.90m to 23.30m, lose gravels and rocks noted.

Open hole section of bore at 21.70m & 22.00m, showing large cavity.

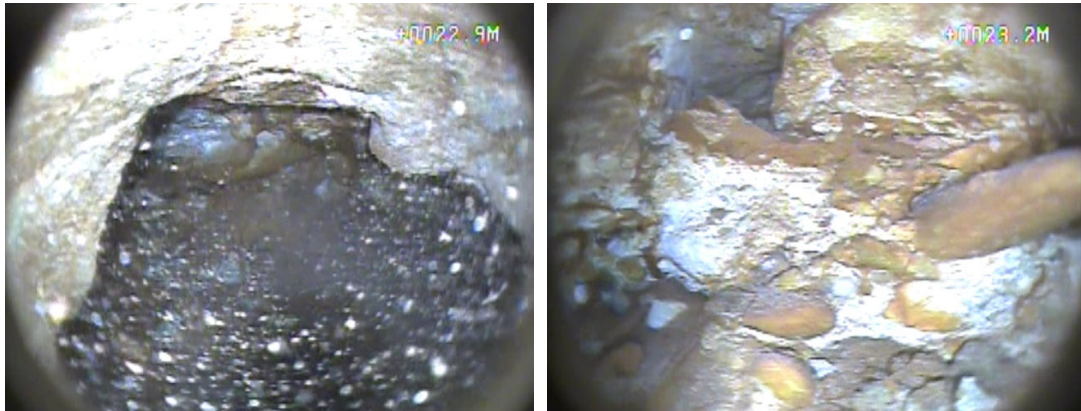
Open hole section of bore at 22.90m & 23.20m, showing large cavity.

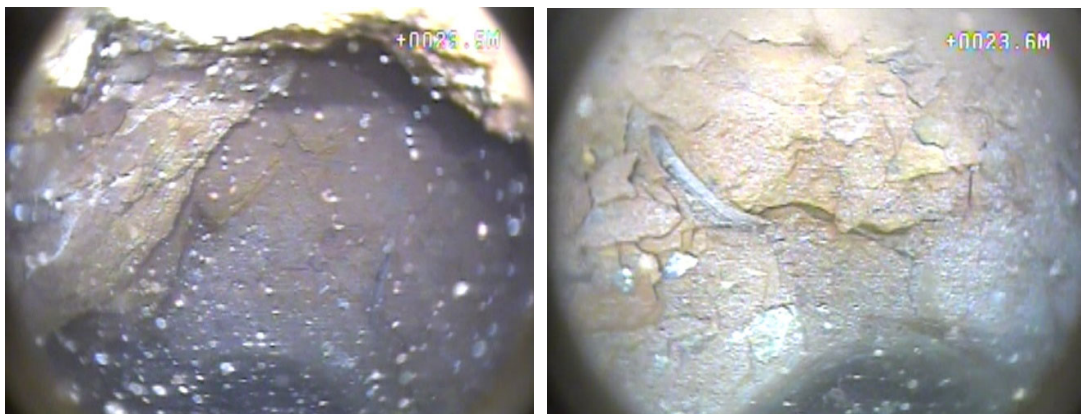
- Large cavity noted through open section of the bore from 23.50m to 23.80m, lose gravels and rocks noted.
- Bottom depth encountered was 24.00m and the construction depth specified in the Groundworks report is 36.60m indicating that there is 12.60m of debris / fill present in the bottom of the bore.

Open hole section of bore at 23.50m & 23.60m, showing large cavity.

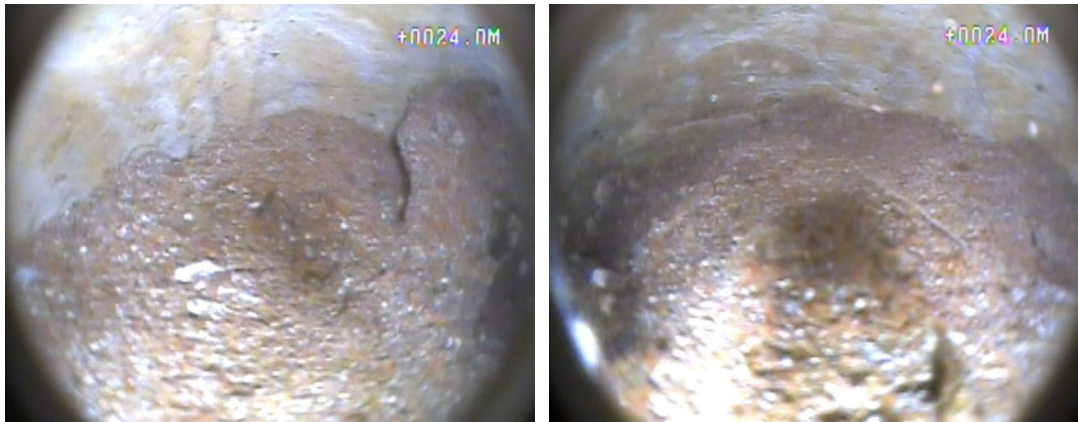
Bottom of bore at 24.00m, obstructions encountered and bore noted to be filled with sand and gravel.

The construction of the bore was noted to have the mild steel casing terminate at 20.90m with the remainder of the bore open through rock to 36.60m. However, the open hole section of the bore was noted to have become unstable with large cavities and loose formation noted which has resulted in the bore having approximately 12.60m of fill and debris present in the bottom and an encountered depth of 24.00m.

- Removal of the bore pump to allow the corrective works to be undertaken.
- Removal of the fill noted in the bottom of the bore and reopening the bore back to its original constructed depth via bailing operations.
