WARRUMBUNGLE SHIRE COUNCIL DUNEDOO OLD BORE ASSESSMENT REPORT 16/12/2022

DUNEDOO OLD BORE

Report No: WARRSC16122022
Date: 16/12/2022
Revision: 01
Author: Luke Woods
Project Manager: Luke Woods
File Name: Warrumbungle Shire Council – Dunedoo Old Bore Assessment Report 16/12/2022

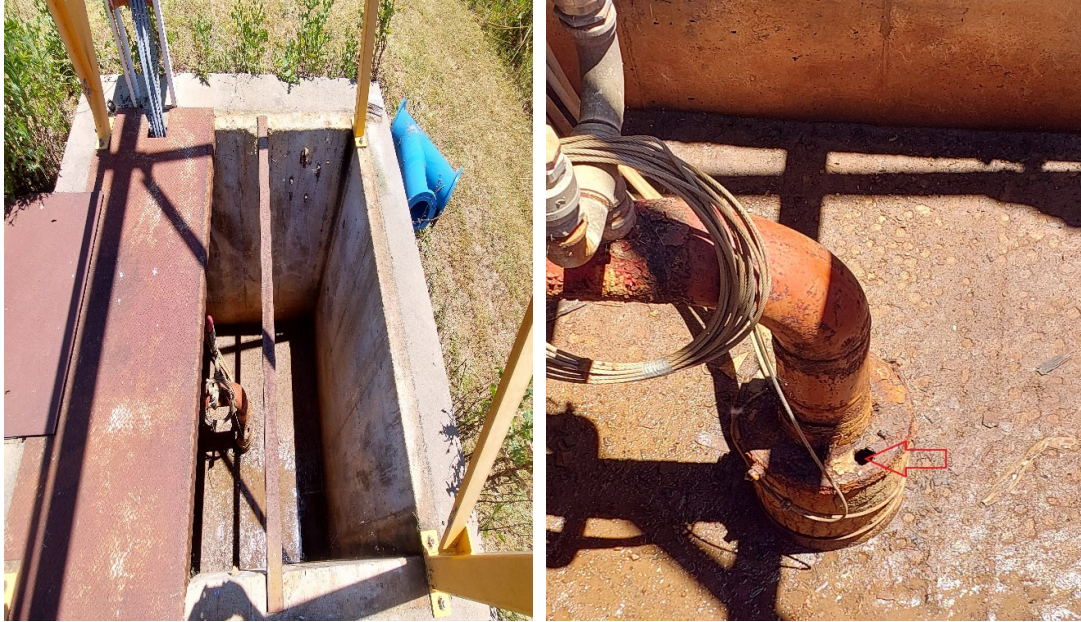
- The top of the mild steel casing was noted to be 0.45m above the pit floor and 1.96m below ground level.
- Bore headworks noted to be of poor design which would fail to meet the NSW health guidelines for groundwater. Bore headworks noted to be unsealed and open at ground level, which would be allowing biological contaminants to enter the bore.

- Bore headworks noted to be in extremely poor condition with rust, corrosion and holes evident.
- Rising main construction noted to be 145mm Galvanized steel column in 3.00m lengths with threaded couplings. Column couplings and threads were noted to be seized and required cutting during pump extraction.

Condition of pumping headworks.

- Removal of the bore pump to allow the corrective works to be undertaken.
- Corrective works undertaken on the headworks to meet the NSW health guidelines for ground water. This will need to include IP68 rated electrical glands and redesign of the bore cap.

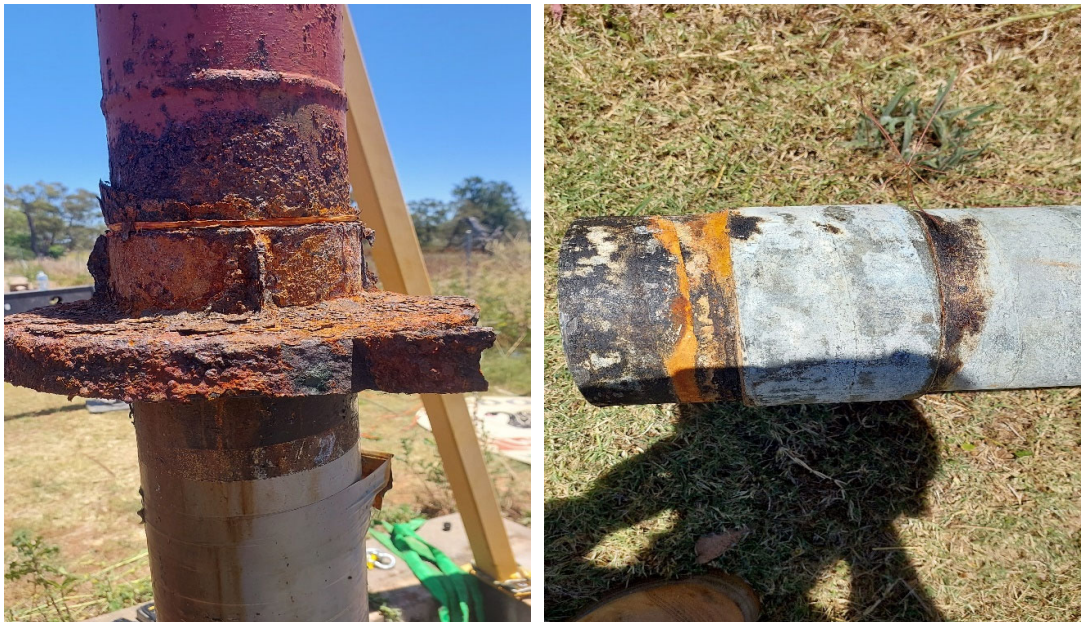
Condition of pumping headworks and column.

- Disinfection and cleaning of the bore pump prior to reinstallation.
- Upgrading the pump rising main from the stainless-steel column to a 127mm Flexibore 250 crusader hose for ease of future maintenance.

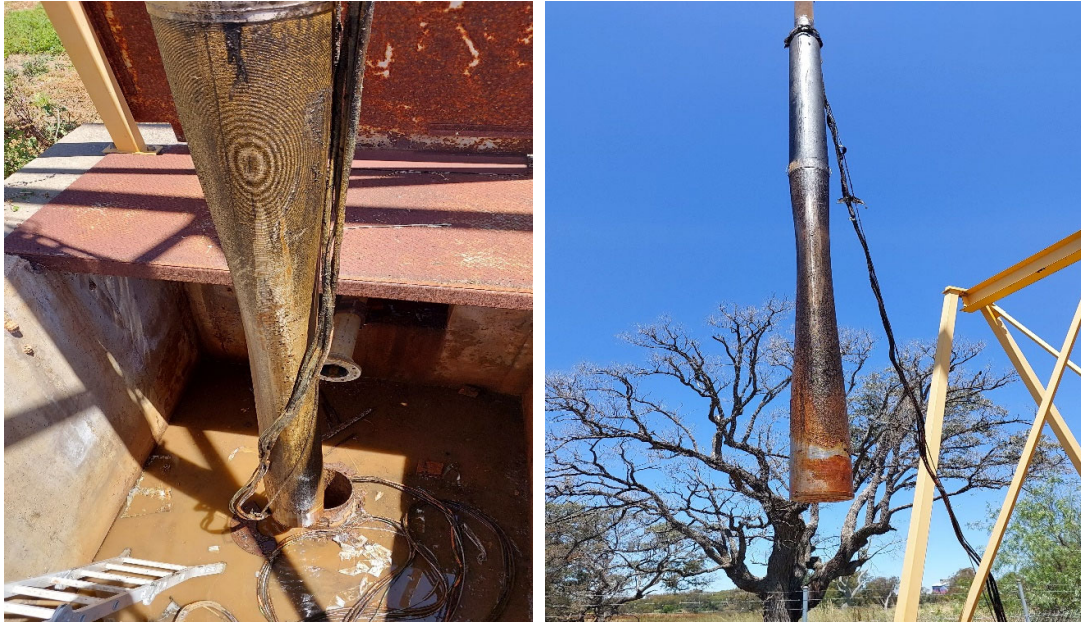
- The bore pump was noted to be 3m in length with a PVC shroud fitted, below the shroud a 3m section of stainless steel screen was also fitted. This indicates that the bore has had previous issues with gravel ingress. The stainless steel screen was noted to have collapsed due to the suction pressure.

Illustration of stainless-steel screen fitted to pump.

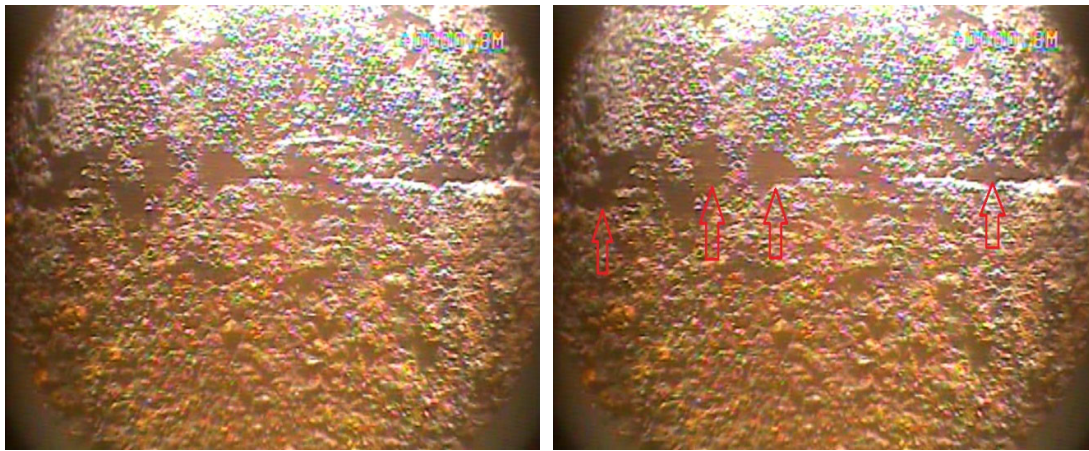
- Corrosion and holes noted through mild steel weld joint at 0.80m.
- Standing water table at 4.90m.
- Corrosion, holes, and separation noted on mild steel weld joint at 7.50m.

Corrosion and holes noted through mild steel weld joint at 0.80m.

- Removal of the fill noted in the bottom of the bore and reopening the bore back to its original constructed depth via bailing operations.
- Stainless steel swage relining operations to be undertaken over all mild steel cased sections. This will effectively create a full stainless steel bore design.

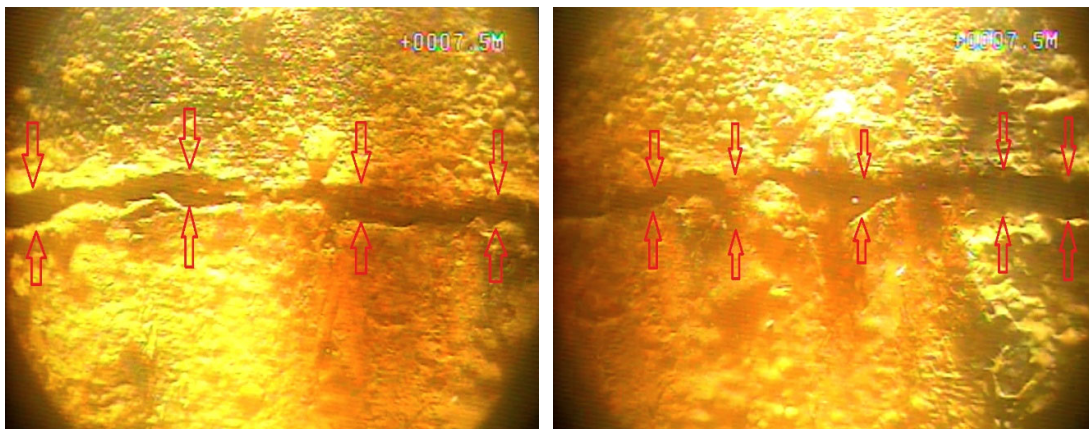
Corrosion, holes, and separation noted on mild steel weld joint at 7.50m.

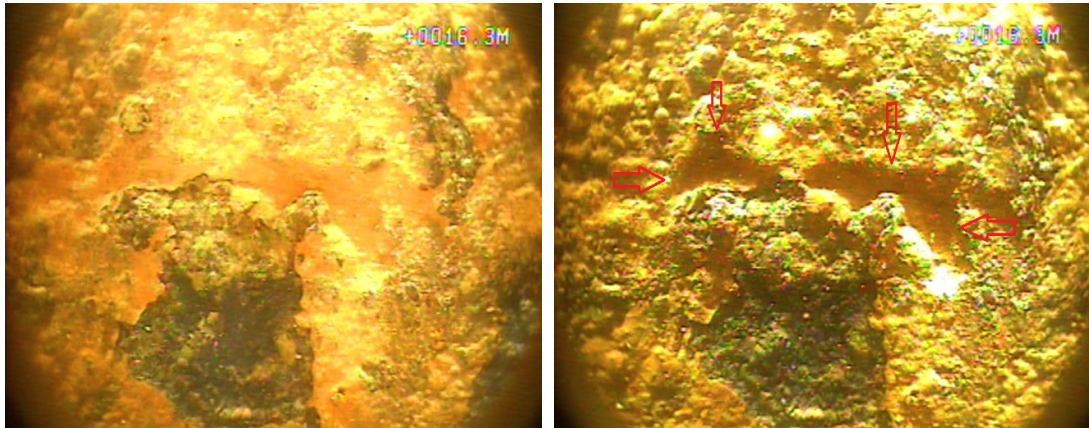
- Significant levels of iron related bacteria growth noted to be present on the mild steel casing wall.
- Corrosion and holes noted through mild steel casing wall at 16.30m.

Corrosion and holes noted through mild steel casing wall at 16.30m.

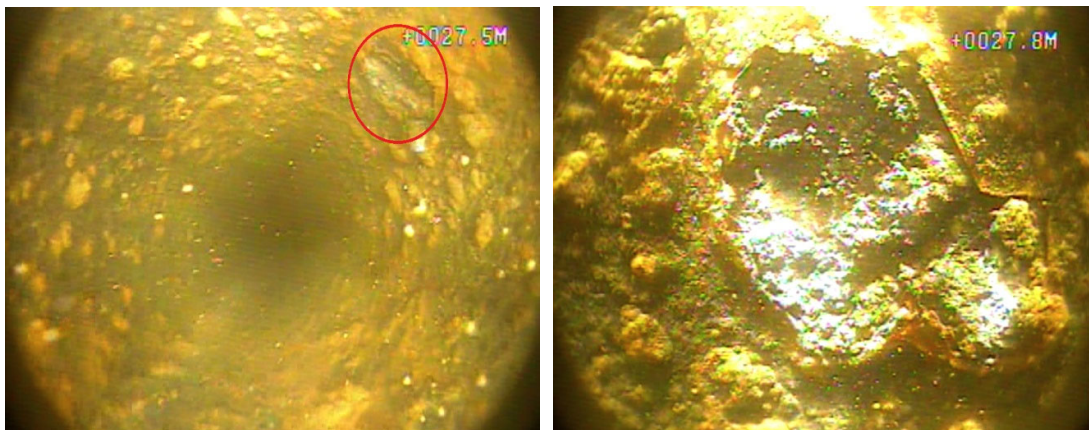
- Corrosion and holes noted through mild steel casing wall at 27.80m.
- Screen section noted to commence at 29.70m
- Corrosion and holes noted on mild steel to stainless steel weld joint at commencement of screen section at 29.70m.

Corrosion and holes noted through mild steel casing wall at 27.80m.

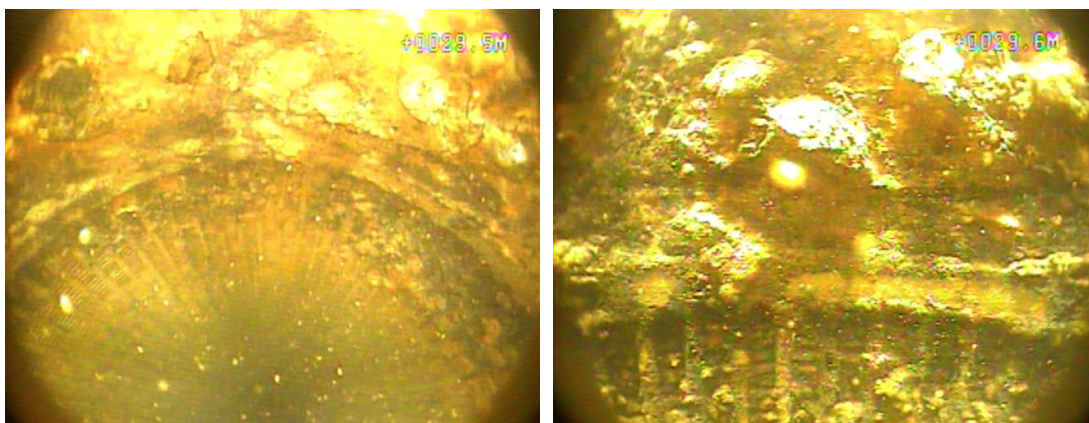
Commencement of screen section at 29.70m, corrosion and holes noted on mild steel to stainless steel weld join.

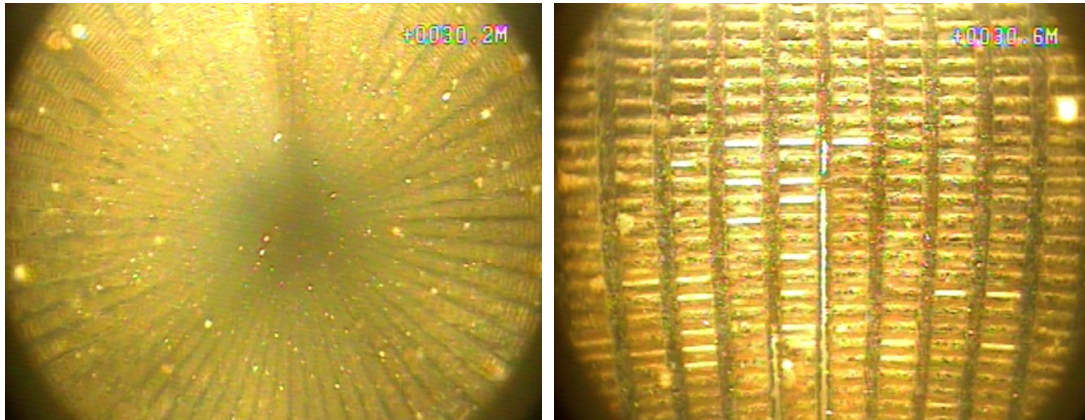
- Screen section noted to have significant growth and biofouling levels present.
- Screen apertures through screen section suffering from significant growth, resulting in a decreased draw area of the bore and increased suction velocities.

Screen section at 30.20m & 30.60m, showing significant growth levels present.

- Redeveloping and reconditioning the water bearing zone via the ACS Equip redevelopment operations consisting of an Aquaclear Bore Cleaner dosage to be injected over the entire length of the bore followed by high pressure redevelopment operations for gravel pack development.

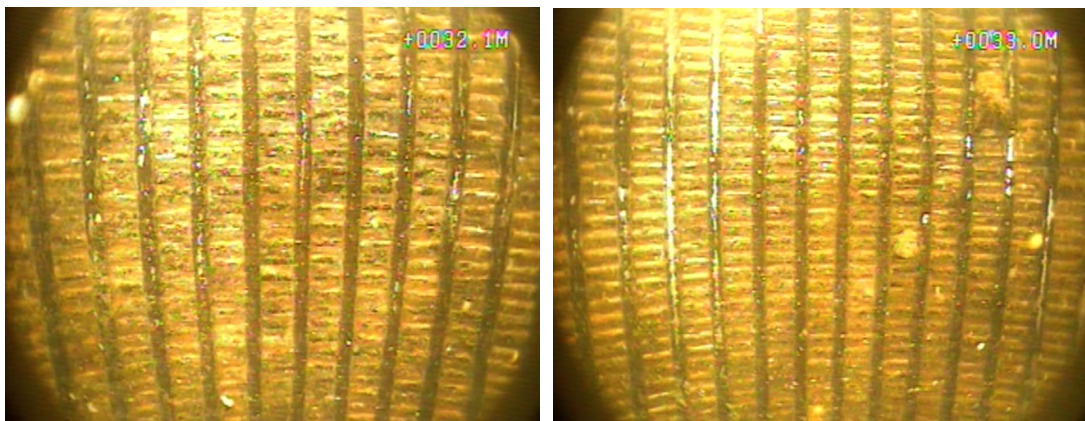
Screen section at 32.10m & 33.00m, showing significant growth levels present.

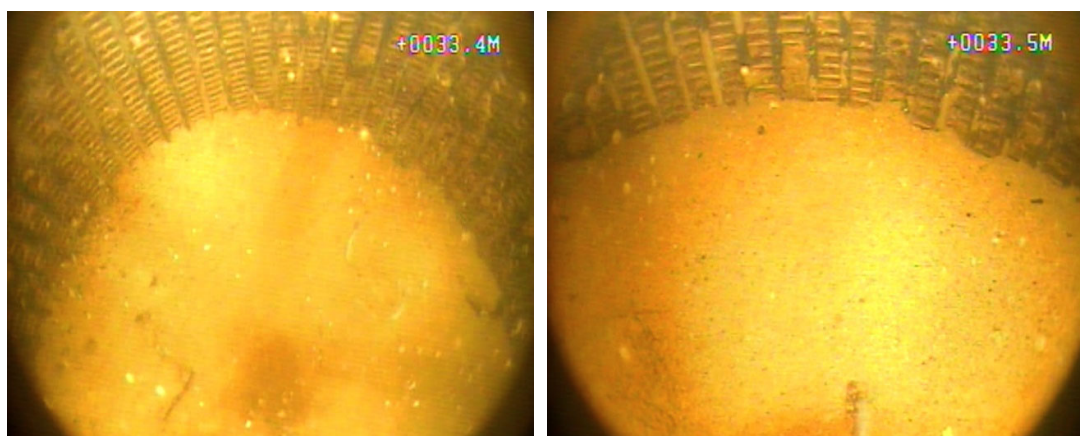
- Bottom depth encountered was 33.50m and the construction depth specified in the Groundworks report is 38.00m indicating that there is 4.50m of debris / fill present in the bottom of the bore.

Bottom of bore encountered at 33.50m.

The encountered bottom depth was 33.50m and the construction depth specified in the groundworks report is 38.00m indicating that the bore has 4.50m of fill and debris present in the bottom.
