WARRUMBUNGLA SHIRE COUNCIL KENEBRI BORE ASSESSMENT REPORT 07/12/2022

Warrumbungle Shire Council – Kenebri Bore

Assessment Report 07/12/2022

Report No: WARRSC07122022
Date: 07/12/2022
Revision: 01
Author: Luke Woods
Project Manager: Luke Woods
File Name: Warrumbungle Shire Council – Kenebri Bore Assessment Report 07/12/2022

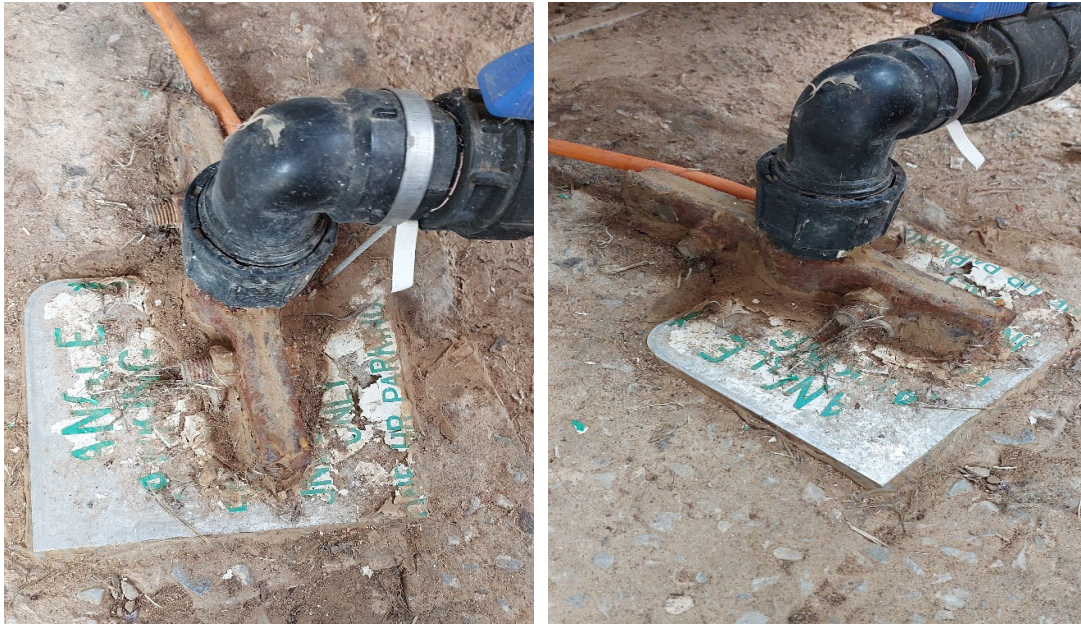
- Bore headworks noted to be of poor design which would fail to meet the NSW health guidelines for groundwater. Bore headworks noted to be unsealed and open at ground level, which would be allowing biological contaminants to enter the bore.

Unsealed headworks as viewed from surface.

- Corrective works undertaken on the headworks to meet the NSW health guidelines for ground water. This will need to include IP68 rated electrical glands and redesign of the bore cap to allow a weatherproof seal to the top of the bore casing.

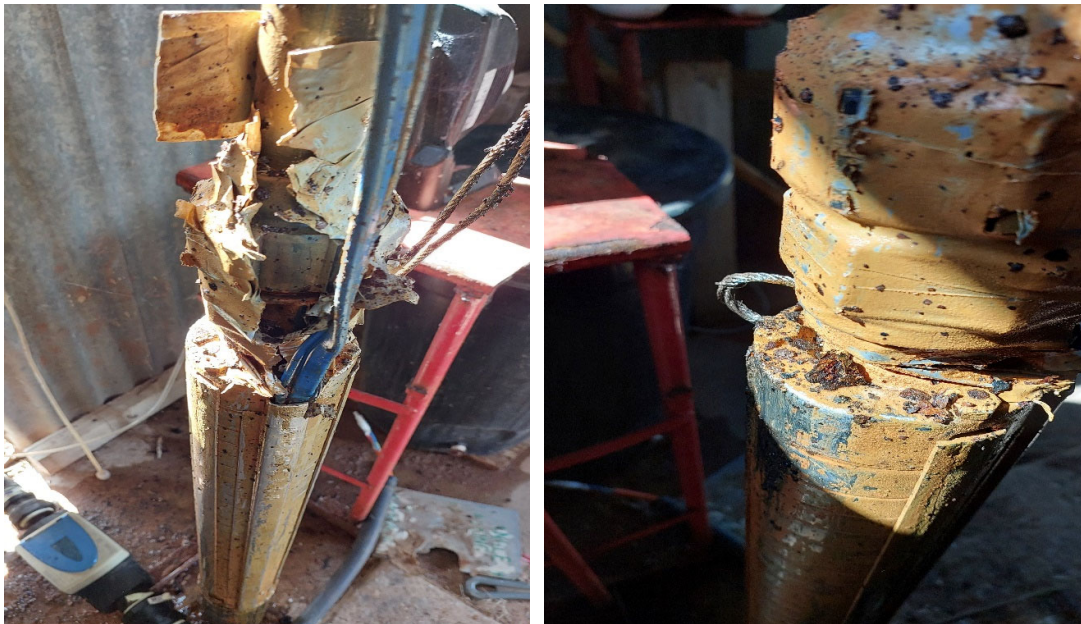
- The Pump set depth was noted to be approximately 30m.
- Submersible pump and poly rising main were noted to have moderate growth levels present.
- Substantial pitting and corrosion noted through mild steel casing wall above standing water table, this indicates that the apparent metal loss has been severe and the casing wall will be extremely thin.

Condition of pumping equipment showing Iron Bacteria and rusted casing pieces.

- Disinfection and cleaning of the bore pump prior to reinstallation.

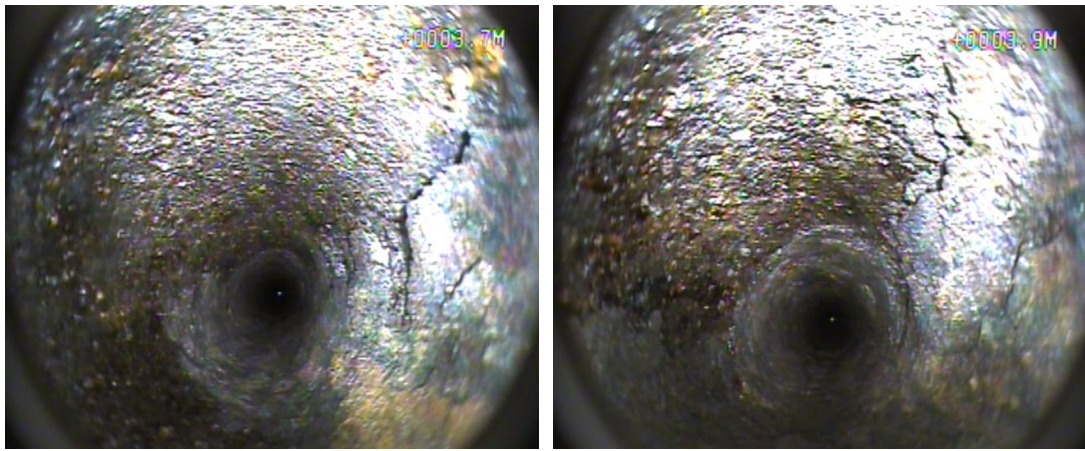
Bore at 3.70m and 3.90m showing condition of mild steel casing above the standing water level.

- Stainless steel swage relining operations to be undertaken over the full depth of the bore with stainless steel screens installed over the slotted mild steel section and stainless-steel casing over the mild steel section. This will effectively create a full stainless steel bore design.

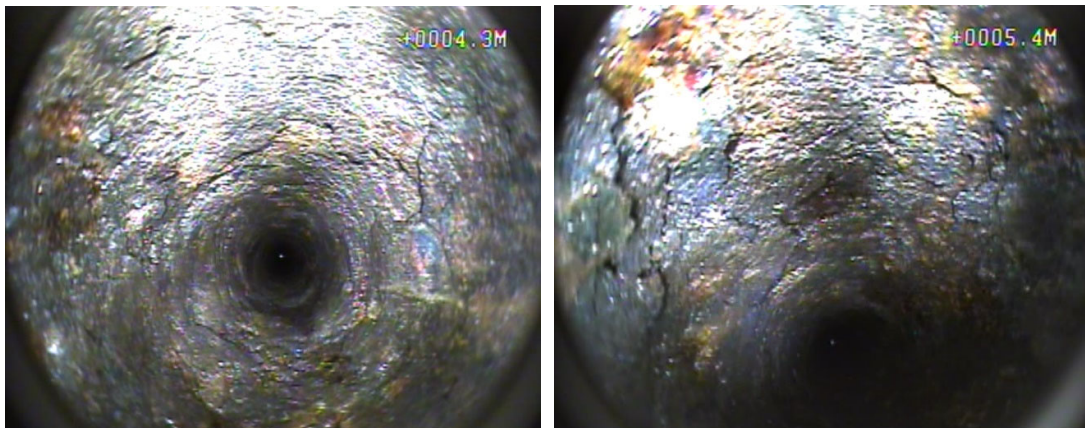
Bore at 4.30m and 5.40m showing condition of mild steel casing above the standing water level.

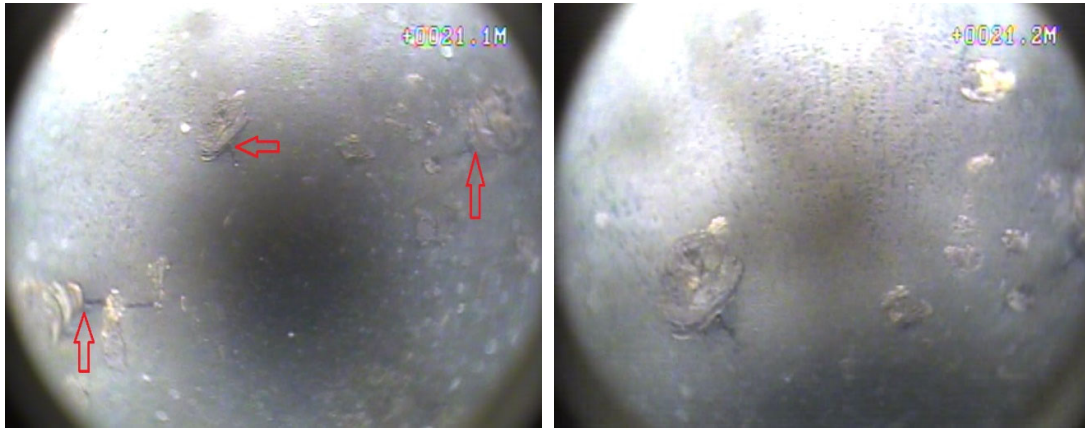
- Bore construction noted to consist of threaded mild steel casing.
- Standing water table at 17.50m.
- Slotted section noted to commence at 21.00m.
- Slotted section noted to have significant growth and encrustation present over the slotted apertures.

- Slotted apertures suffering from substantial growth resulting in a decreased draw area of the bore and increased suction velocities
- Slotted apertures noted to be significantly corroded and enlarged.

Slotted section at 21.10m and 21.20m.

- Redeveloping and reconditioning the water bearing zone via the ACS Equip redevelopment operations consisting of an Aquaclear Bore Cleaner dosage to be injected over the entire length of the bore followed by high pressure redevelopment operations for gravel pack development.

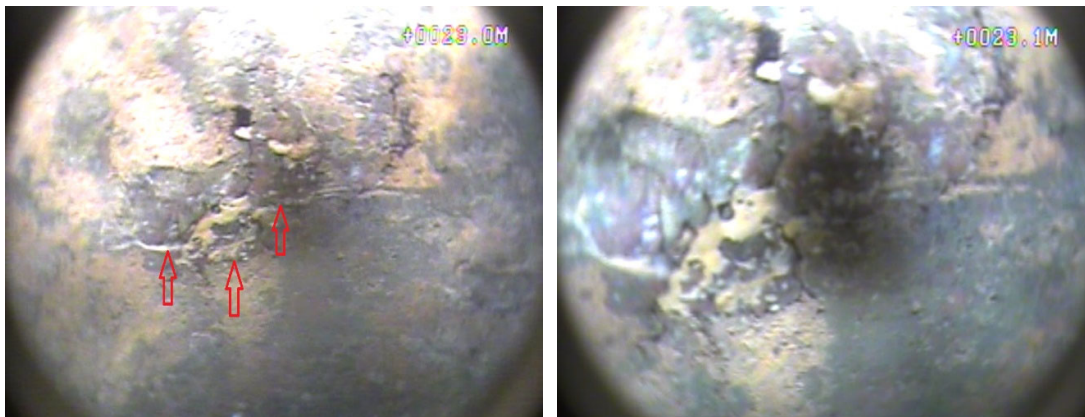
- Significant corrosion and holes noted through mild steel casing wall between 23.10m.

Corrosion / hole noted through mild steel casing wall at 23.10m.

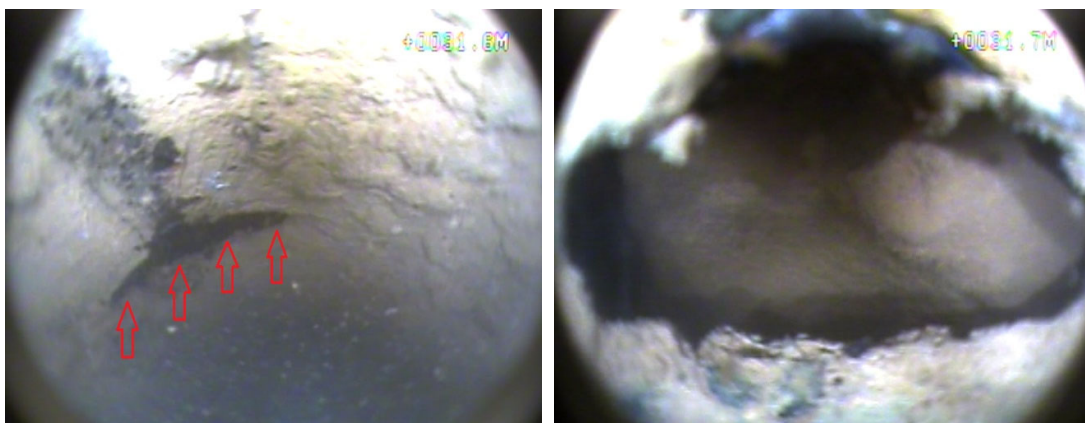
- Large hole noted through mild steel casing wall at 31.70m.
- Bottom depth encountered was 34.50m and the construction depth specified in the Groundworks report is 47.20m indicating that there is 12.70m of debris / fill present in the bottom of the bore.

Large hole noted through mild steel casing wall at 31.70m.

During the camera inspection implemented on the 07/12/2022 the overall structural condition of the bore was noted to be extremely poor. Numerous areas of significant corrosion were noted through the mild steel casing wall including a catastrophic failure in the casing wall at 31.70m. This indicates that the mild steel casing has reached the end of its useful lifespan.

In the bores current condition further use is not advisable (**continued use can result in catastrophic bore failure**) due to the structural failings identified in the mild steel casing wall;

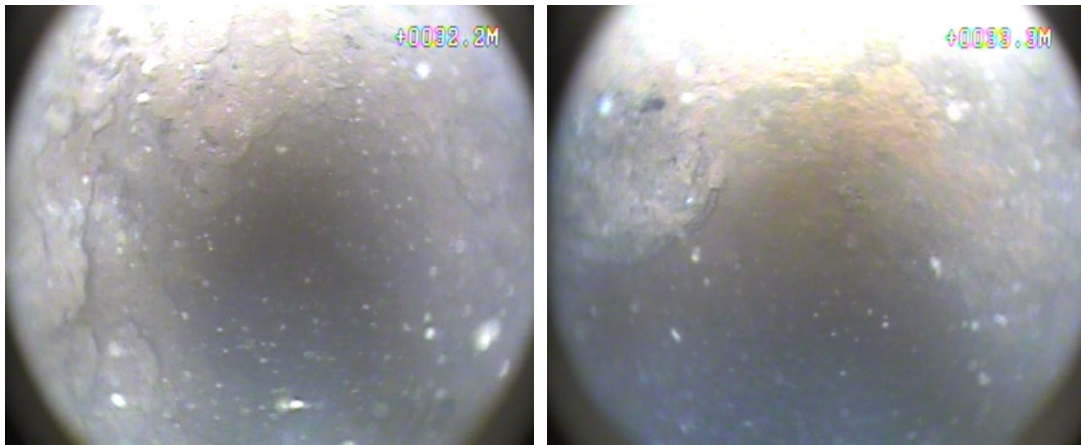
Bore at 32.20m and 33.30m showing condition of mild steel casing and growth levels present.

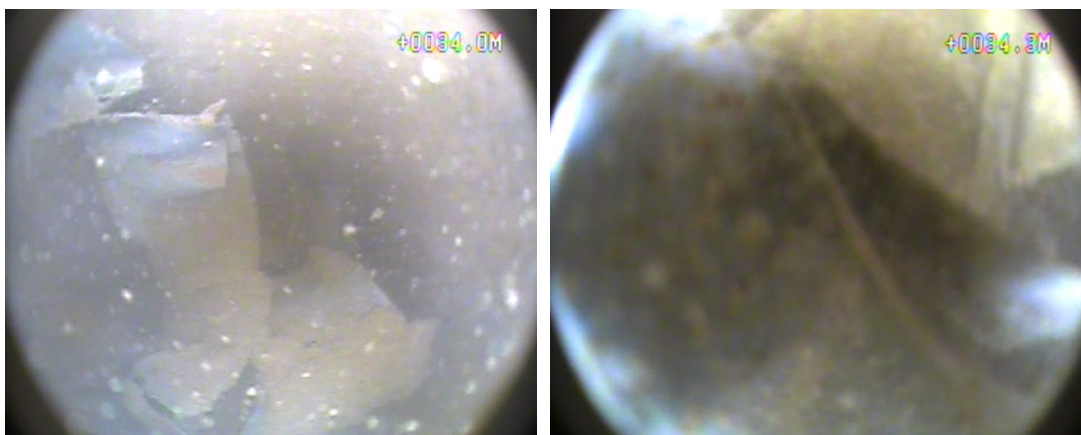
Bottom of bore encountered at 34.40m.

The encountered bottom depth was 34.50m and the construction depth specified in the groundworks report is 47.20m indicating that the bore has 12.70m of fill and debris present in the bottom.

- Removal of the bore pump to allow the corrective works to be undertaken.
- Removal of the fill noted in the bottom of the bore and reopening the bore back to its original constructed depth via bailing operations.
