# Condition Assessment of Existing Ground Water Bores

**Orana Water Utilities Alliance  
Warrumbungle Shire Council**

**PREPARED BY Access Environmental Planning**

**January 2021**

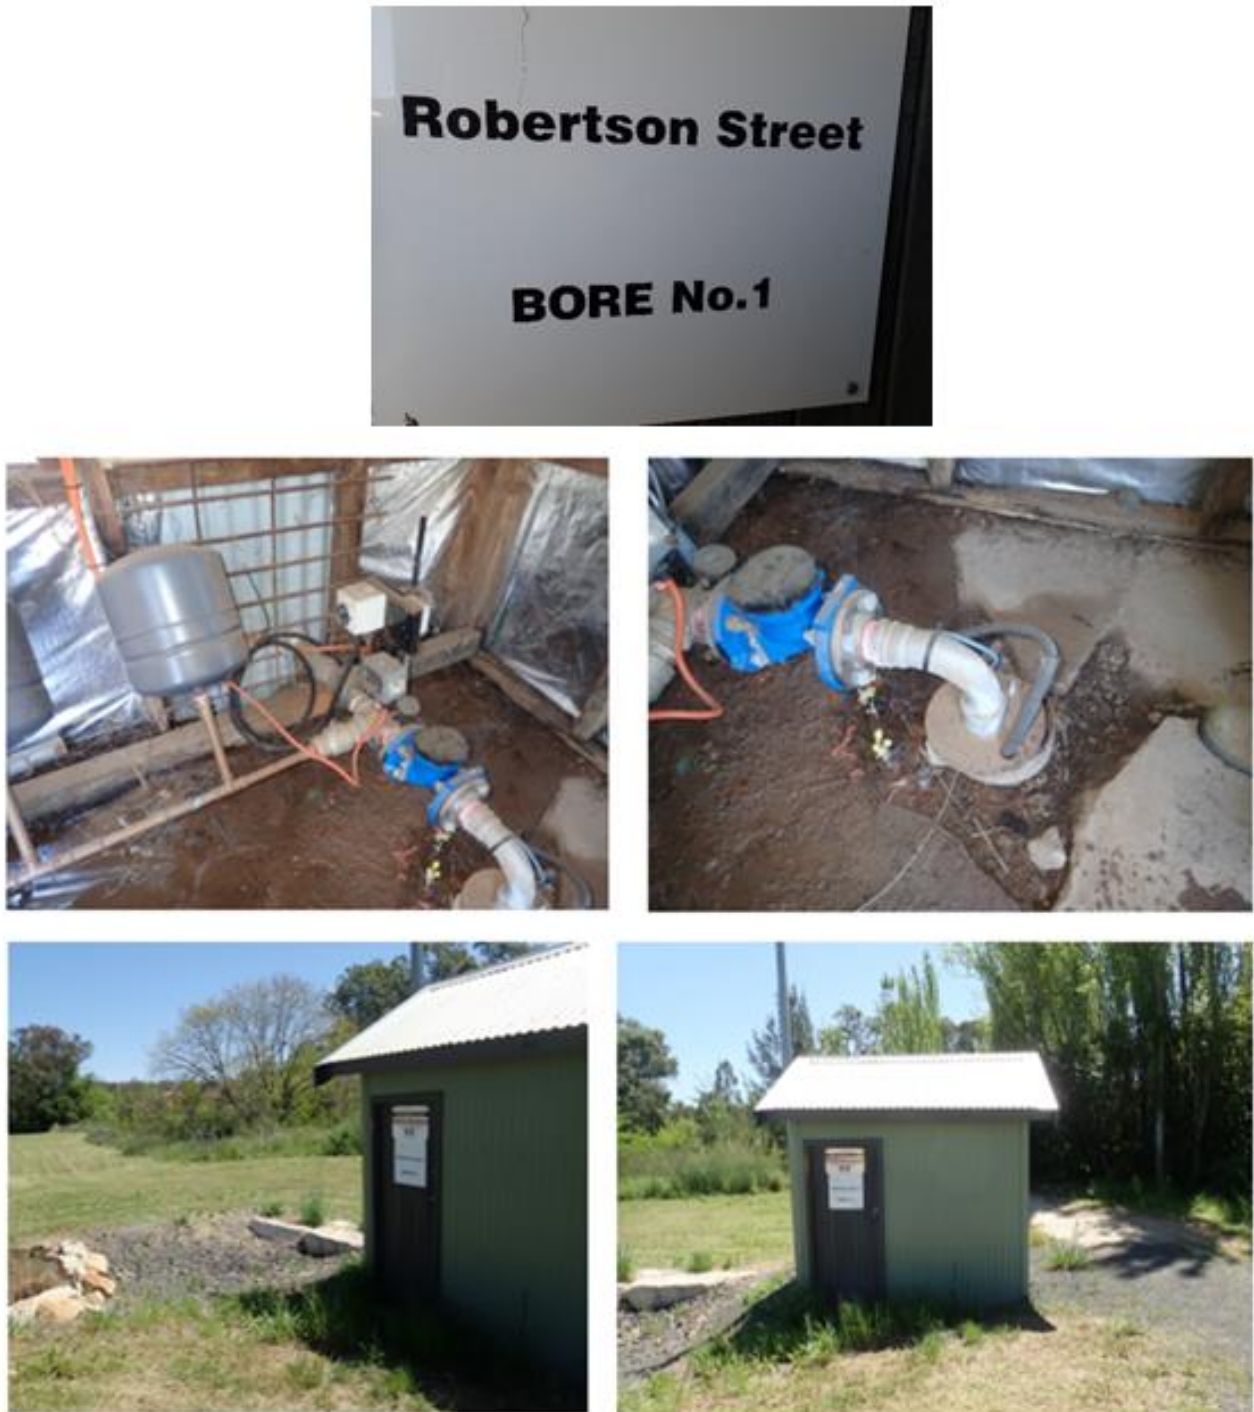
**Figure 1 - Coonabarabran Robertson Street Bore**

This bore is located at the end of Robertson St, Coonabarabran. There is limited information available about this bore. The column was replaced 3 years ago and has not had issues since.

<b>Estimate of specific capacity of the well. Flow rate vs drawdown</b>	NA
<b>Site details including accessibility</b>	NA
<b>Additional comments</b>	Column is 3 years old

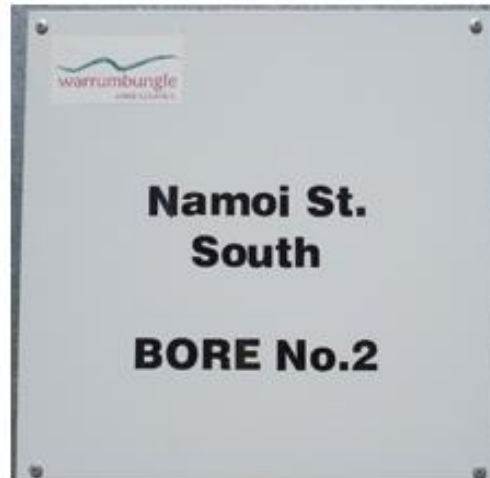
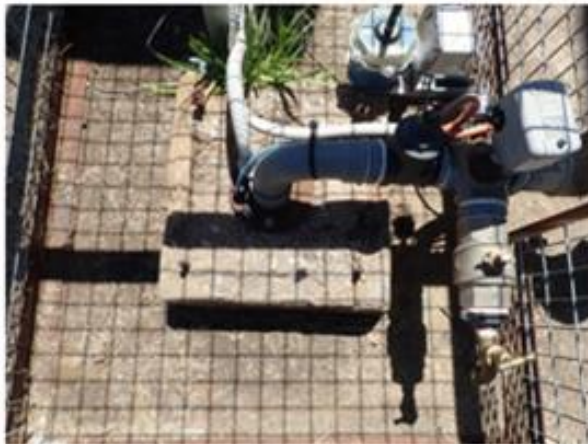
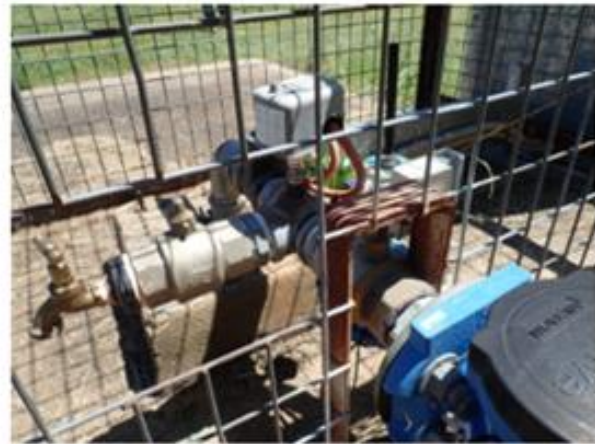
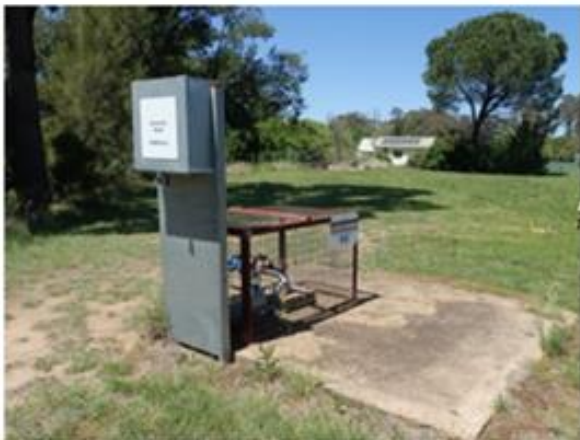
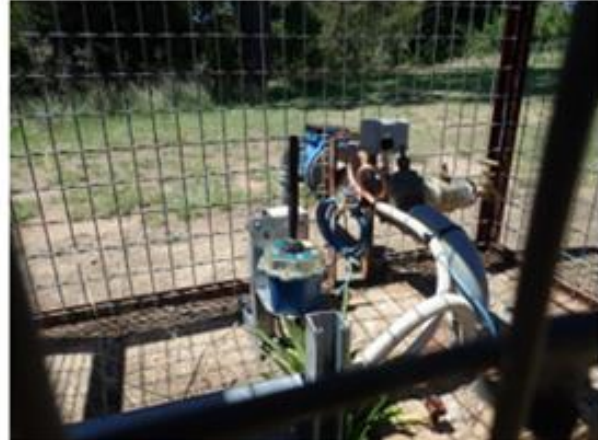
**Figure 2 - Coonabarabran Namoi Street South Bore**

<b>Condition of casing well cap and slab</b>	Good condition
<b>Well age</b>	82 years old, high risk
<b>Well type</b>	Low to moderate risk
<b>Screen material</b>	Assume slotted, high risk
<b>Bore material</b>	Moderate/high risk
<b>Pump depth setting</b>	20-30 meters
<b>Bore cementing</b>	No record
<b>Water quality</b>	No record
<b>Iron level</b>	No record
<b>Salinity Level</b>	No record
<b>Relationship of pump depth setting and screen level to Iron Hydroxide potential</b>	Moderately high risk, pump is in slotted casing area
<b>Comments</b>	Not enough records, the bore us accessing sandstone
<b>Conclusion</b>	Moderate/high risk

Bore is high risk due to age and the mild steel casing. Recommend a Camera inspection and pump test to monitor bore performance.

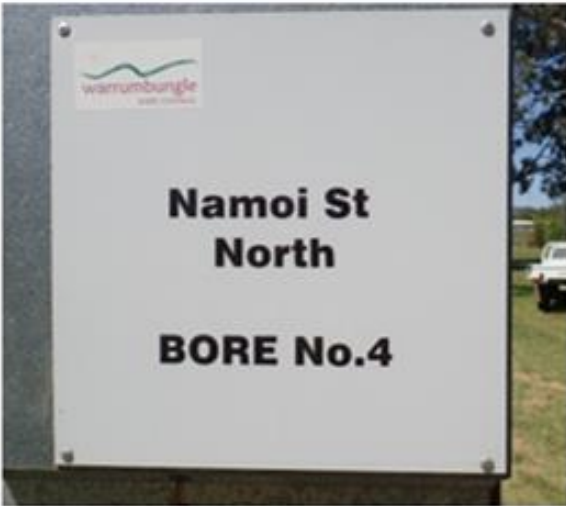
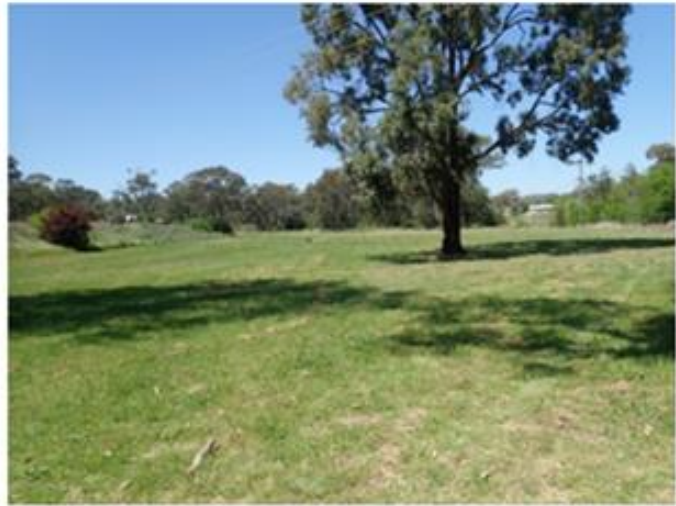
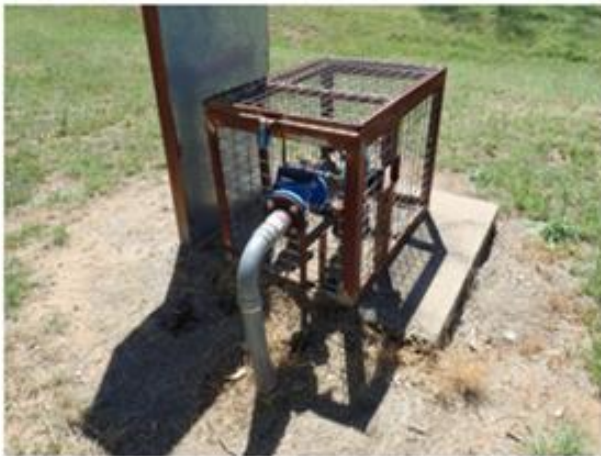
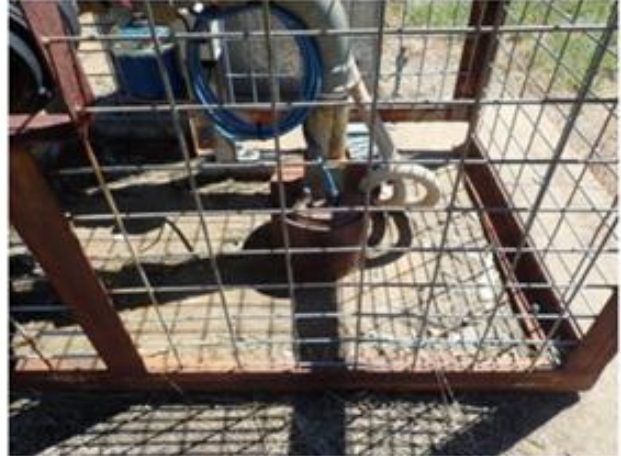
**Figure 4 - Coonabarabran Namio St North Bore 4**

**Bore 4 – Namoi St North** This bore is located further north on Namoi Street on Lot 1, DP 1085566 Coonabarabran. This bore does not yield much water and pumps a small amount of sand. Due to this it is used as a backup water supply.

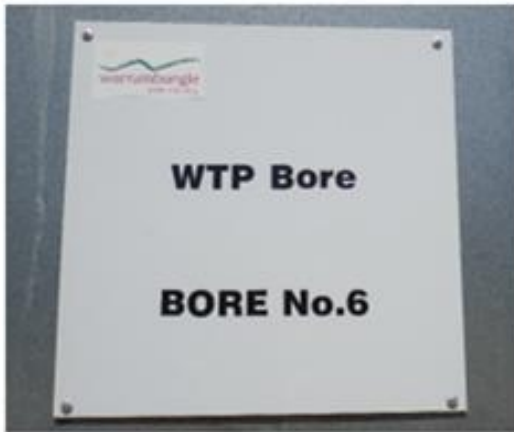
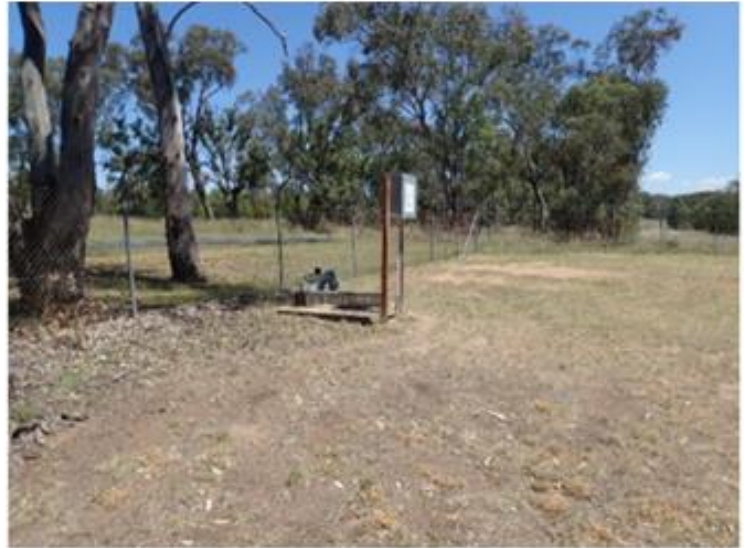
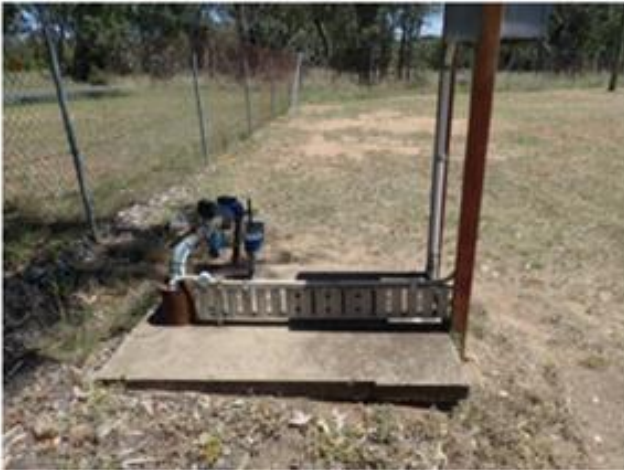
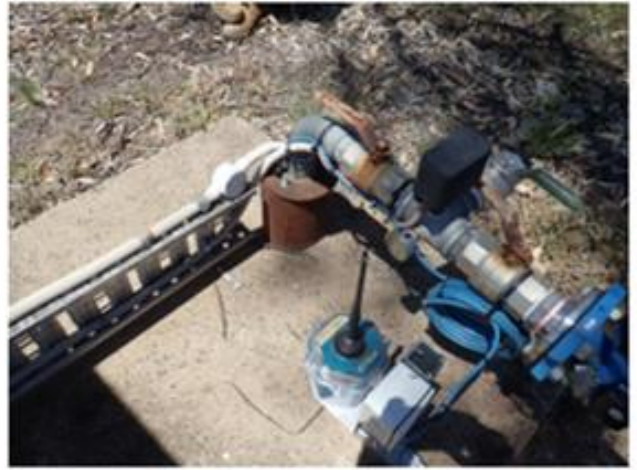
**Figure 5 - Coonabarabran Water Plant Bore**

The water plant is located on Timor Rd, 1.4 km west of the Coonabarabran town centre. It is the major water supply for Coonabarabran. This bore has had minimal issues after the pump replacement in 2015. There is limited information available on this bore.

<b>Estimate of specific capacity of the well. Flow rate vs drawdown</b>	NA
<b>Site details including accessibility</b>	No overhead powerlines
<b>Additional comments</b>	Bore not in shed

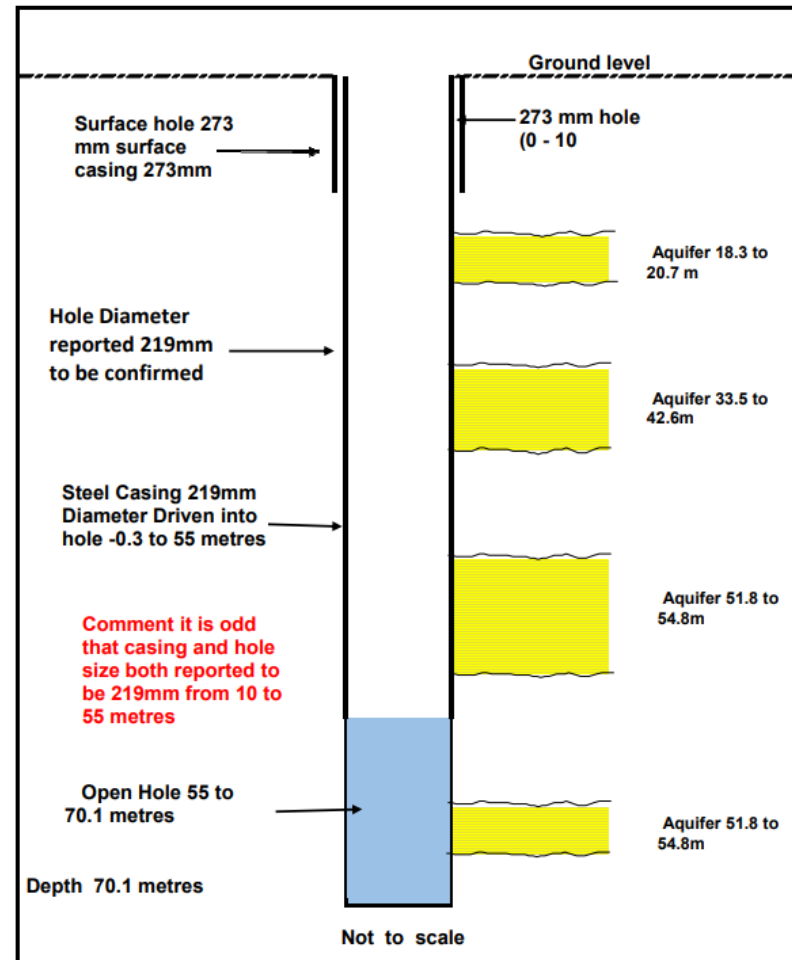
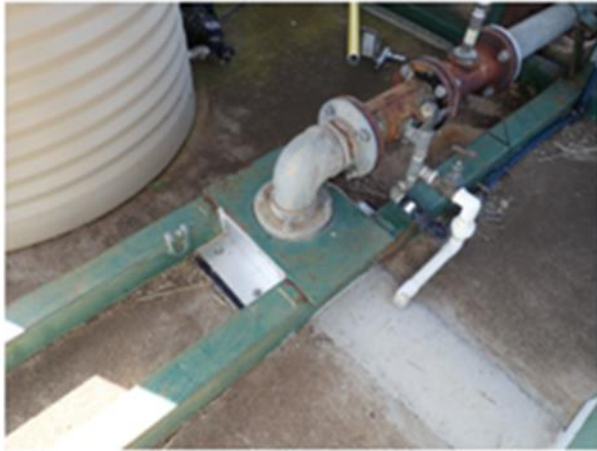
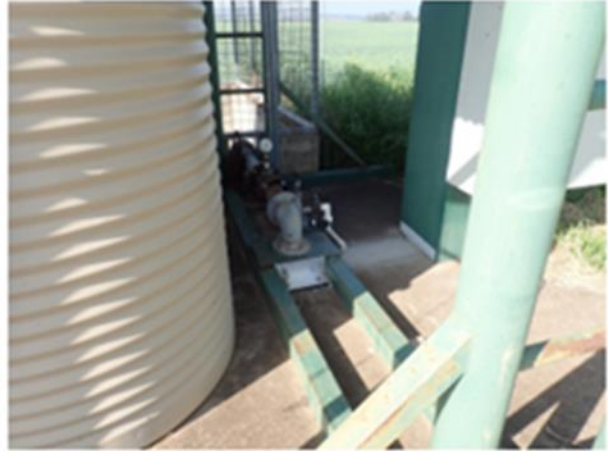
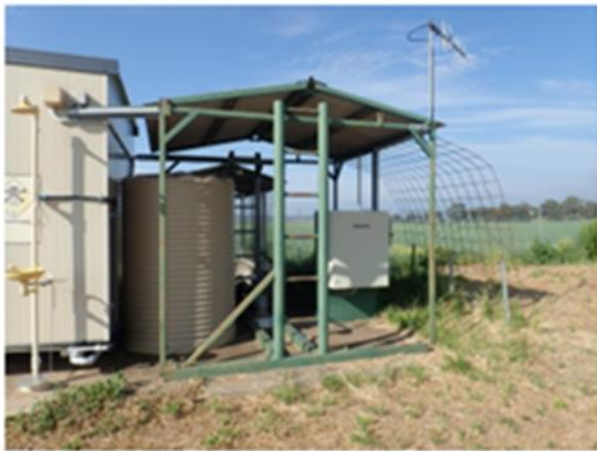
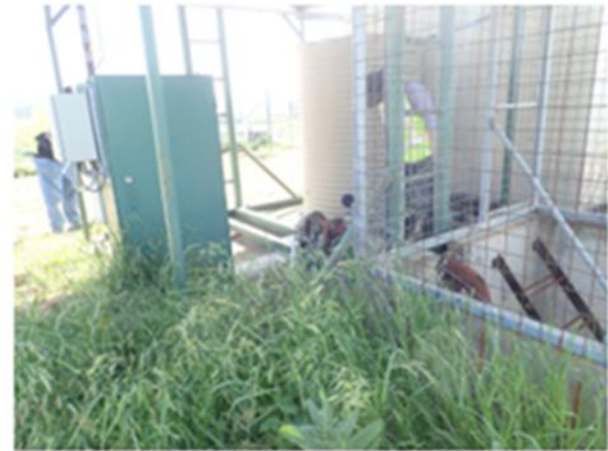
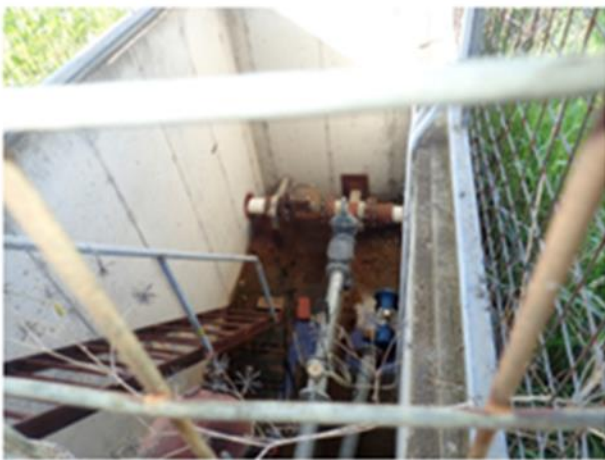
**GW800090  
Coolah TWS Bore 2**

Condition of casing, well cap and slab	Unknown
Well age	24 years, low/moderate risk
Well type	Low risk
Screen type	Slotted casing, low/moderate risk
Bore material	Mild steel, moderate/high risk
Pump depth setting	NA
Bore cementing	No
Gravel pack or natural pack	Gravel pack, sedimentary rock
Water quality	No record
Iron level	No record
Salinity level	No record
Relationship between pump depth setting and screen level on Iron Hydroxide potential	No record
Comments	Not enough information to make a full risk assessment. A camera inspection is suggested
Conclusion	Low/moderate risk

The bore is a low to moderate risk as it is cased in sedimentary rock. Unclear what is in the annulus if any material. A camera inspection is recommended and a stage test to record bore performance should be considered.

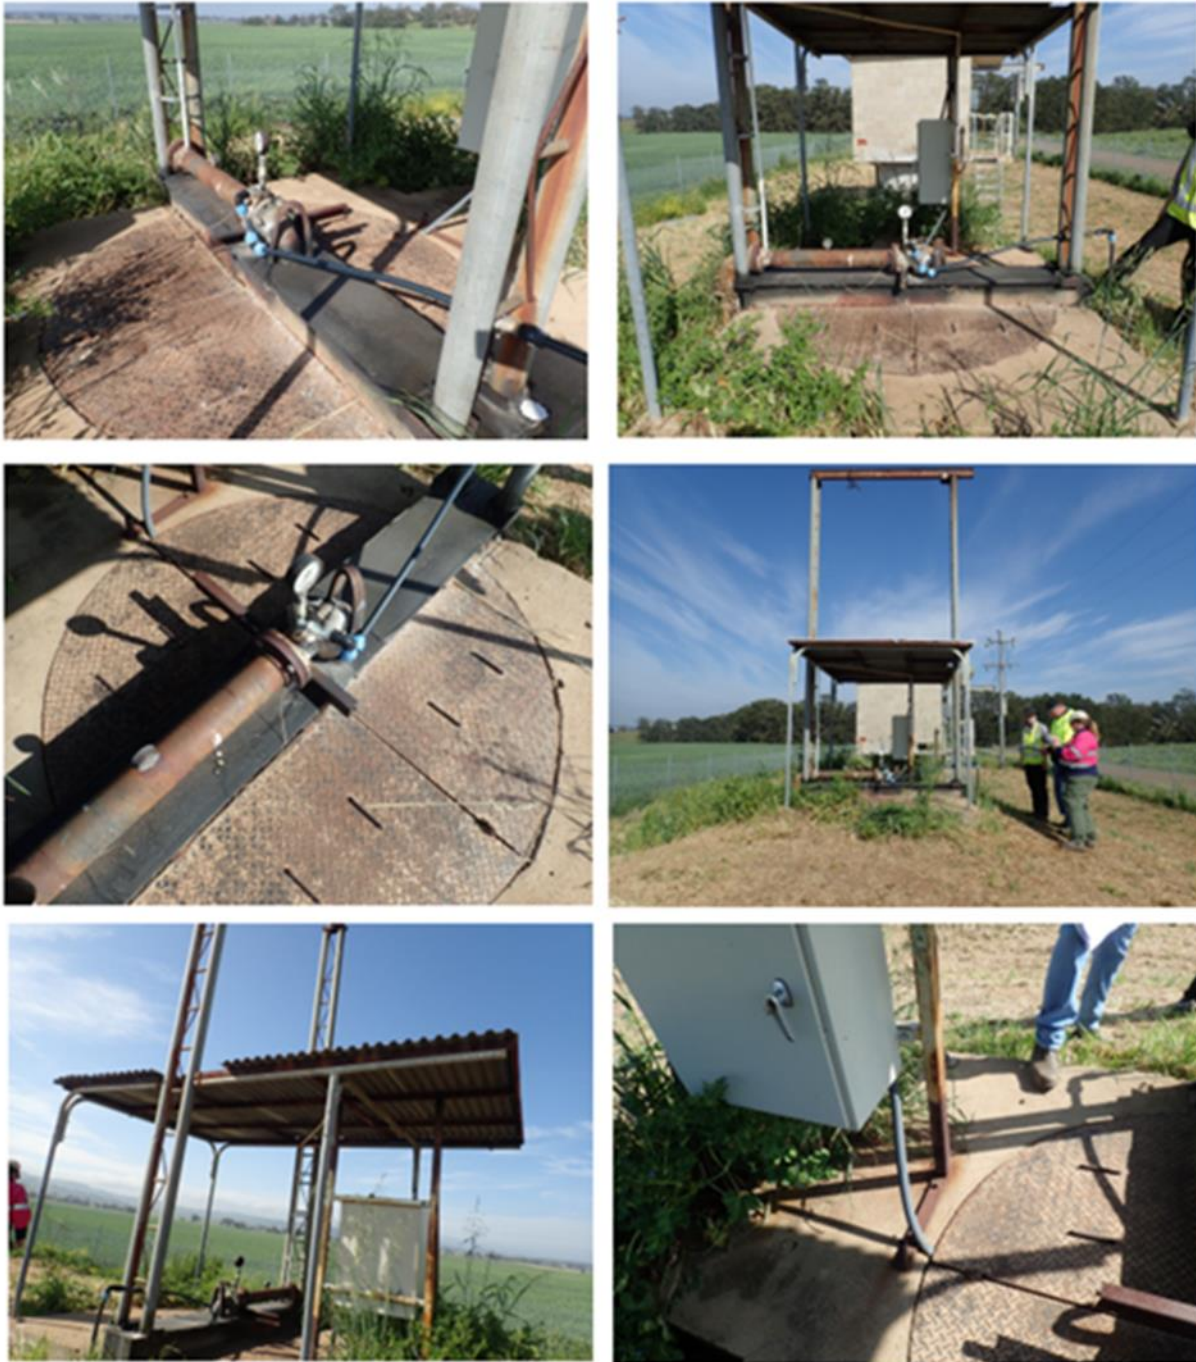
**Figure 7 - Coolah Back -up Well**

<b>Estimate of specific capacity of the well. Flow rate vs drawdown</b>	NA
<b>Site details including accessibility</b>	5 m water table
<b>Additional comments</b>	9 m to sandstone

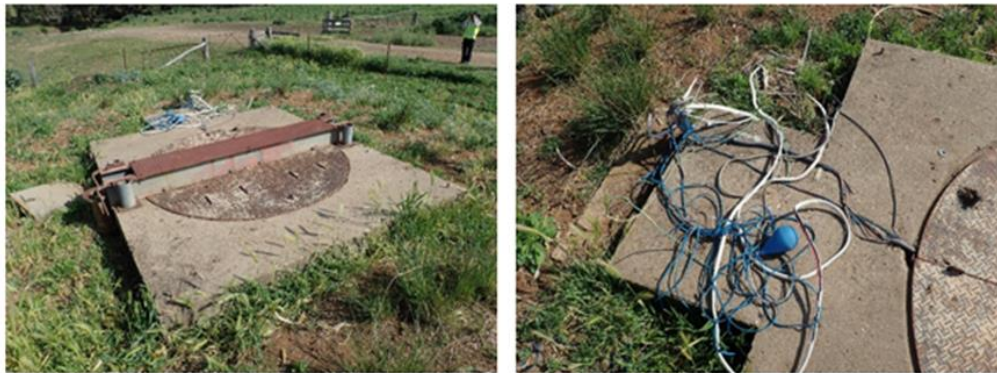
**Figure 8 - Coolah Extra Well**

<b>Site details including accessibility</b>	NA
<b>Additional comments</b>	6 ft hole/well

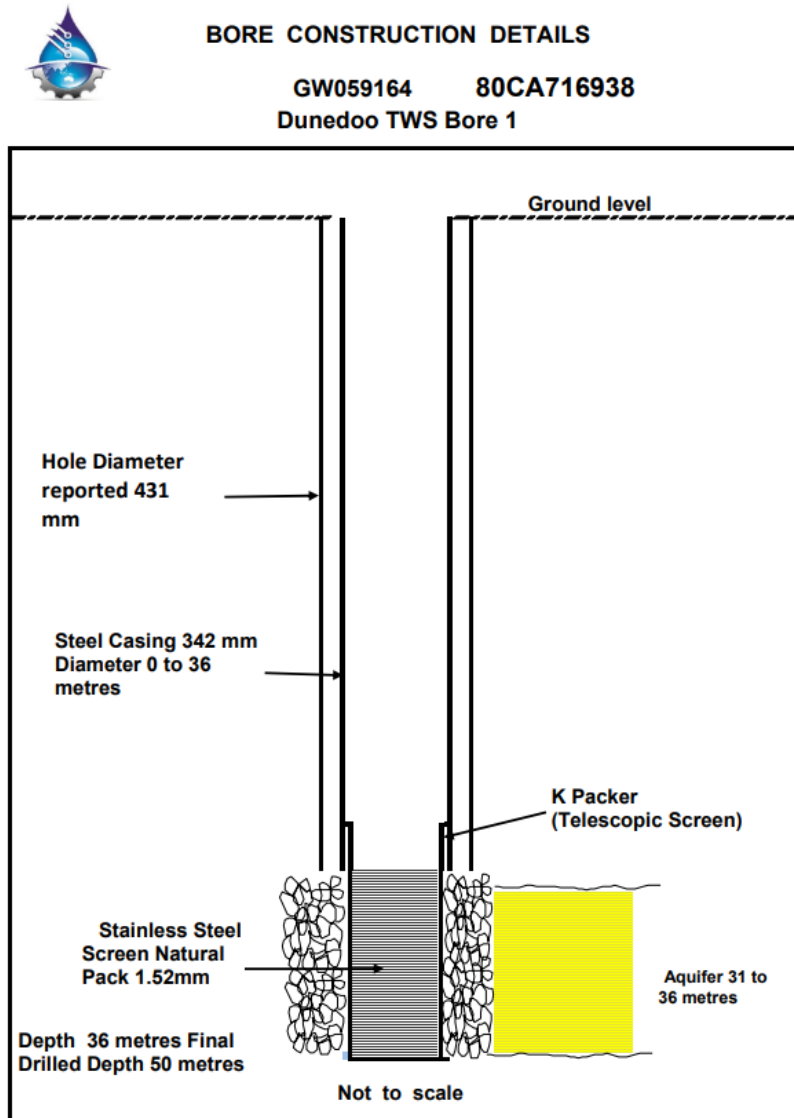
**Figure 9 - Dunedoo Town Water Bore**

Condition of casing, well cap and slab	Bore is in a pit, corrosion of surface casing could be an issue
Well age	37 years, moderate risk
Well type	Low risk
Screen type	Telescopic screen, low/moderate risk
Bore material	Mild steel, moderate/high risk
Pump depth setting	No record
Bore cementing	No
Gravel pack or natural pack	Natural pack, moderate/high risk
Water quality	No record
Iron level	No record
Salinity level	No record
Relationship of pump depth setting and screen level to iron hydroxide potential	No record
Comments	There is a presence of a white material on the pump column (possibly calcium)
Conclusion	Moderate risk

The bore is at moderate risk and due to its old age and a camera inspection is recommended, possibly in conjunction with a stage pump test, with retention of annual records to monitor bore performance over the long term.

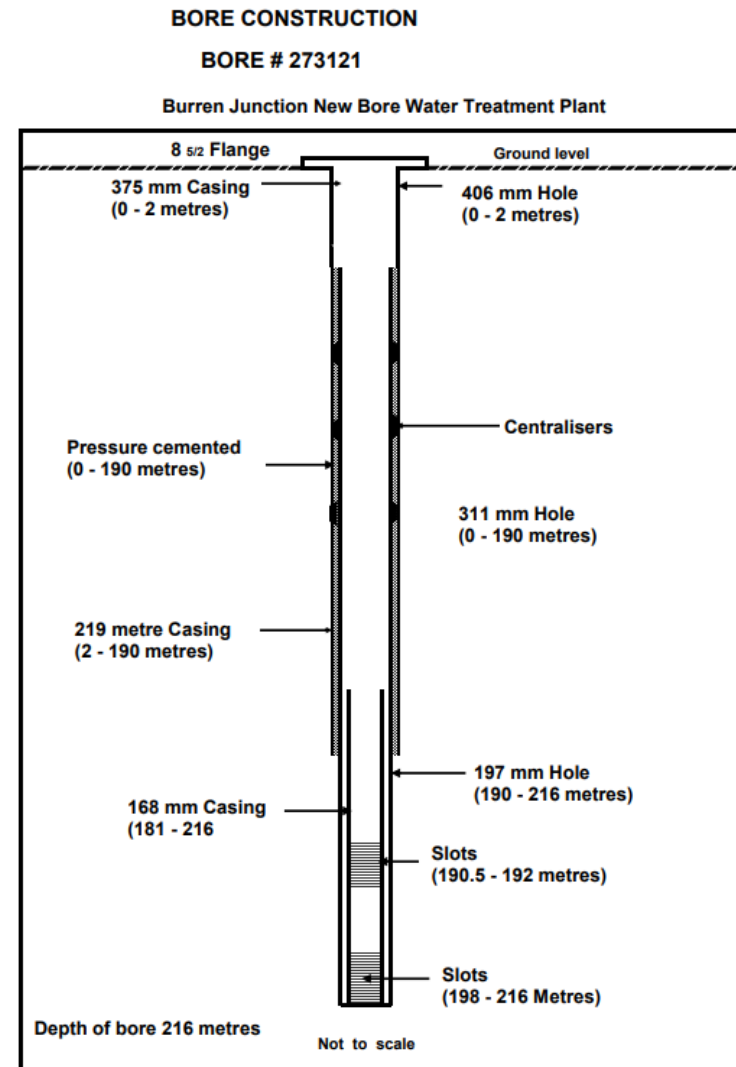
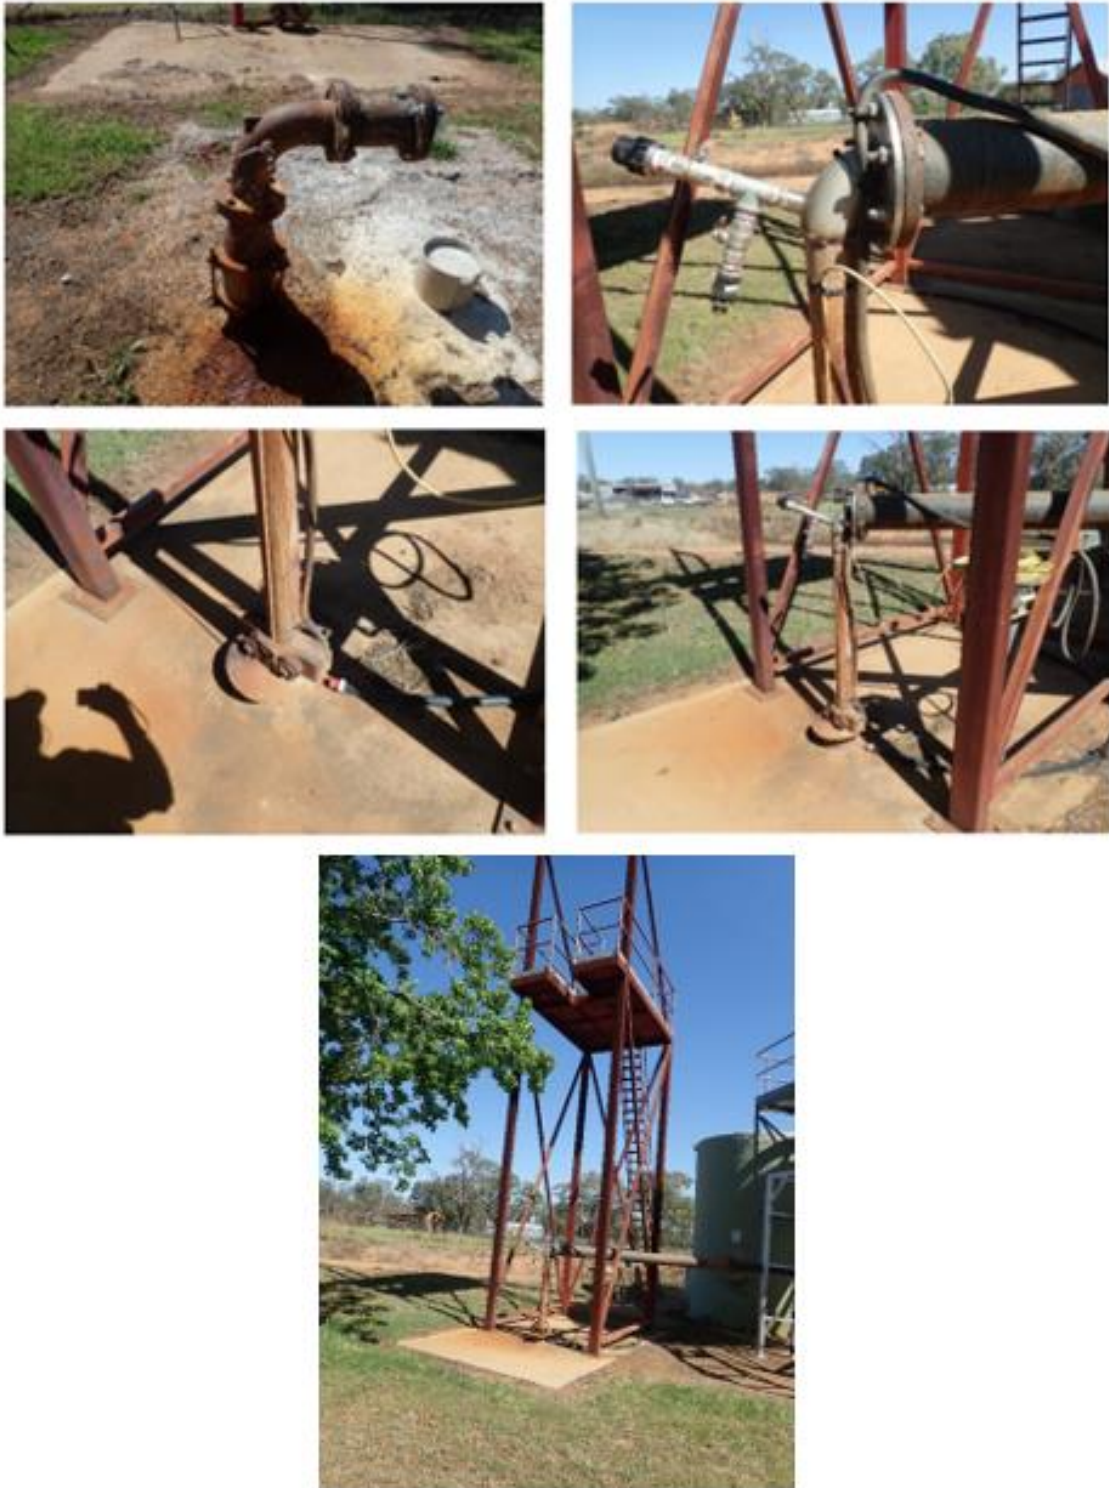
**Figure 10 - Baradine Main Supply Bore**

Condition of casing, well cap and slab	Low risk
Well age	11 years
Bore Reconditioned	No
Well Design	Low risk, cemented to 180 m and sub artesian
Screen material	Slotted casing, low risk
Bore material	Mild steel, low risk, cemented
Dissimilar metals	No
Bore cementing	Cemented to 180 m, surface casing, low risk
Water quality	No record
Iron level	No record, high in iron and manganese
Salinity level	No record
Relationship of pump depth setting and screen level to iron hydroxide potential	No record
Comments	Bore is only 11 years old, good design, low risk
Conclusion	Low risk

Camera inspection recommended to ensure iron and manganese fouling is not occurring in the bore.

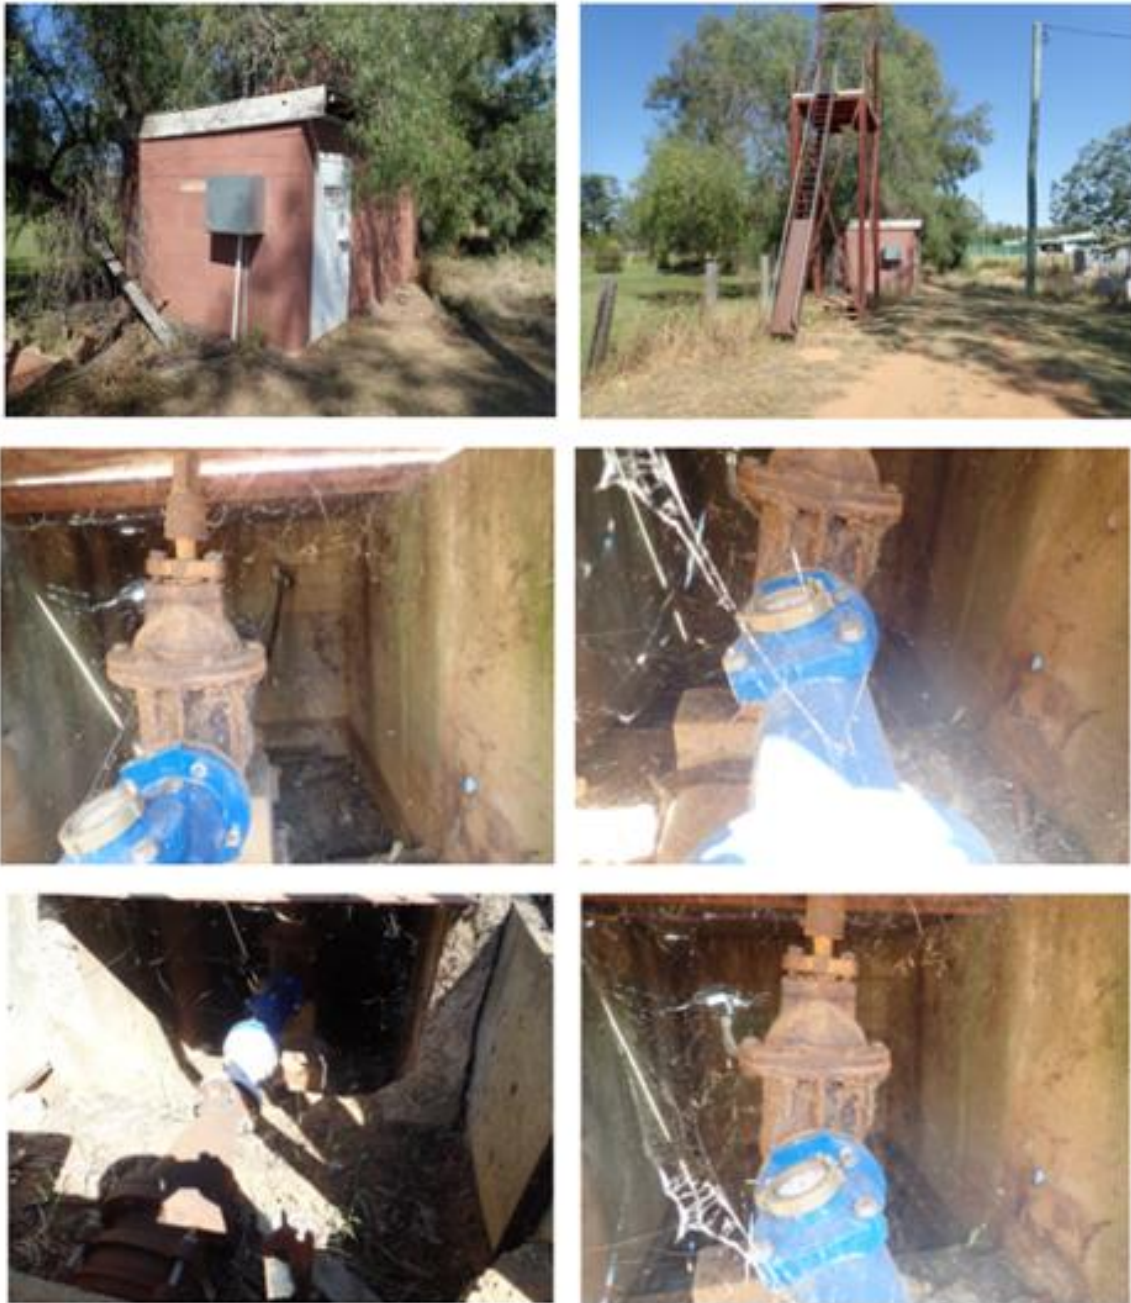
**Figure 11 - Baradine Back-up Bore**

<b>Condition of casing, well cap and slab</b>	Bore in brick building and concrete slab
<b>Well age</b>	52 years
<b>Bore Reconditioned</b>	No
<b>Well Design</b>	High risk, cemented to 93 m only with a liner to 220 m
<b>Screen material</b>	Slotted casing, low risk
<b>Bore material</b>	Mild steel, moderate risk
<b>Dissimilar metals</b>	No
<b>Bore cementing</b>	Only cemented surface casing to 93 m
<b>Water quality</b>	No record
<b>Iron level</b>	No record
<b>Salinity level</b>	No record
<b>Relationship of pump depth setting and screen level to iron hydroxide potential</b>	No record
<b>Comments</b>	Bore design is high risk but in sub artesian areas, less risk
<b>Conclusion</b>	Moderate risk

Recommend Camera inspection and start performance records of bore.

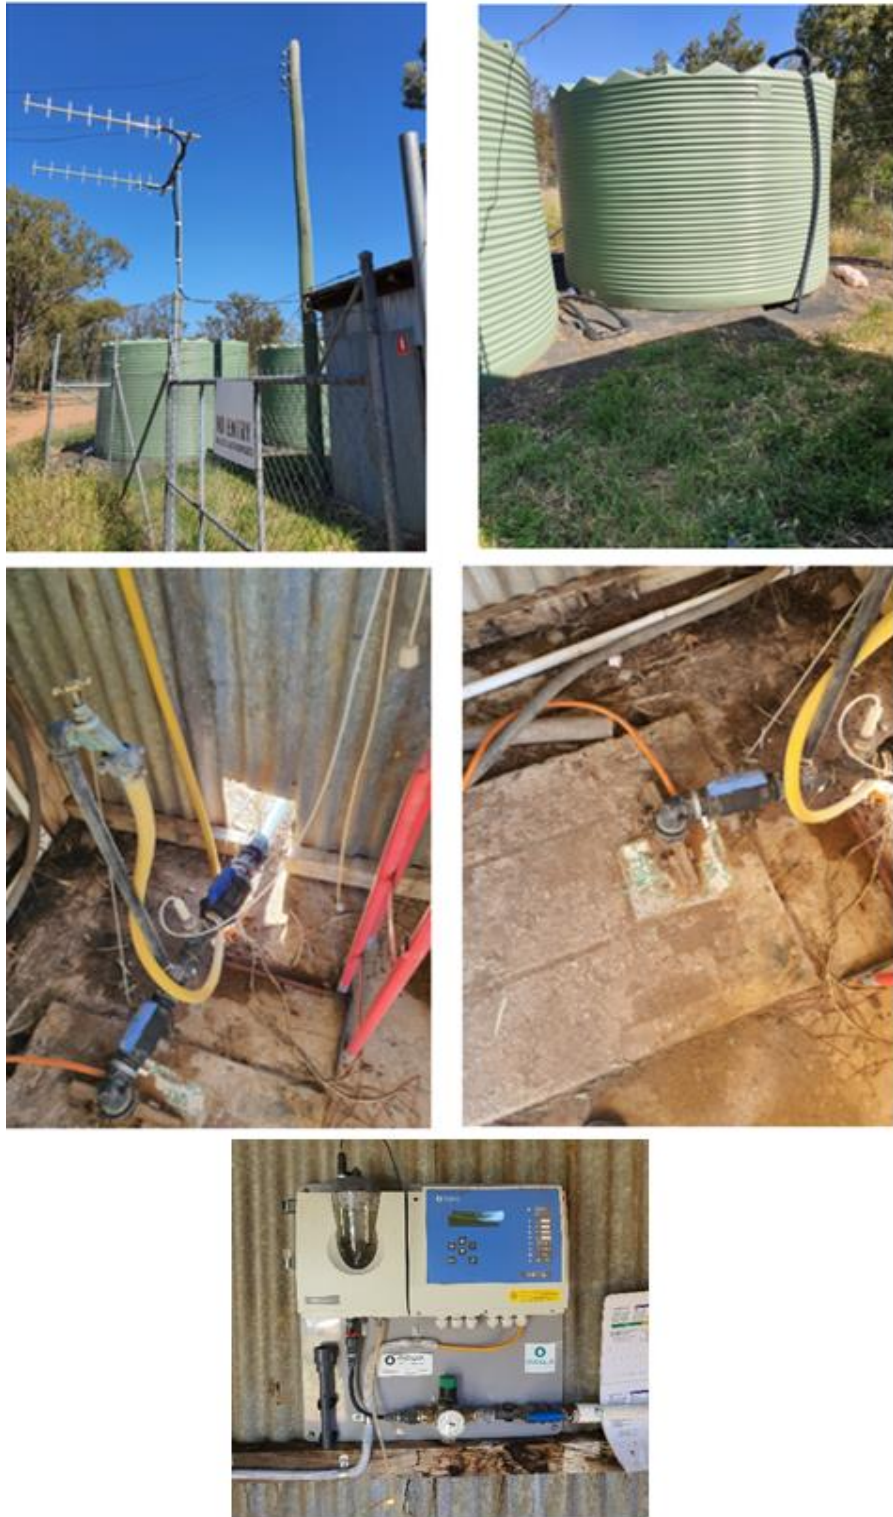
**Figure 13 - Kenebri Bore**

<b>Condition of casing, well cap and slab</b>	Low risk, no obvious surface problems
<b>Well age</b>	71 years, high risk
<b>Well type</b>	Low/moderate risk
<b>Screen type</b>	Assume slotted casing and open hole bottom, 4 m
<b>Bore material</b>	Mild steel, moderate/high risk
<b>Pump depth setting</b>	No record
<b>Bore cementing</b>	No
<b>Gravel pack or natural pack</b>	Sedimentary rock
<b>Water quality</b>	Some comments on iron and sand, no data recorded
<b>Iron level</b>	No record
<b>Salinity level</b>	No record
<b>Relationship of pump depth setting and screen level to iron hydroxide potential</b>	No record
<b>Comments</b>	This bore has had some sand problems in the past
<b>Conclusion</b>	High risk
