Baradine WTP

Filter Inspection

NSW Health / Warrumbungle Shire Council

JUNE 2020

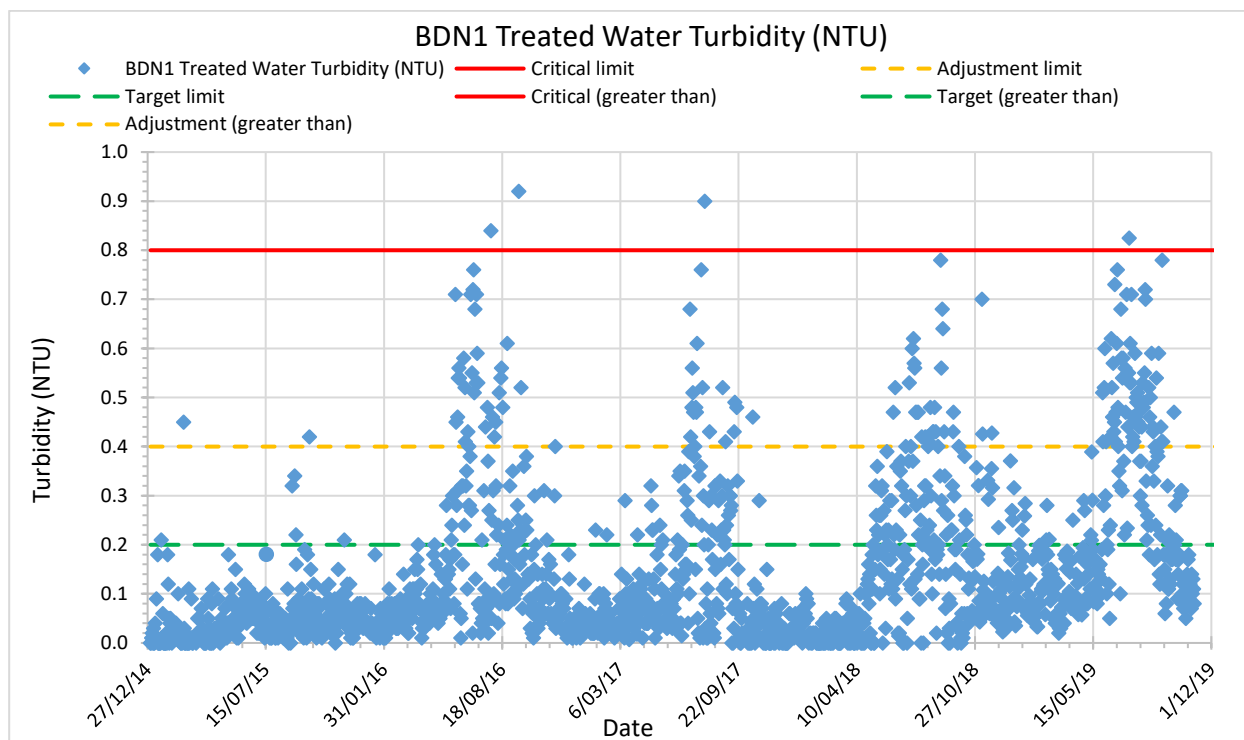
Figure 2-5: Filtered Water Turbidity (January 2015 - November 2019)

It can be seen from Figure 2-5 that filtered (treated) water turbidity periodically increases during winter months, implying that during spring – autumn, lower turbidities are typical, while during winter the plant experiences higher turbidities. It is also of note that the winter of 2015 did not see the same increase in filtered water turbidity compared to 2016 through to 2019. There has also been an increase in filtered water turbidity during spring to autumn in 2018-2019 compared to previous years. This could suggest that some variable has changed which is now resulting in poor filtered water quality at times, with greater variability observed in winter months.

The data exhibits a wide variability in the turbidity results especially in the winter months. Therefore, the root cause of the high turbidity cannot be confirmed given the lack of data. Likely causes could be:

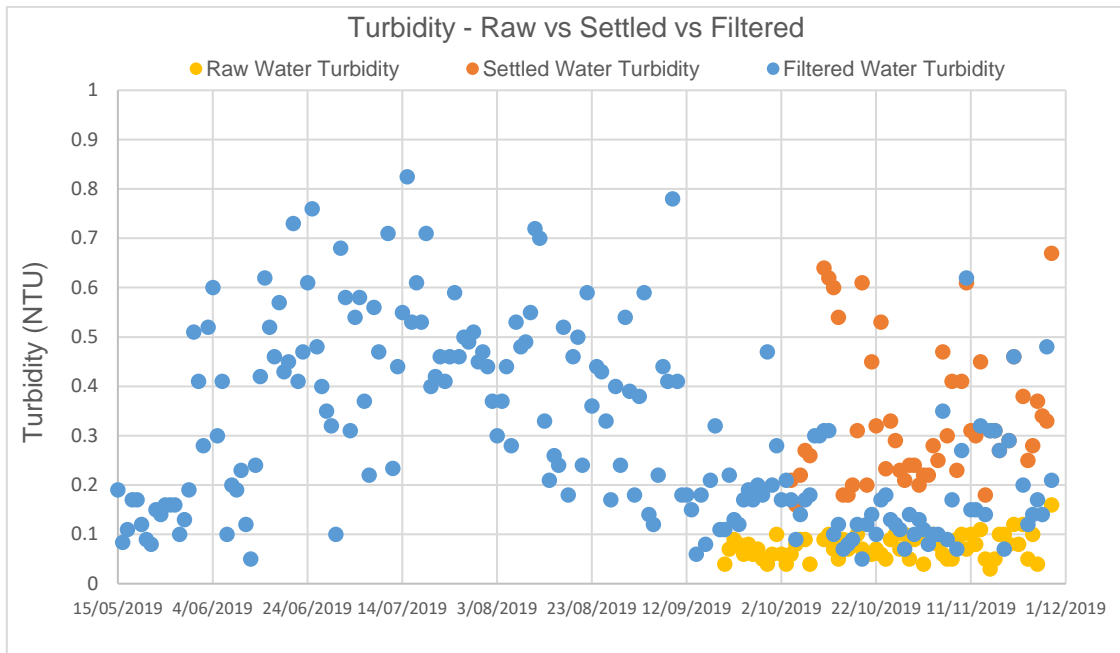
Figure 2-8: Turbidity Comparison for Raw, Settled and Filtered Water

It can be seen from Figure 2-7 that raw and settled water turbidity data prior to September 2019 has not been provided or does not exist, therefore, any effect on filter performance could not be assessed. The raw water turbidity appears to be stable (based on grab sample data) and is lower than the settled water turbidity. It can however be seen from Figure 2-7 that raw water turbidity is generally lower than settled water, maintaining <0.2 NTU, while settled water exceedances >0.4 NTU have been observed. This is likely due to iron and manganese oxidation via aeration at a high pH. This is expected and the filter would have been designed to remove the remaining precipitate and solids remaining in the settled water quality. However, filter media loss is likely contributing to elevated filtered water turbidities.

The high variability in sample results is concerning and therefore a focus on process optimisation and or sampling regime should be considered and investigated further. Sampling daily at different times of the day or at different durations after the WTP has been running can alter the results and thus make root cause analysis difficult. Online instrumentation enables trending of data which can then be used to identify issues and determine the root cause more easily.

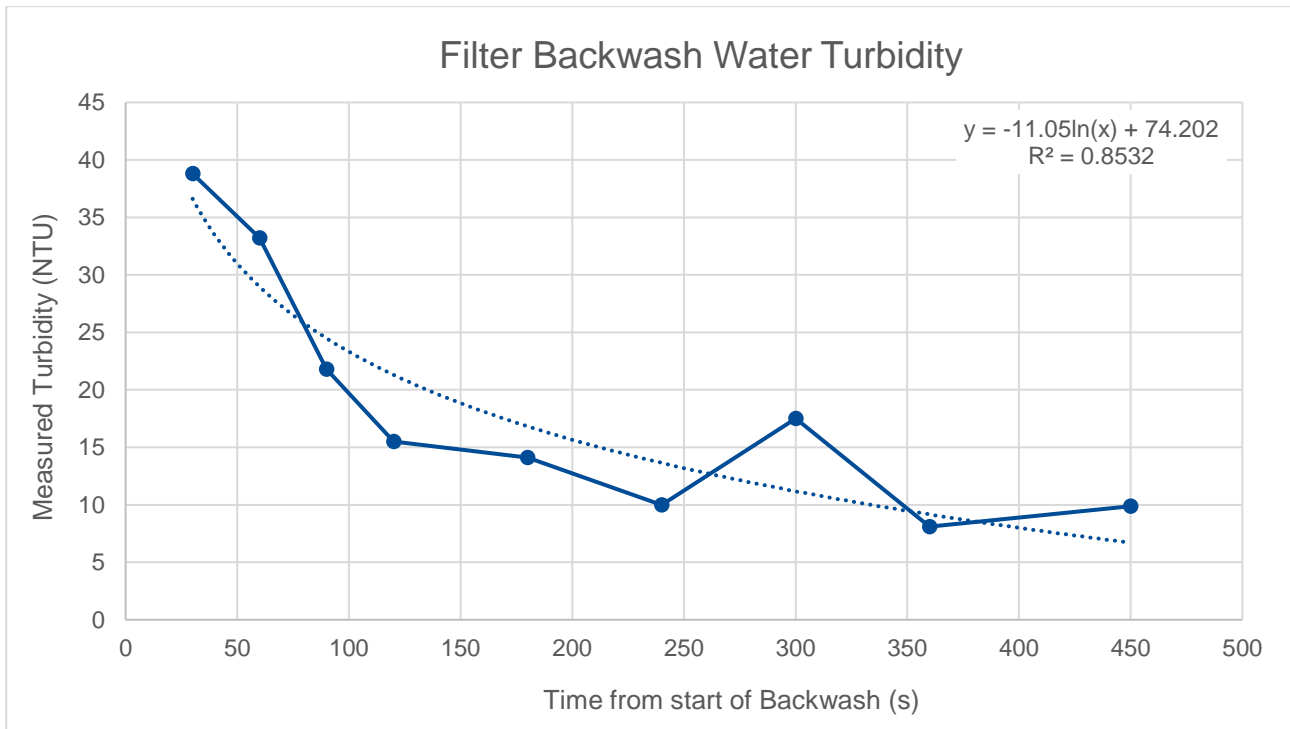
Figure 3-1: Filter backwash turbidity profile

In considering the turbidity profiling of the backwash from Figure 3-1, the turbidity of the washwater reached ~10 NTU between 4 - 7.5 minutes of high flow washing. There is an outlier value of 17 NTU captured at five minutes which does not seem to fit the trend. Using the trend line however would indicate that 10 NTU is achieved after ~5.8 minutes.

A common problem with having a very low turbidity at the end of the backwash cycle is that the filter may take a long time to ripen during which time the turbidity leaving the filter will be high. The ripening period is unknown, however as there is currently no individual filtered effluent turbidity analyser. If filter ripening was confirmed to be an issue, then there may be an opportunity to reduce the backwash duration marginally to assist filter ripening.

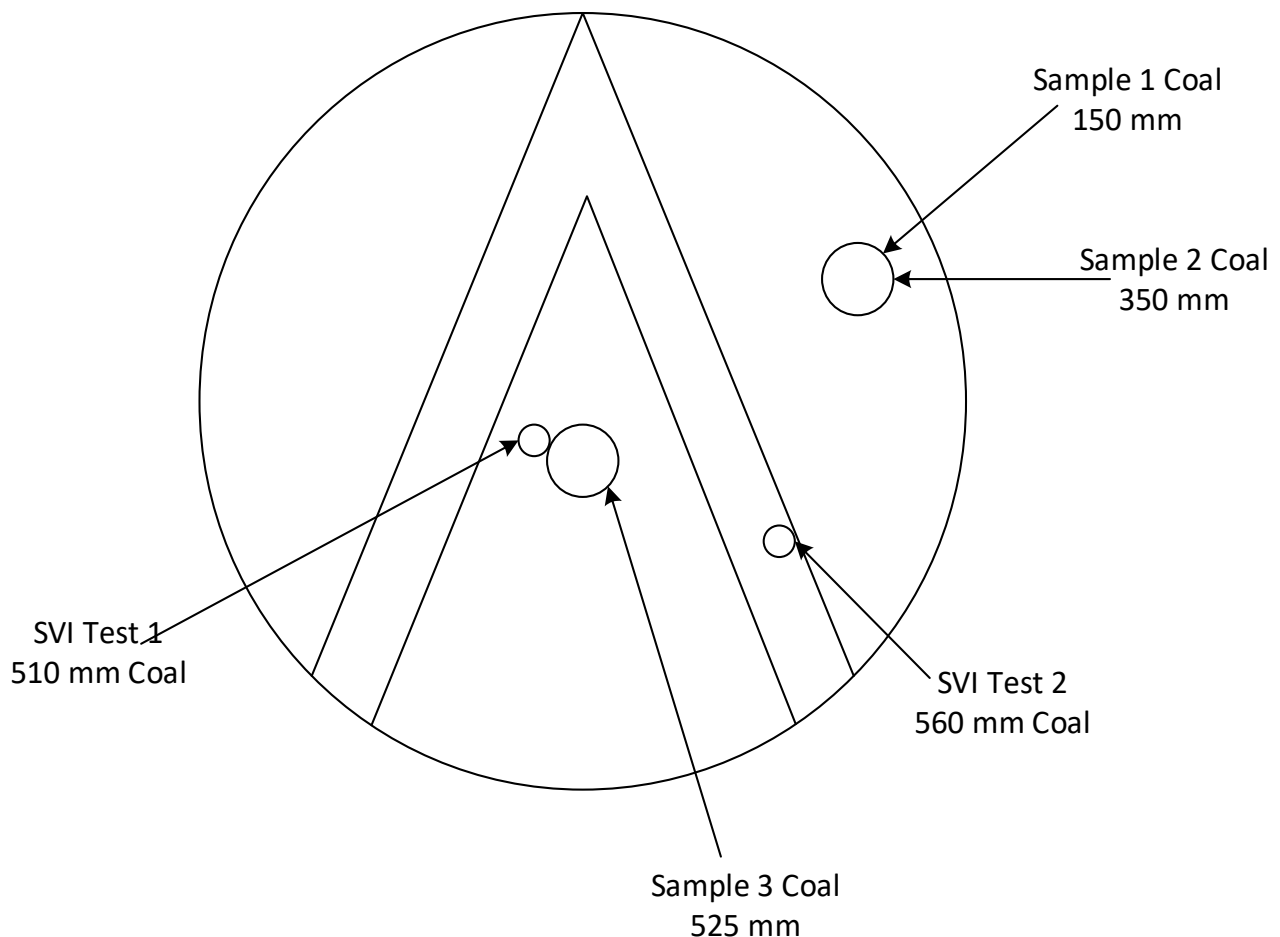
Figure 3-3: Filter Media Sampling Locations

While digging through the filter media at the sampling points, no mudballs were identified and there was minimal to zero fines situated on the top layer of the filter coal. The filter coal media looked angular in shape

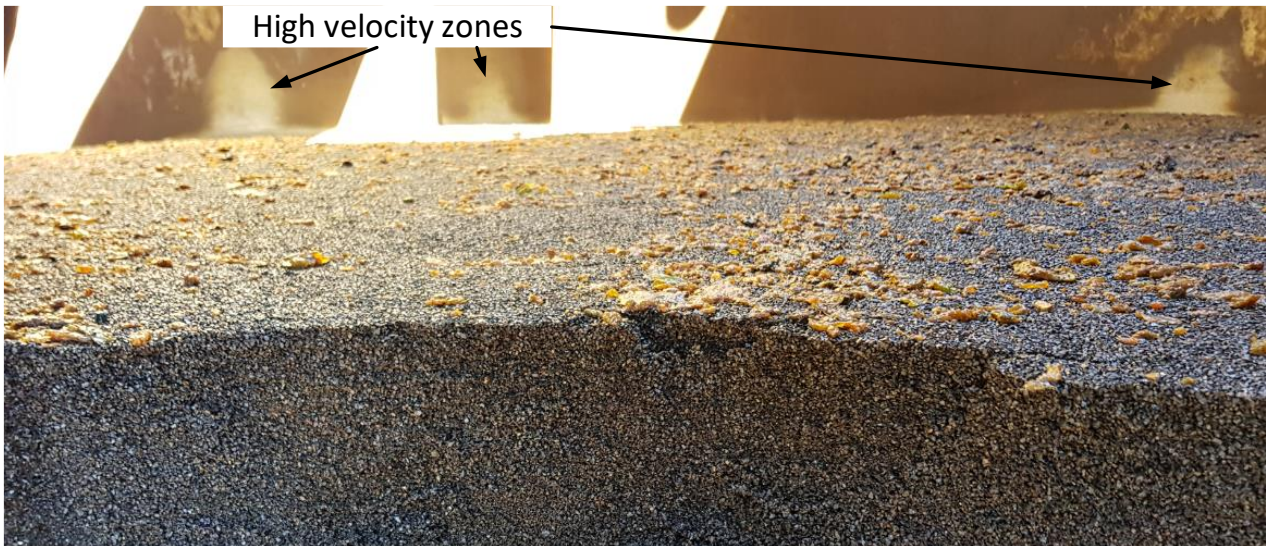
with low deterioration. However there was plenty of algae and floc/sludge that had sloughed off from the filter walls which was present on top of the filter media (Figure 3-4). It can also be seen in Figure 3-4 that there were scouring marks at various points across the filter wall which indicate potential high washwater velocity points along the filter walls. This suggests that the plenum floor may have separated from the filter wall in sections causing filter washwater to exit at high velocity through the compromised sections. This would also allow the filter to be bypassed in certain sections in filtration mode.

Figure 3-4: View from filter access hole across filter media surface with wall scouring observed.

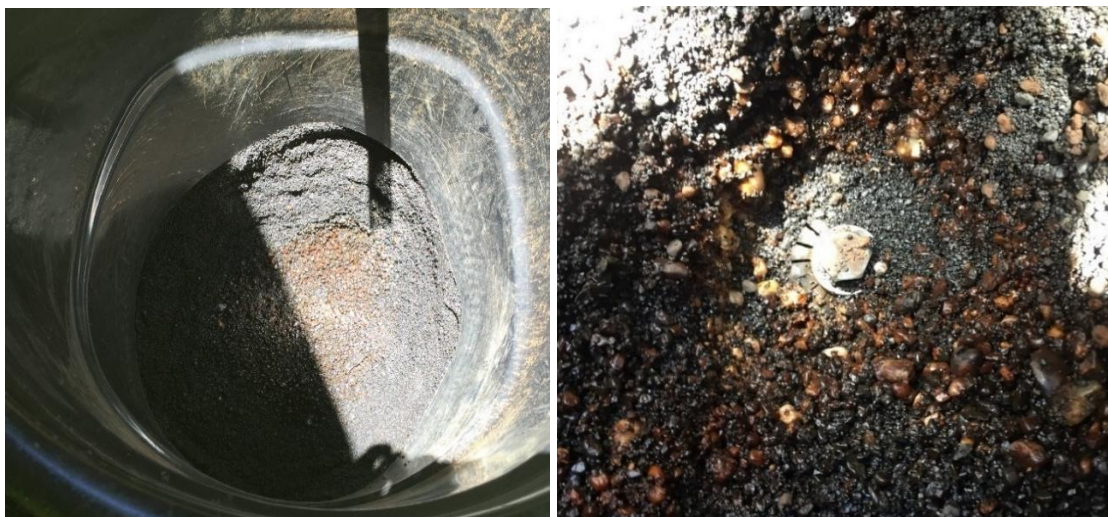
At filter sample point 3 it was observed that coal or coated black sand had been mixed with support gravel. Underdrain filter nozzles were also observed to be exposed at the depth (~525 mm) of sample 3 (demonstrated by Figure 3-5).

Figure 3-5: Filter nozzle exposed with coal with gravel and media intermixing

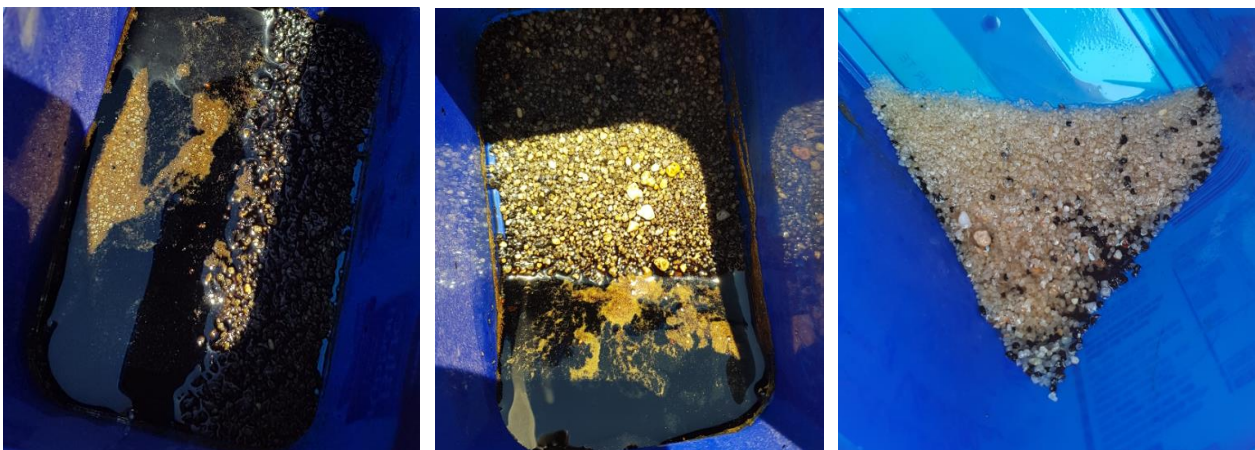
Figure 3-6: Filter media soaked and washed with acid (left to right: beginning to end of washing)

It can be seen from Figure 3-6 that the filter sand was black before the acid soak and washing and then clean following rising. The acid also turned black indicating manganese. In addition, once the acid was added to the media there was an exothermic reaction occurring which further supports this finding. It is unclear if a manganese coating had developed on the coal, however this is also suspected to have occurred to some degree. The manganese coating was not excessive or built up to the point where it could be broken off the filter media when applying pressure from fingers, as was seen at Binnaway WTP during the filter inspection in 2017. Manganese staining was also visible under underdrains and on the filter walls.

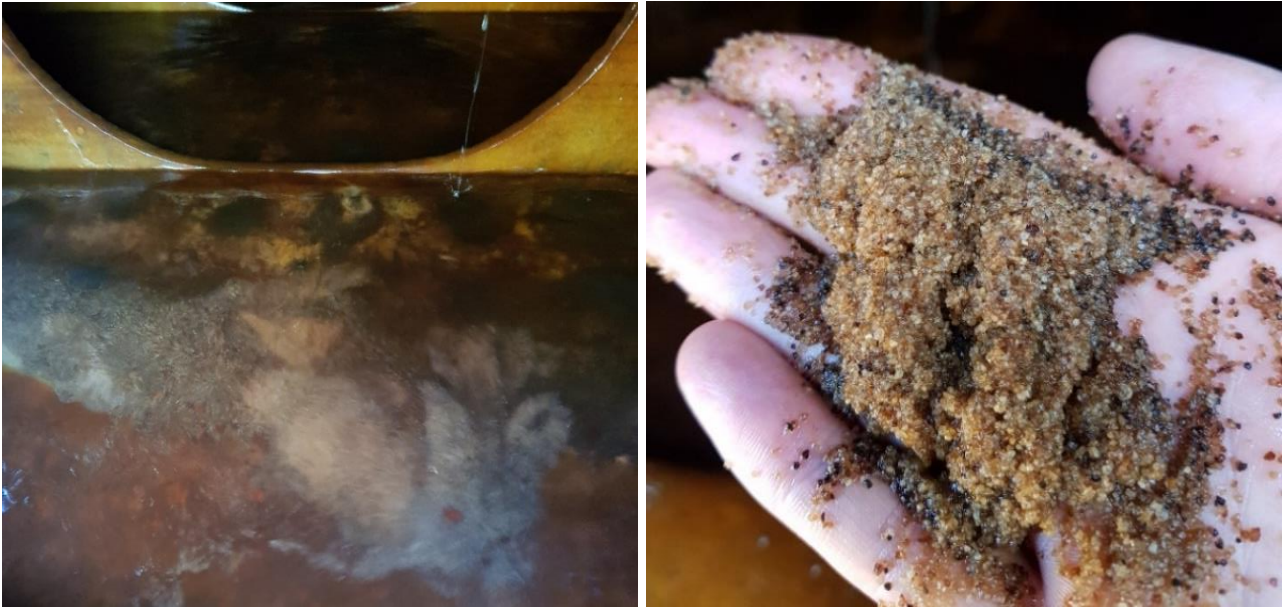
Prior to entering the filter, confined space entry of the underdrain was undertaken with the aim of assessing the plenum floor and filter nozzles. It was observed upon entry that a large quantity of sand was present on the underdrain floor (Figure 3-4). Filter media present in the underdrain suggests either broken nozzles or a disturbance of support gravel layers which has allowed sand and coal to migrate to and through the nozzles. The filter nozzle slot size (measured to be ~1.6mm on site) is also large and this would allow filter sand (0.55 – 0.65 mm) to pass through to the underdrain if a disturbance of the support layers occurs, which has occurred at some point in the past.

Figure 3-7: Filter sand and coal found in filter underdrain

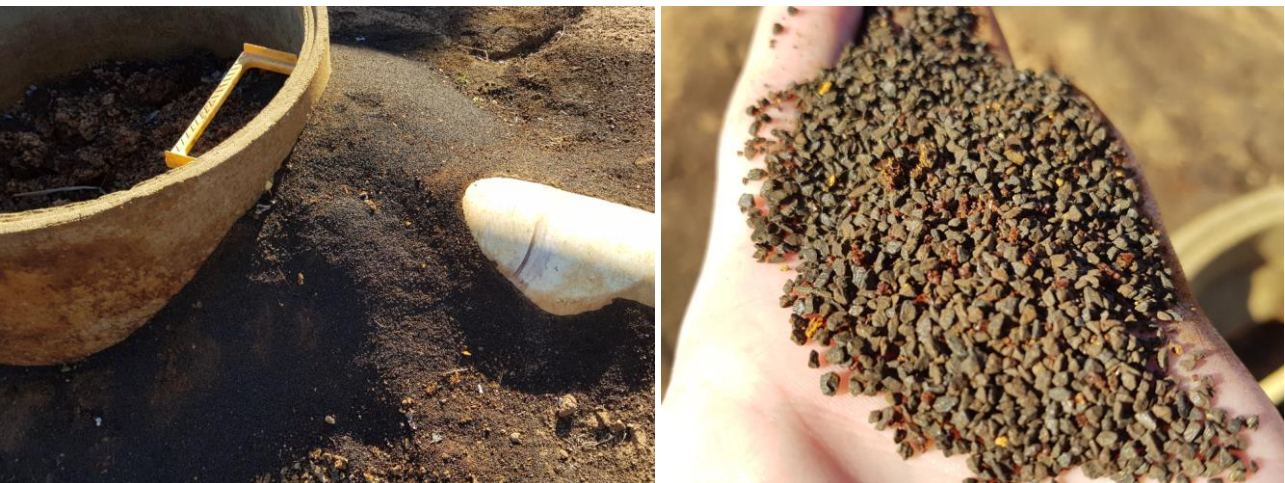
Large quantities of filter coal were also identified at the inlet of the empty sludge lagoon (Figure 3-8).

Figure 3-8: Filter media in sludge lagoon

The large volume of filter media found in the sludge lagoon supports the finding that draindown level float switch was positioned too high which was contributing to filter coal loss during the air scouring process. The media lost during each filter backwash would have then been carried to the lagoons by the high rate backwash flows.

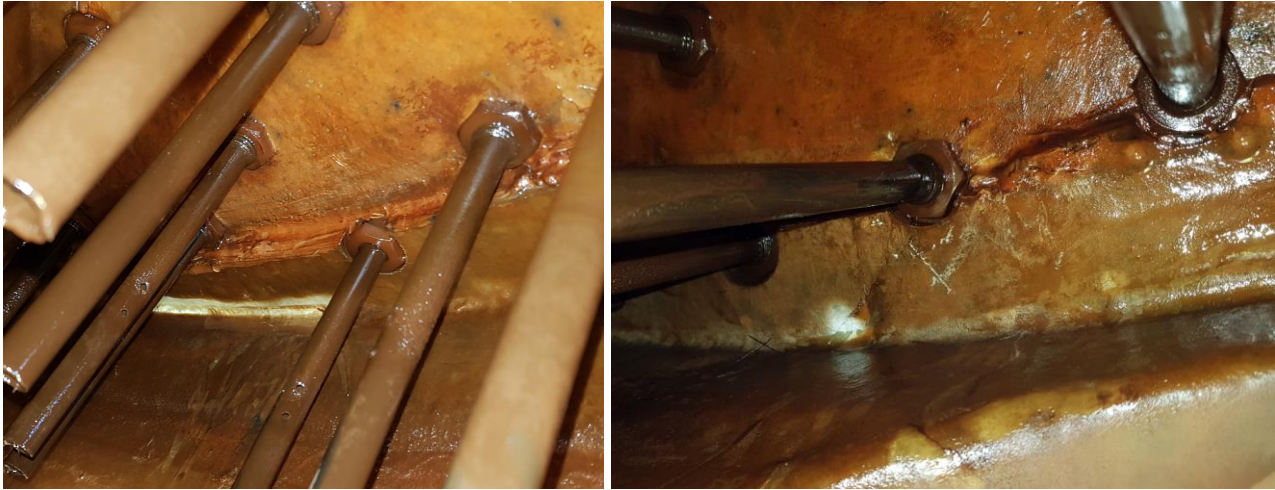
The damage to the underdrain (previously mentioned) was also confirmed by visual inspection of the underdrains which revealed similar scouring points along the joint between the plenum floor and filter wall, evidenced by clean white sections (with no manganese build up due to scouring effects). In addition, water was also observed leaking and dripping through these compromised sections (refer Figure 3-9). Visual inspection also revealed hair line cracks and damage on and around the joints (floor and wall). There was therefore sufficient evidence of wall to floor joint failure and cracking suggesting potentially bypassing of filter media.

Figure 3-9: Underdrain floor joint failure and cracking

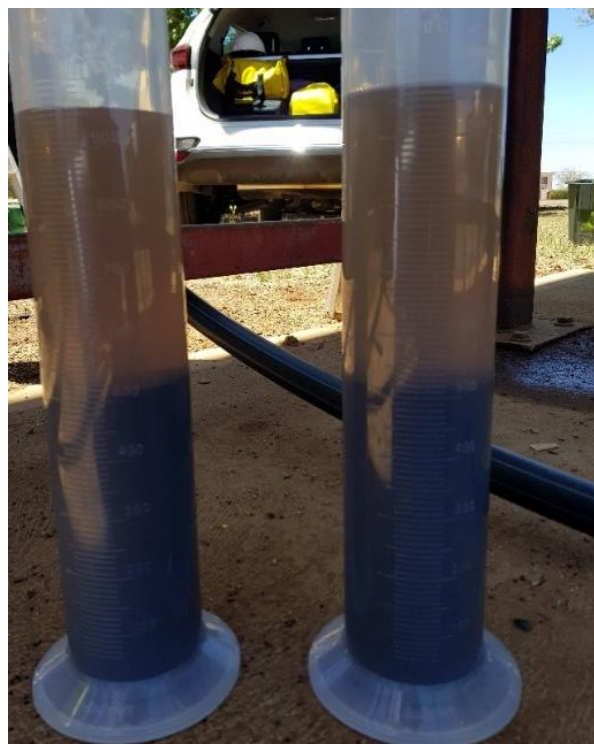
Figure 3-10: SVI testing for SVI1 (left) & SVI2 (right)

The test undertaken at the SVI 1 and SVI 2 sample locations did not produce any visible sludge layer after the water had settled, as both tests produced very fine floc that did not settle. No sludge layer formed on top of the media and thus the observed SVI was considered to be quite low. A SVI of <5% is generally acceptable as being 'good' (Murray, 2005).
