Town Water Supply Bores

Review of casing condition

Warrumbungle Shire Council

22 May 2023

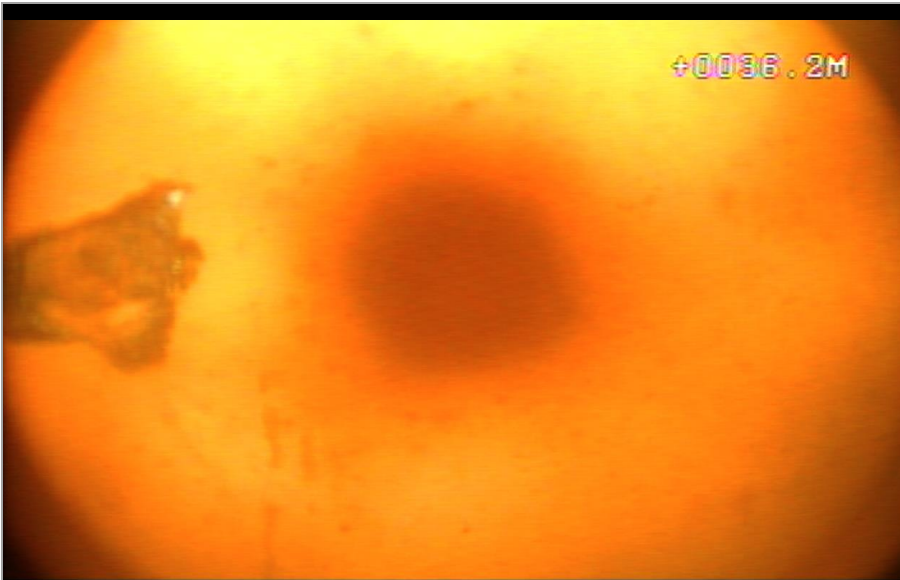
Poor picture quality below the water. Occasional scaling otherwise interior surface condition of casing is relatively smooth.

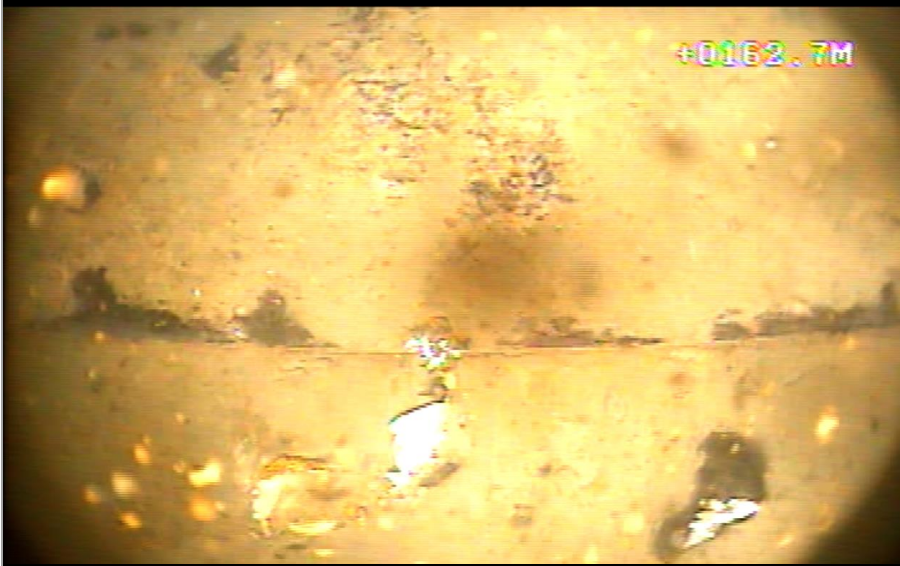
Example of a casing joint and relatively high quality imaging. Note suspended particles.

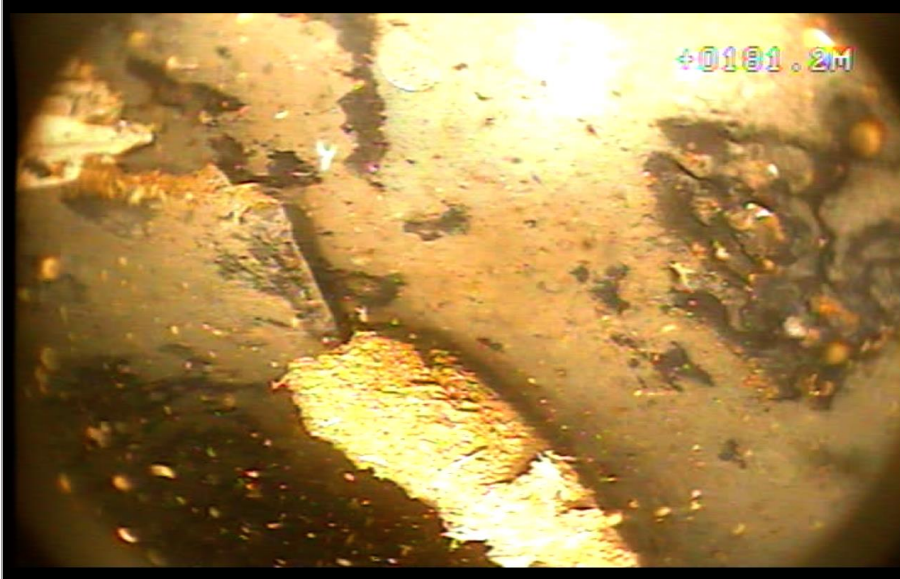
J-Latch has been partly damaged, likely through passage of drilling rods through this zone.

The top of the j-latch appears to be partially bent, however, there appears to be sufficient clearance through this zone. Furthermore, approximately 30 m of pipe has been lost down the hole. Care will need to be exercised when drilling contractors enter this area of the bore, or with future inspection works.

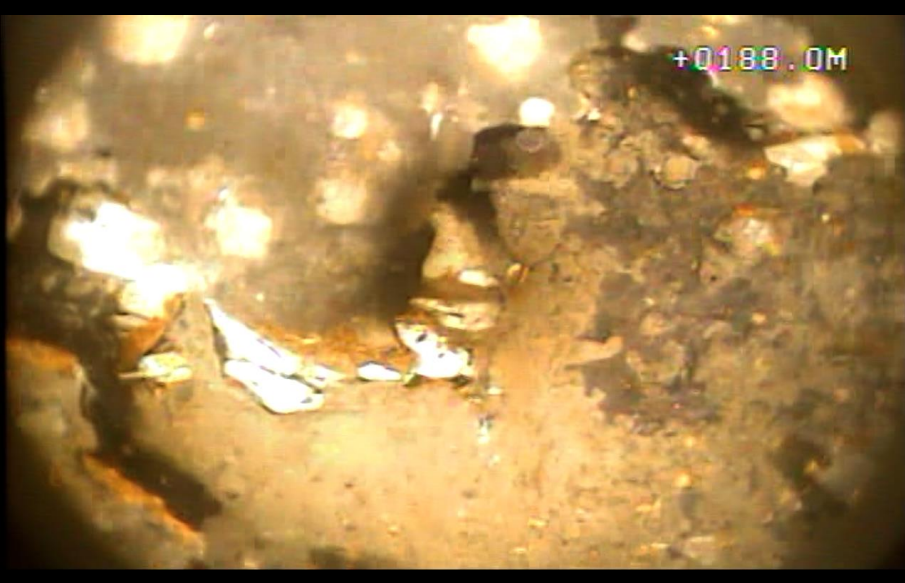
<p>Appears that casing at 188 m has been corroded through. This is part of the section telescoped inside the pressure cemented pumphouse casing.</p>

The casing does appear to be partly compromised in the area of cross-over, where the DN150 production casing has been suspended inside of the pressure cemented DN200 casing. However, this will not significantly effect the short term operation of the production bore. Consider that the Baradine Back-Up bore is 40 years older and still operational (albeit in a poorer condition).

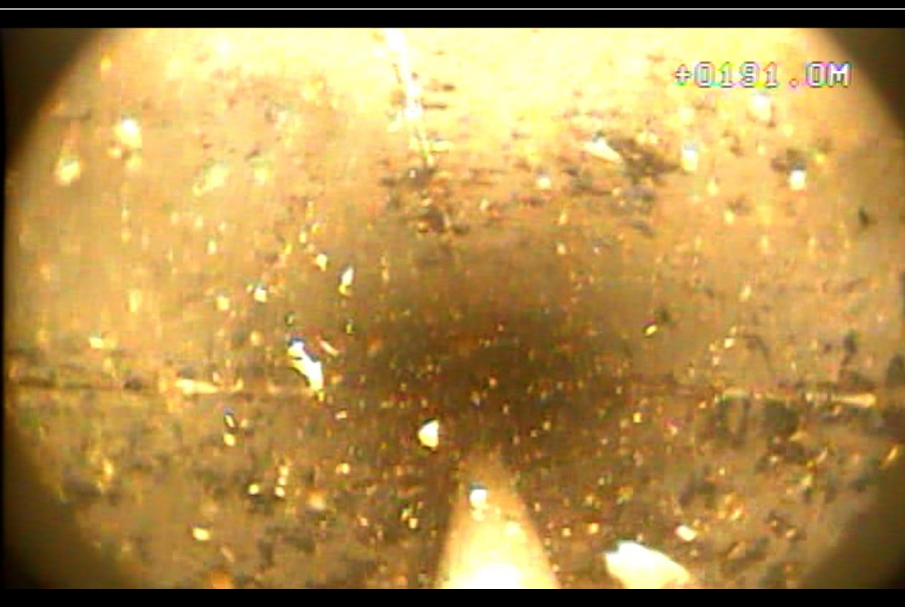
<p>Plasma cut vertical slots. Note 'foreign pipe' still present.</p>

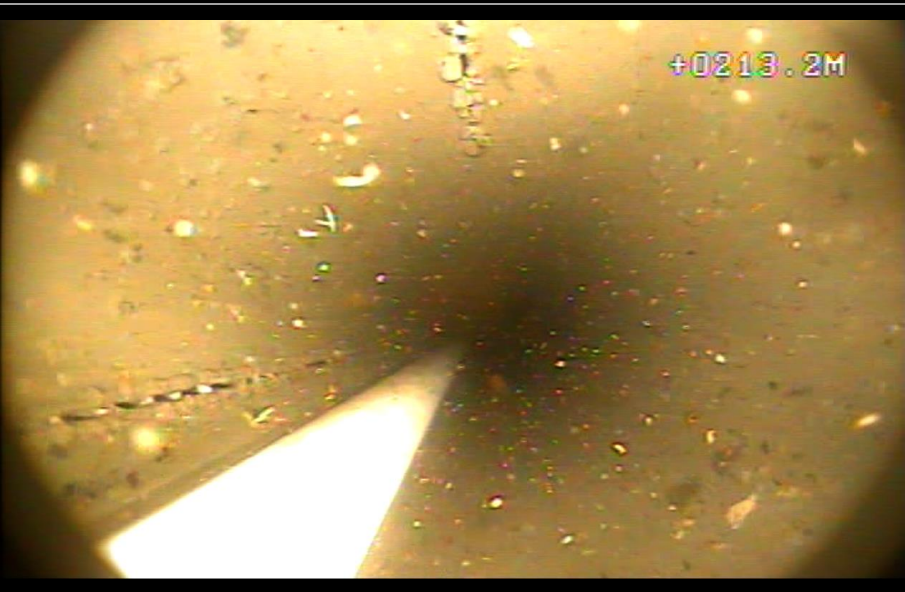
<p>Slot apertures at greater depth are in reasonable condition.</p>

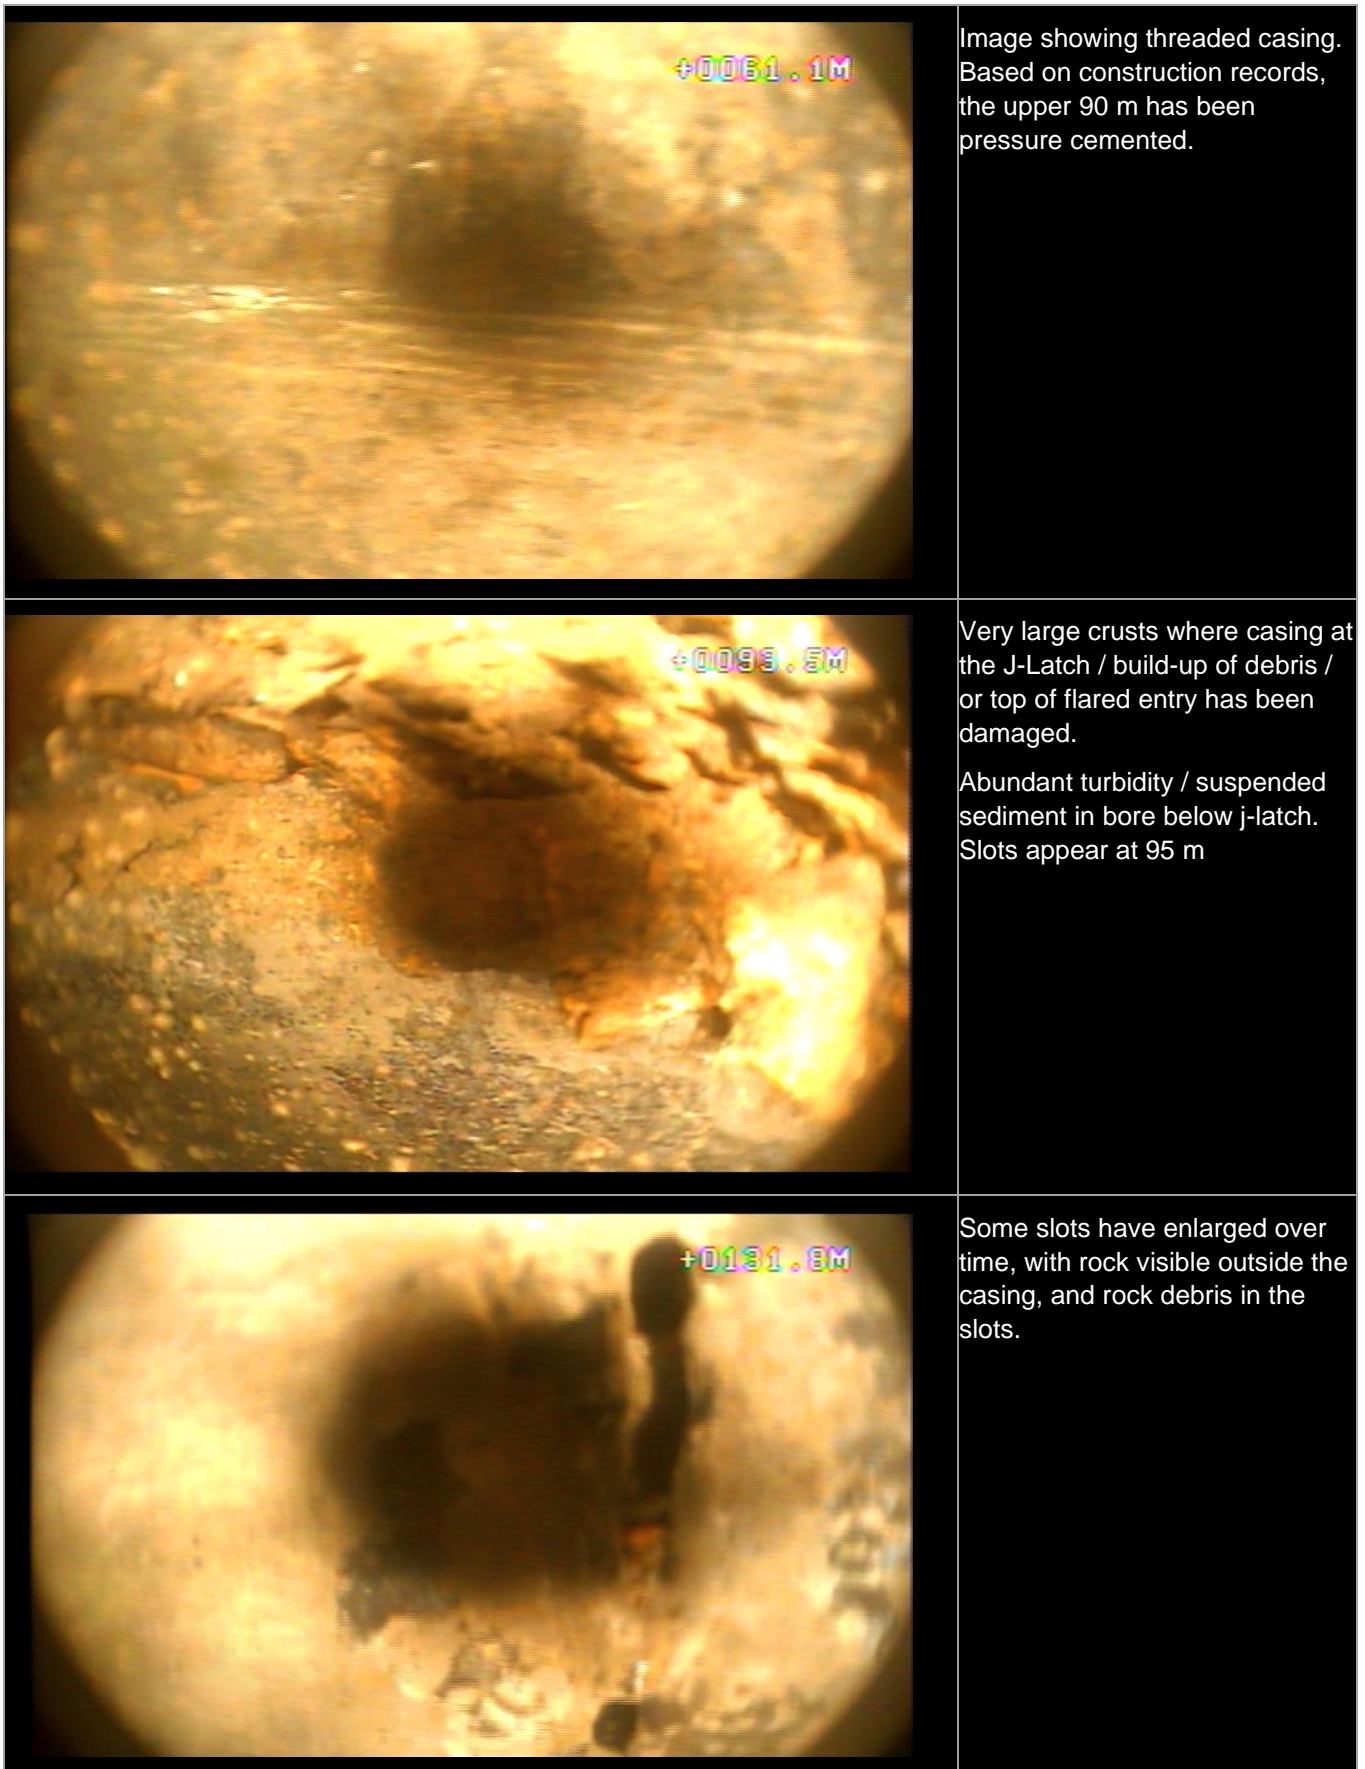
Figure 2 Selected imagery – Baradine Back-up production bore

- Numerous areas where corrosion had penetrated through the bore casing wall, e.g. 54.7 m, 86.8 m, and parting of joints, indicating casing has reached the end of its useful lifespan. Gravel ingress in bore from slot at 128.3 m.

Some selected imagery from the CCTV inspection is provided in Figure 2. Other observations:

- High surface roughness in the splash zone of the bore, i.e. when water levels are drawn down through pumping. The drawdown in the bore is unknown and therefore an understanding of the splashing is not known.
- Cable ties were on the water table. These may have been dropped into the bore during pump installation and retrieval.
- Abundant suspended material in water and poor picture quality directly below water level / splash zone.
- Some areas of deep pitting / roughness e.g. 54 m, 80 m to 90 m
- Many of the slots have been enlarged
- Many areas of the DN150 with scaling and pitting

This bore should be decommissioned and replaced with an inert cased bore to provide long term security of supply to Barradine township. However, there may be an opportunity for Council to defer the replacement, subject to their risk appetite, i.e. continue to operate the bore and monitor its performance for possible signs of failure. This may provide time for Council to plan and budget for its replacement.

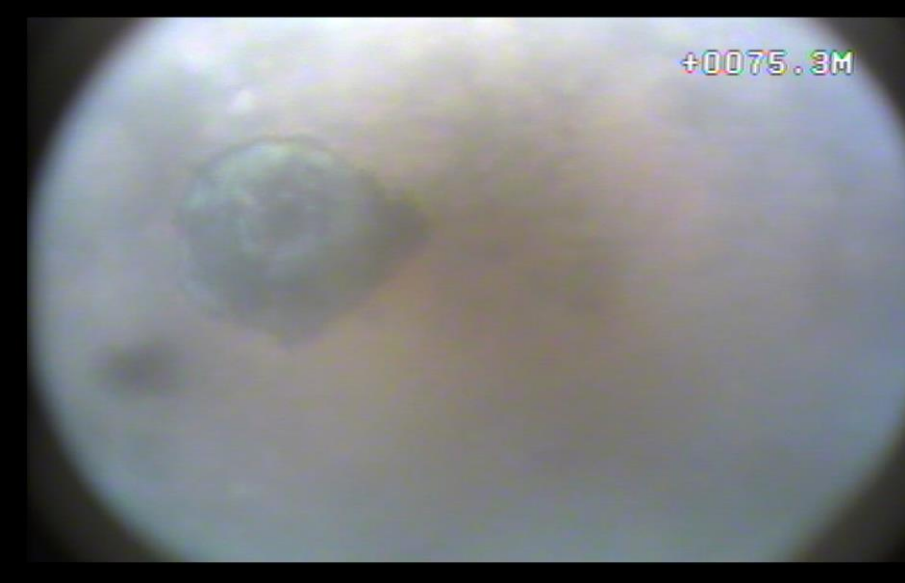
<p>Discoloured scaling on surface of casing. Poor visibility below water table.</p>

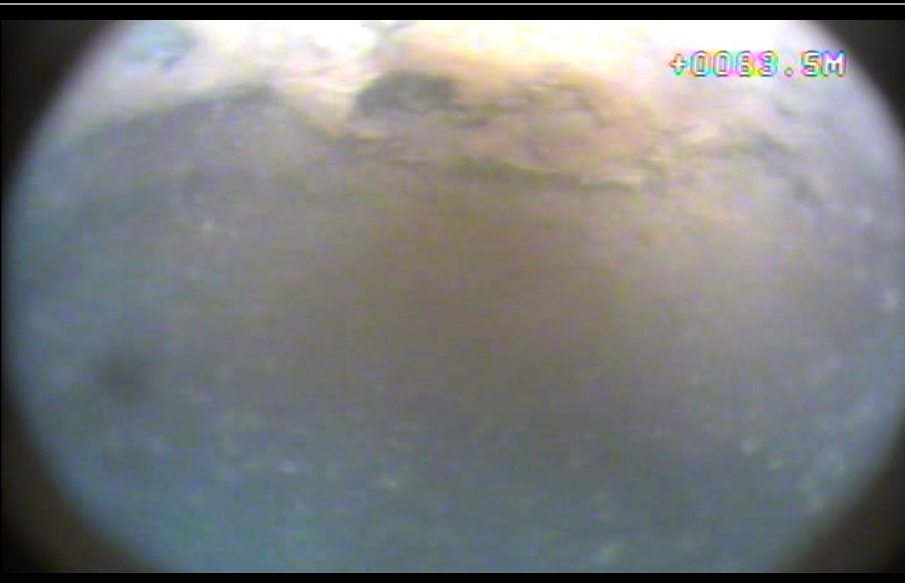
<p>Bottom of the steel casing</p>

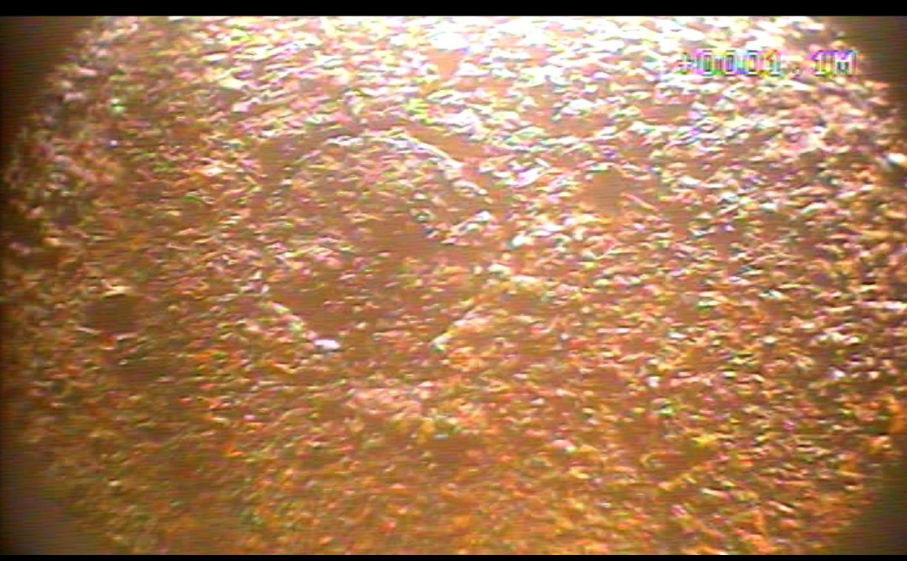
<p>Such marks were noted at multiple locations in the casing. It is interpreted that these are torch cut holes that were used to elevate the casing into position. The lugs are then hammered back into position and welded. These represent high risk areas for corrosion and ingress of fines into the bore. They result from poor drilling practice – the use of lugs ('dog ears') attached to casing exterior or collars is preferred.</p>

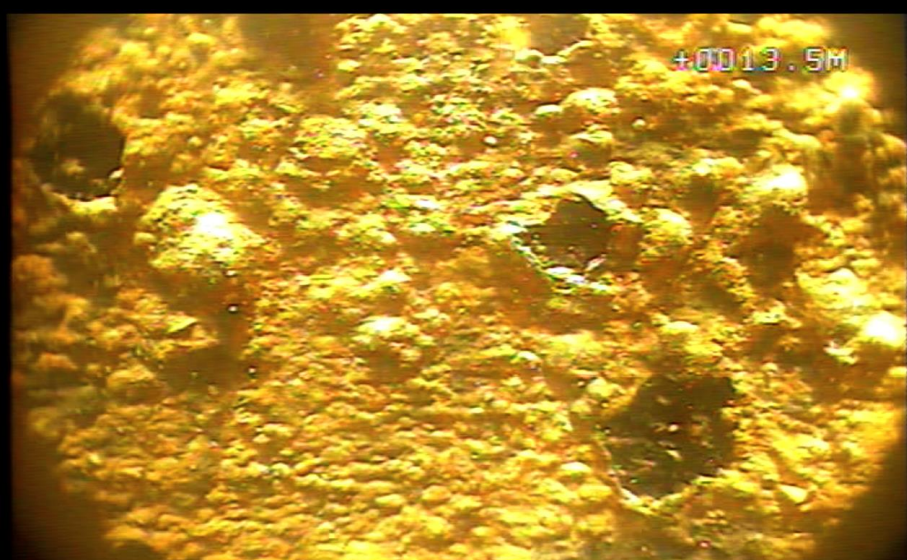
<p>Casing has considerable crusts formed on the exterior surface. Darker areas could be where the crusts have been knocked by retrieval of the production pump.</p>

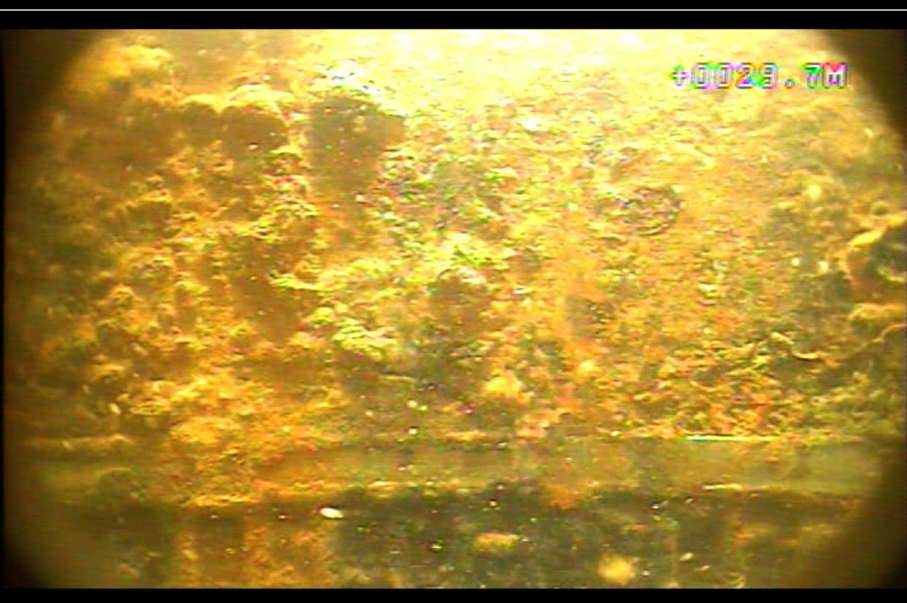
<p>Severe precipitates / crusts forming – high risk area for corrosion (bimetallic) due to welding mild steel casing to stainless steel.</p>

At this depth, it would seem far more reasonable (and economically comparable) to construct a replacement bore, using inert casing materials e.g. Class 12 PVC (or the more expensive stainless steel), and continuous slot stainless steel screens. The bore construction should be consistent with NUDLC (2020) guidelines and include formation sampling to accurate size bore screen apertures. Another benefit of the replacement bore drilling is that appropriate annular environmental seals can be incorporated into construction to provide greater wellhead protection and water quality security. Hence, this is GHD's preferred approach to managing the bore.

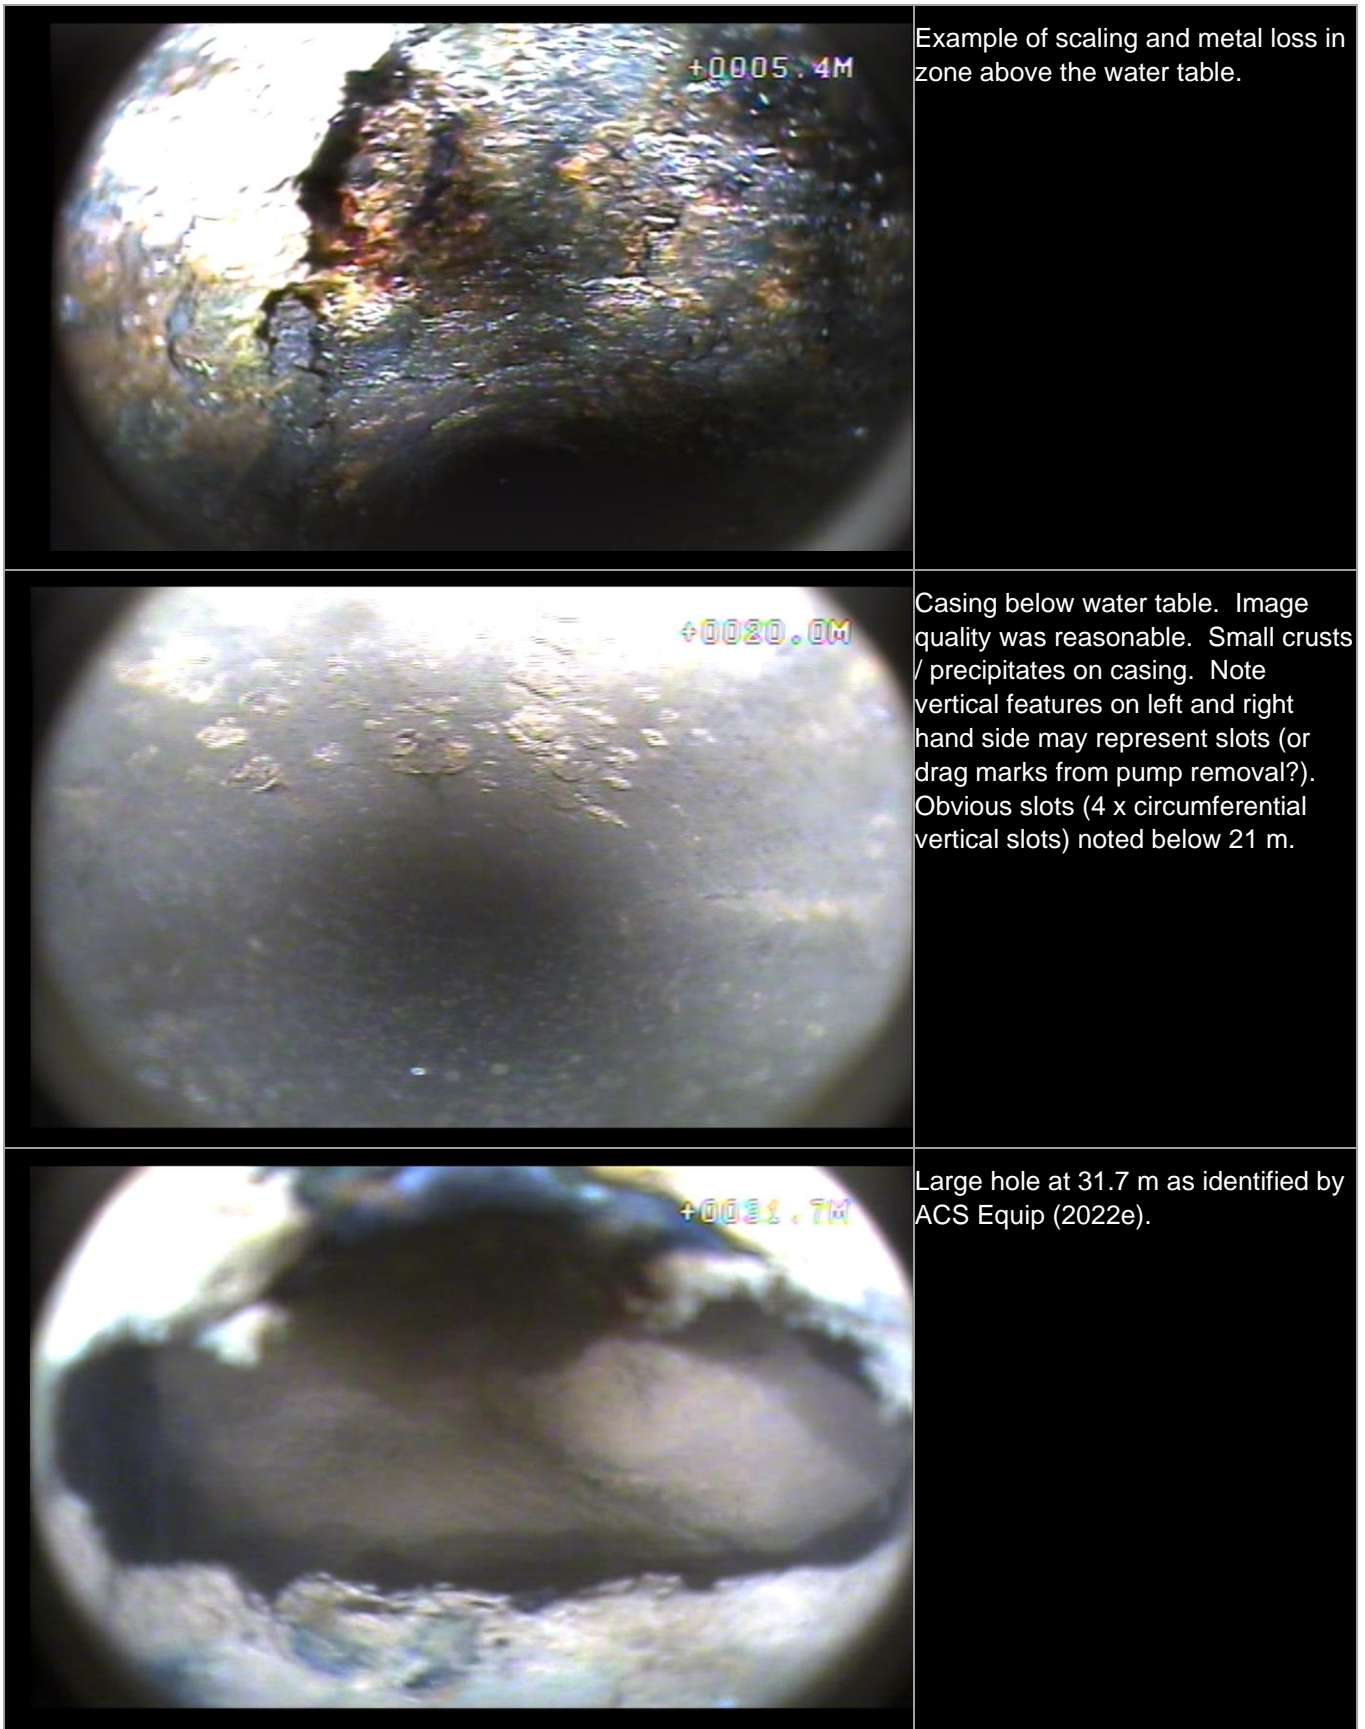
Figure 5 Selected imagery – Kenebri production bore

At over 70 years in age this bore is beyond its service life and expected to be in a poor condition. Water levels are deep (17.5 m) and therefore large proportion of the overall casing is exposed to atmosphere, excluding the splash zone (between the water table and dynamic drawdown level). Selected imagery has been shown in Figure 5.

- Significant, obvious scaling and metal loss in the zone above the water table.
- Image quality below the water table and splash zone was reasonable and the casing interior surface exhibited less rugosity / roughness.
- Slotted sections were difficult to differentiate as in some areas the slots were heavily encrusted.
- Heavily scaled at 23 m, however, no sediment or increased turbidity was noted.
- Duct tape and other debris identified at 34 m.

GHD agrees with the assessment made by ASC Equip (2022d) that the bore is in poor condition and represents a significant risk to Council because:

- Increasing likelihood of additional failure and catastrophic collapse
- Increasing likelihood of the pumping of sedimentary material, resulting in damage to production pumps, and sediment within the tanks and water supply system
- The headworks are insecure from a sanitary perspective

This bore should be decommissioned in accordance with the NUDLC (2022) guidelines and a replacement bore drilled, consistent to the same standard. The replacement bore design should include:

- Inert casing materials, e.g. Class 12 PVC is sufficient for this bore depth
- Continuous slot, wire would stainless steel screen.
Such screens have a greater open area and with considered bore design, e.g. appropriate sizing of apertures and gravel packing, should result in a more efficient bore, i.e. less drawdown for the same flow. This would necessitate formation sampling and sieve analysis during the drilling program to size screens.
- Bore headworks erected with a concrete slab to support valving, metering and associated equipment e.g. sampling ports, electrical panels.
- Wireline logging, e.g. natural gamma may assist in identifying a screen zone for the bore.
- Pumping test to enable sizing of an appropriate production pump (and determine a specific capacity baseline).
