Warrumbungle Shire Council

Pedestrian Access and Mobility Plan

June 2015

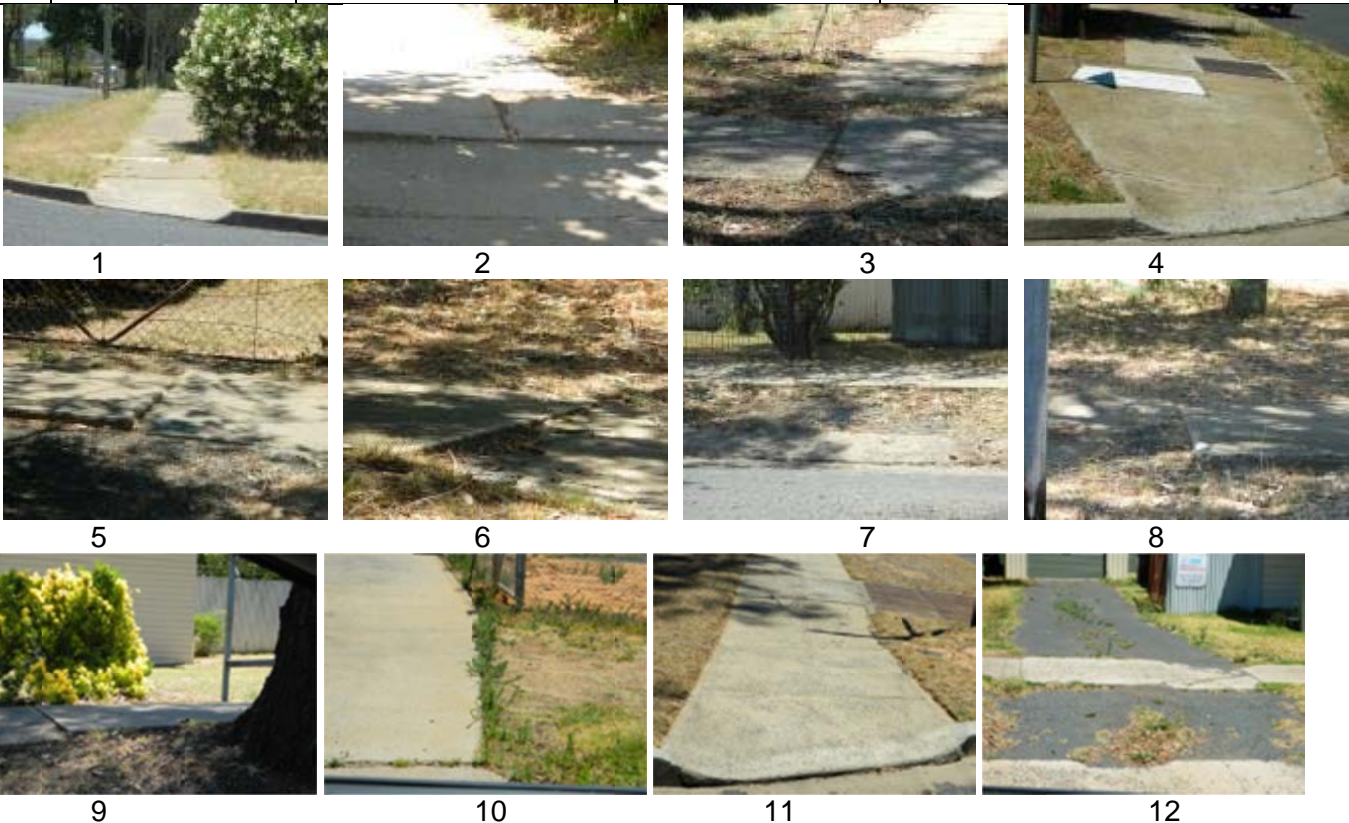
ID	Location	Street/feature	Location/feature	Issue
1	Dalgarno Street	Horsley Street	North west ramp	25mm edge, steep, rough and bush covers path
2	Dalgarno Street	West of Horsley Street	North side	Broken path at driveway, limited mobility access.
3	Dalgarno Street	West of Horsley Street	North side	Broken path at driveway, limited mobility access.
4	Dalgarno Street	Cowper Street	North east mobility ramp	25mm edge gutter to ramp, steep to angled pathway.
5	Dalgarno Street	West of Cowper St	North side	25mm edge vertical misalignment each side at driveway
6	Dalgarno Street	West of Cowper Street	North side	Vertical misalignment and broken path
7	Dalgarno Street	East of Charles Street	North side	Steep drop off at driveway
8	Dalgarno Street	East of Charles St	North side	Broken path and vertical misalignment
9	Dalgarno Street	East of Charles St	North side	Broken path and vertical misalignment
10	Charles Street	West side	Short path	Steep drop off, 25mm edge

11	Dalgarno Street	SW of Cowper St	South side	Good mobility ramp but has 25mm edge
12	Dalgarno Street	East of Charles	South side	Broken path and uneven vertical alignment
