WARRUMBUNGLE SHIRE COUNCIL BUGALDIE BORE ASSESSMENT REPORT 06/12/2022

Warrumbungle Shire Council – Bugaldie Bore

Assessment Report 06/12/2022

Report No: WARRSC06122022
Date: 06/12/2022
Revision: 01
Author: Luke Woods
Project Manager: Luke Woods
File Name: Warrumbungle Shire Council – Bugaldie Bore Assessment Report 06/12/2022

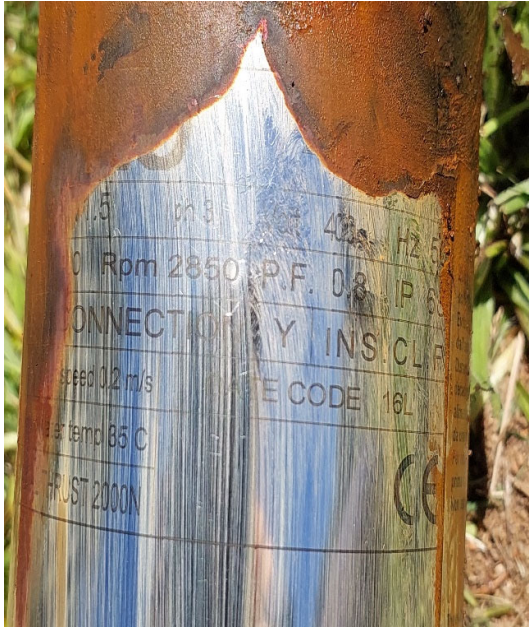
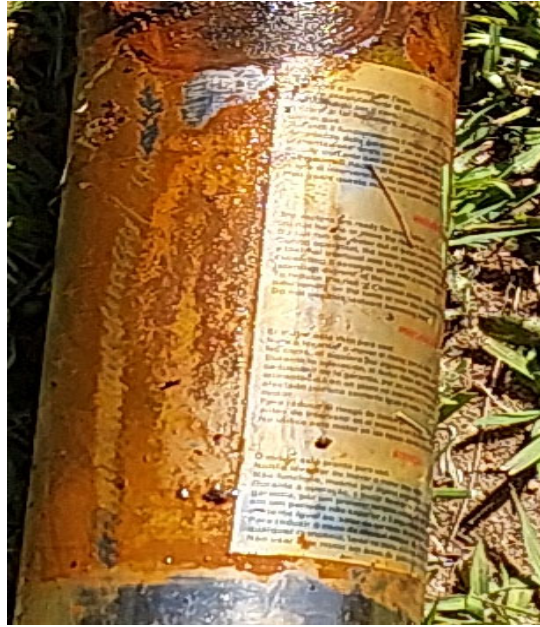
- Submersible pump and poly rising main were noted to have moderate growth levels present.
- Substantial pitting and corrosion noted through mild steel casing wall above standing water table, this indicates that the apparent metal loss has been severe and the casing wall will be extremely thin.

Condition of pumping equipment showing Iron Bacteria.
