# WARRUMBUNGLE SHIRE COUNCIL COONABARABRAN BORE 2 ASSESSMENT REPORT 05/12/2022

Warrumbungle Shire Council – Coonabarabran

Bore 2 Assessment Report 05/12/2022

Report No: WARRSC05122022  
Date: 05/12/2022  
Revision: 01  
Author: Luke Woods  
Project Manager: Luke Woods  
File Name: Warrumbungle Shire Council – Coonabarabran Bore 2 Assessment Report  
05/12/2022

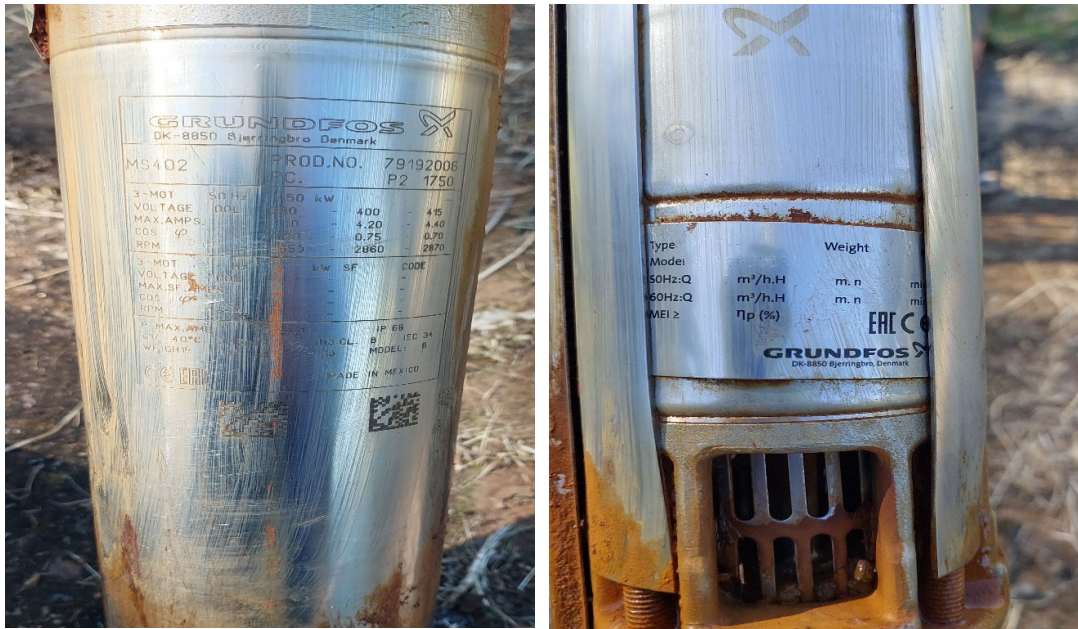
- Upon extraction of the submersible pump and poly pipe rising main was noted to be in reasonable condition.
- Submersible pump was noted to have moderate growth levels present on the pump body.

Condition of pumping equipment showing Iron Bacteria.
