Baradine WTP

Filter Inspection

NSW Health / Warrumbungle Shire Council

JUNE 2020

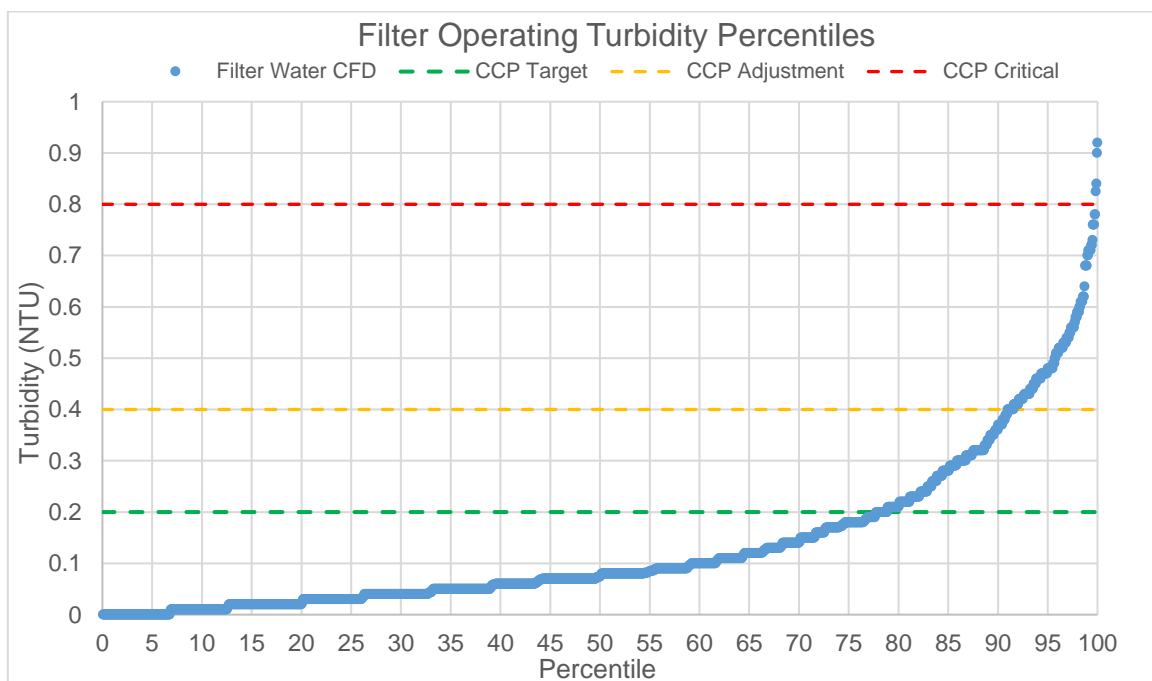
Figure 2-7: Filtered Water Turbidity Profiles (January 2015 – November 2019)

If sampling collection times and methods are confirmed to be suitable and not the cause of the variability in the turbidity results, then it may be possible that the filtration performance was affected following the winter of 2016, due to significant media loss and subsequent reduction in media with an oxide coating within the filter. If this was the cause, then the filtered water manganese concentration could have increased. Increased filtered water-soluble manganese can result in increased turbidity upon chlorination and oxidation of the soluble manganese. However, given the variability in sample results, further investigation is required to confirm why there are some good results in winter while the majority are much worse. Based on the data provided, the root cause of the filtered water spikes is unclear.

The filtered water turbidity data has also been manipulated into a percentile graph (demonstrated by Figure 2-6). This was achieved by dividing the sequential number of turbidity recordings by the total number of data points. For example, in a data set of 1000 data points, when sorted from smallest to largest the 900th data point would become the 90th percentile (900/1000 x 100).

It can be seen from Figure 2-6 that approximately 10% of filtered water turbidity results exceeded the CCP of 0.4 NTU (including turbidity readings pre-June 2018), while ~77% of results remained below 0.2 NTU within the safe range specified by ADWG.

It is recommended that online filtered water turbidity monitoring is installed to confirm the performance of the filter and overall plant performance continuously via SCADA tending (with alarming). Implementation of online filtered water turbidity monitoring should be considered as an effective, long term solution of online water quality review and exercise.

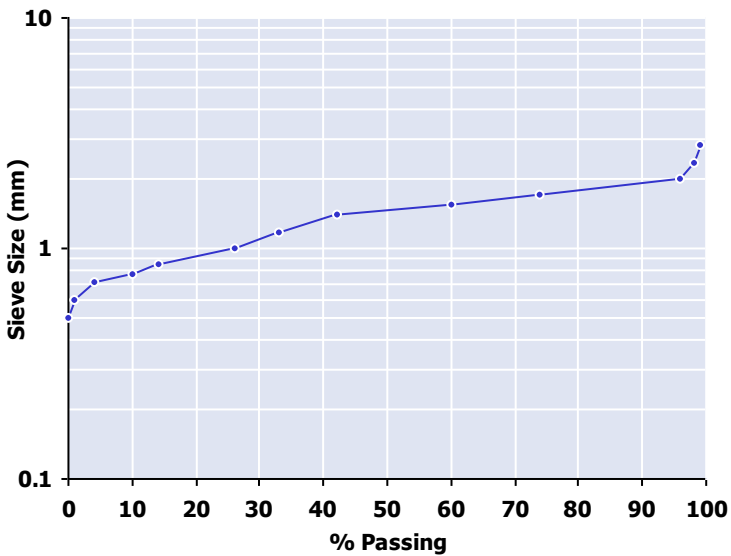
16 December 2019
Report No. 6390
Page 1 of 1
Tested by S.Arnold
Received 06-Dec-19
Analysed 12-Dec-19
Sieve Std AS 1141.11.1
Sampling Std AS RECEIVED

Aperture (mm)	US Std E11 Mesh	Percent Retained	Percent Passing	Indicative grading
2.800	7	0	100	
2.360	8	1	99	
2.000	10	2	96	
1.700	12	22	74	
1.400	14	32	42	
1.180	16	9	34	
1.000	18	7	26	
0.850	20	11	15	
0.710	25	10	5	
0.600	30	3	1	
0.500	35	1	0	
PAN		0	0

D10/ES (mm)	0.78	Above mm (%)	N/A
D60 (mm)	1.56	Below mm (%)	N/A
UC	2.00

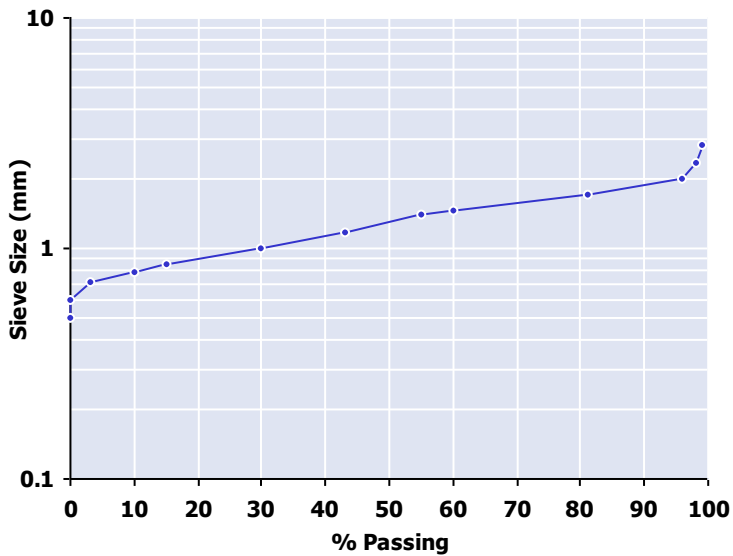
16 December 2019
Report No. 6391
Page 1 of 1
Tested by S.Arnold
Received 06-Dec-19
Analysed 12-Dec-19
Sieve Std AS 1141.11.1
Sampling Std AS RECEIVED

Aperture (mm)	US Std E11 Mesh	Percent Retained	Percent Passing	Indicative grading
2.800	7	1	99	
2.360	8	1	99	
2.000	10	2	96	
1.700	12	14	82	
1.400	14	27	55	
1.180	16	12	43	
1.000	18	12	31	
0.850	20	16	15	
0.710	25	12	3	
0.600	30	3	1	
0.500	35	0	0	
PAN		0	0

D10/ES (mm)	0.79	Above mm (%)	N/A
D60 (mm)	1.45	Below mm (%)	N/A
UC	1.85

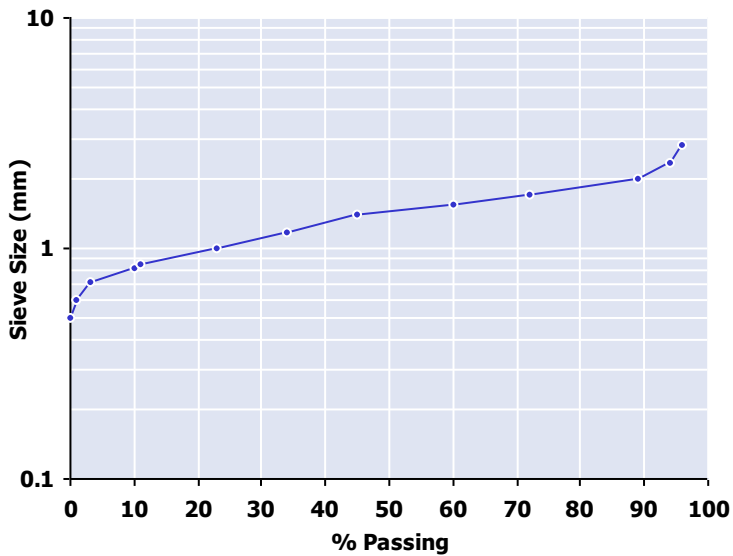
16 December 2019
Report No. 6392
Page 1 of 1
Tested by S.Arnold
Received 06-Dec-19
Analysed 12-Dec-19
Sieve Std AS 1141.11.1
Sampling Std AS RECEIVED

Aperture (mm)	US Std E11 Mesh	Percent Retained	Percent Passing	Indicative grading
2.800	7	3	97	
2.360	8	3	94	
2.000	10	5	89	
1.700	12	17	73	
1.400	14	27	46	
1.180	16	12	34	
1.000	18	11	23	
0.850	20	12	11	
0.710	25	8	3	
0.600	30	2	1	
0.500	35	1	0	
PAN		0	0

D10/ES (mm)	0.83	Above mm (%)	N/A
D60 (mm)	1.55	Below mm (%)	N/A
UC	1.88
