TIMOR DAM RAISING CONCEPT DESIGN REPORT

Report Number ISR18049

November 2018

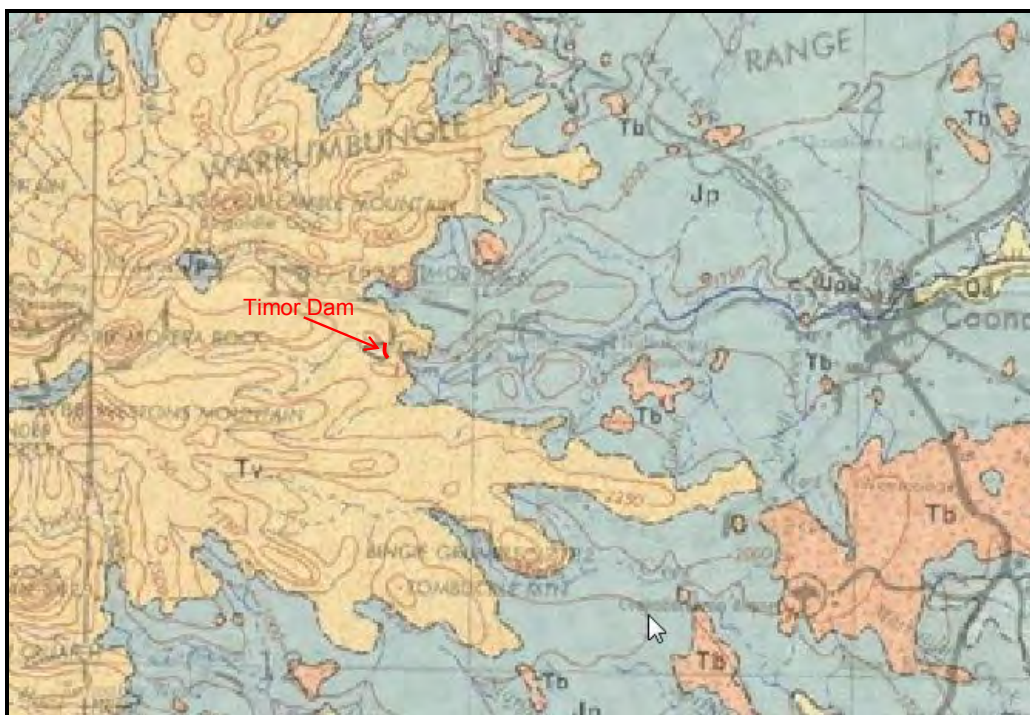
Figure 4.1: Timor Dam Regional Geology

Figure 1 presents the Coonabarabran regional geology from the Gilgandra 1:250,000 geological sheet, compiled by Offenberg (1968). The regional geology of the Timor Dam area has been described by Dent (1982), with extracts of this work presented in SMEC (2016). The Warrumbungles are a volcanic and intrusive shield comprising trachyte and basalt of Tertiary age (**Tv**). These igneous rocks intrude and overlie the **Pilliga Sandstone** that comprises sandstone, conglomerate and shale of Jurassic age (**Jp**).

Other smaller deposits of basalt of Tertiary age (**Tb**) cap the higher areas, especially to the south of Coonabarabran.

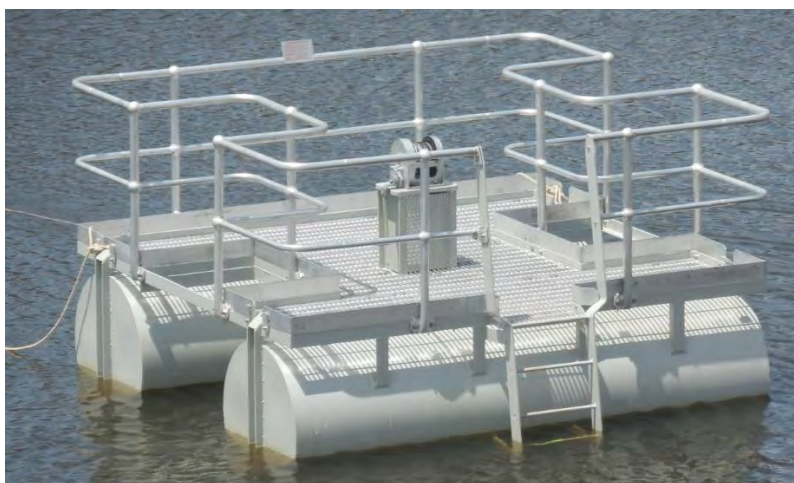
Photo 8-1: Typical trunnion floating buoy

The preferred upgrade option involves decommissioning of the existing arrangement, replacement with an extended trunnion, replacement of the trunnion stay with a larger stay and installation of a floating buoy (capable of raising the trunnion inlet out of the water).

Options for upgrading the trunnion inlet were presented in the recent condition assessment (NSW Public Works, 2016) and the Feasibility Study Report (PWA, 2018).

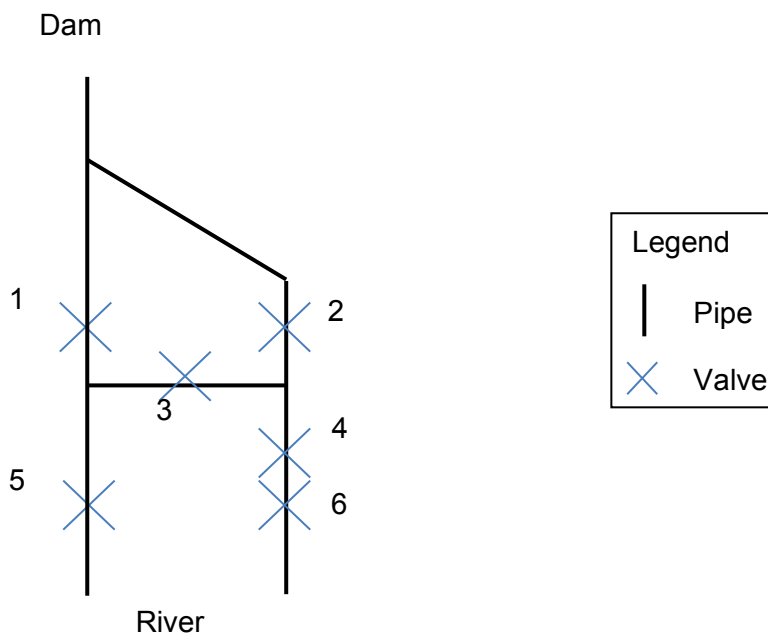
Figure 8-1: Outlet System Schematic

The preferred option includes the normal scour outlet with a separate environmental flow outlet.

A proposed schematic of the system and a table of all the valves are shown below.

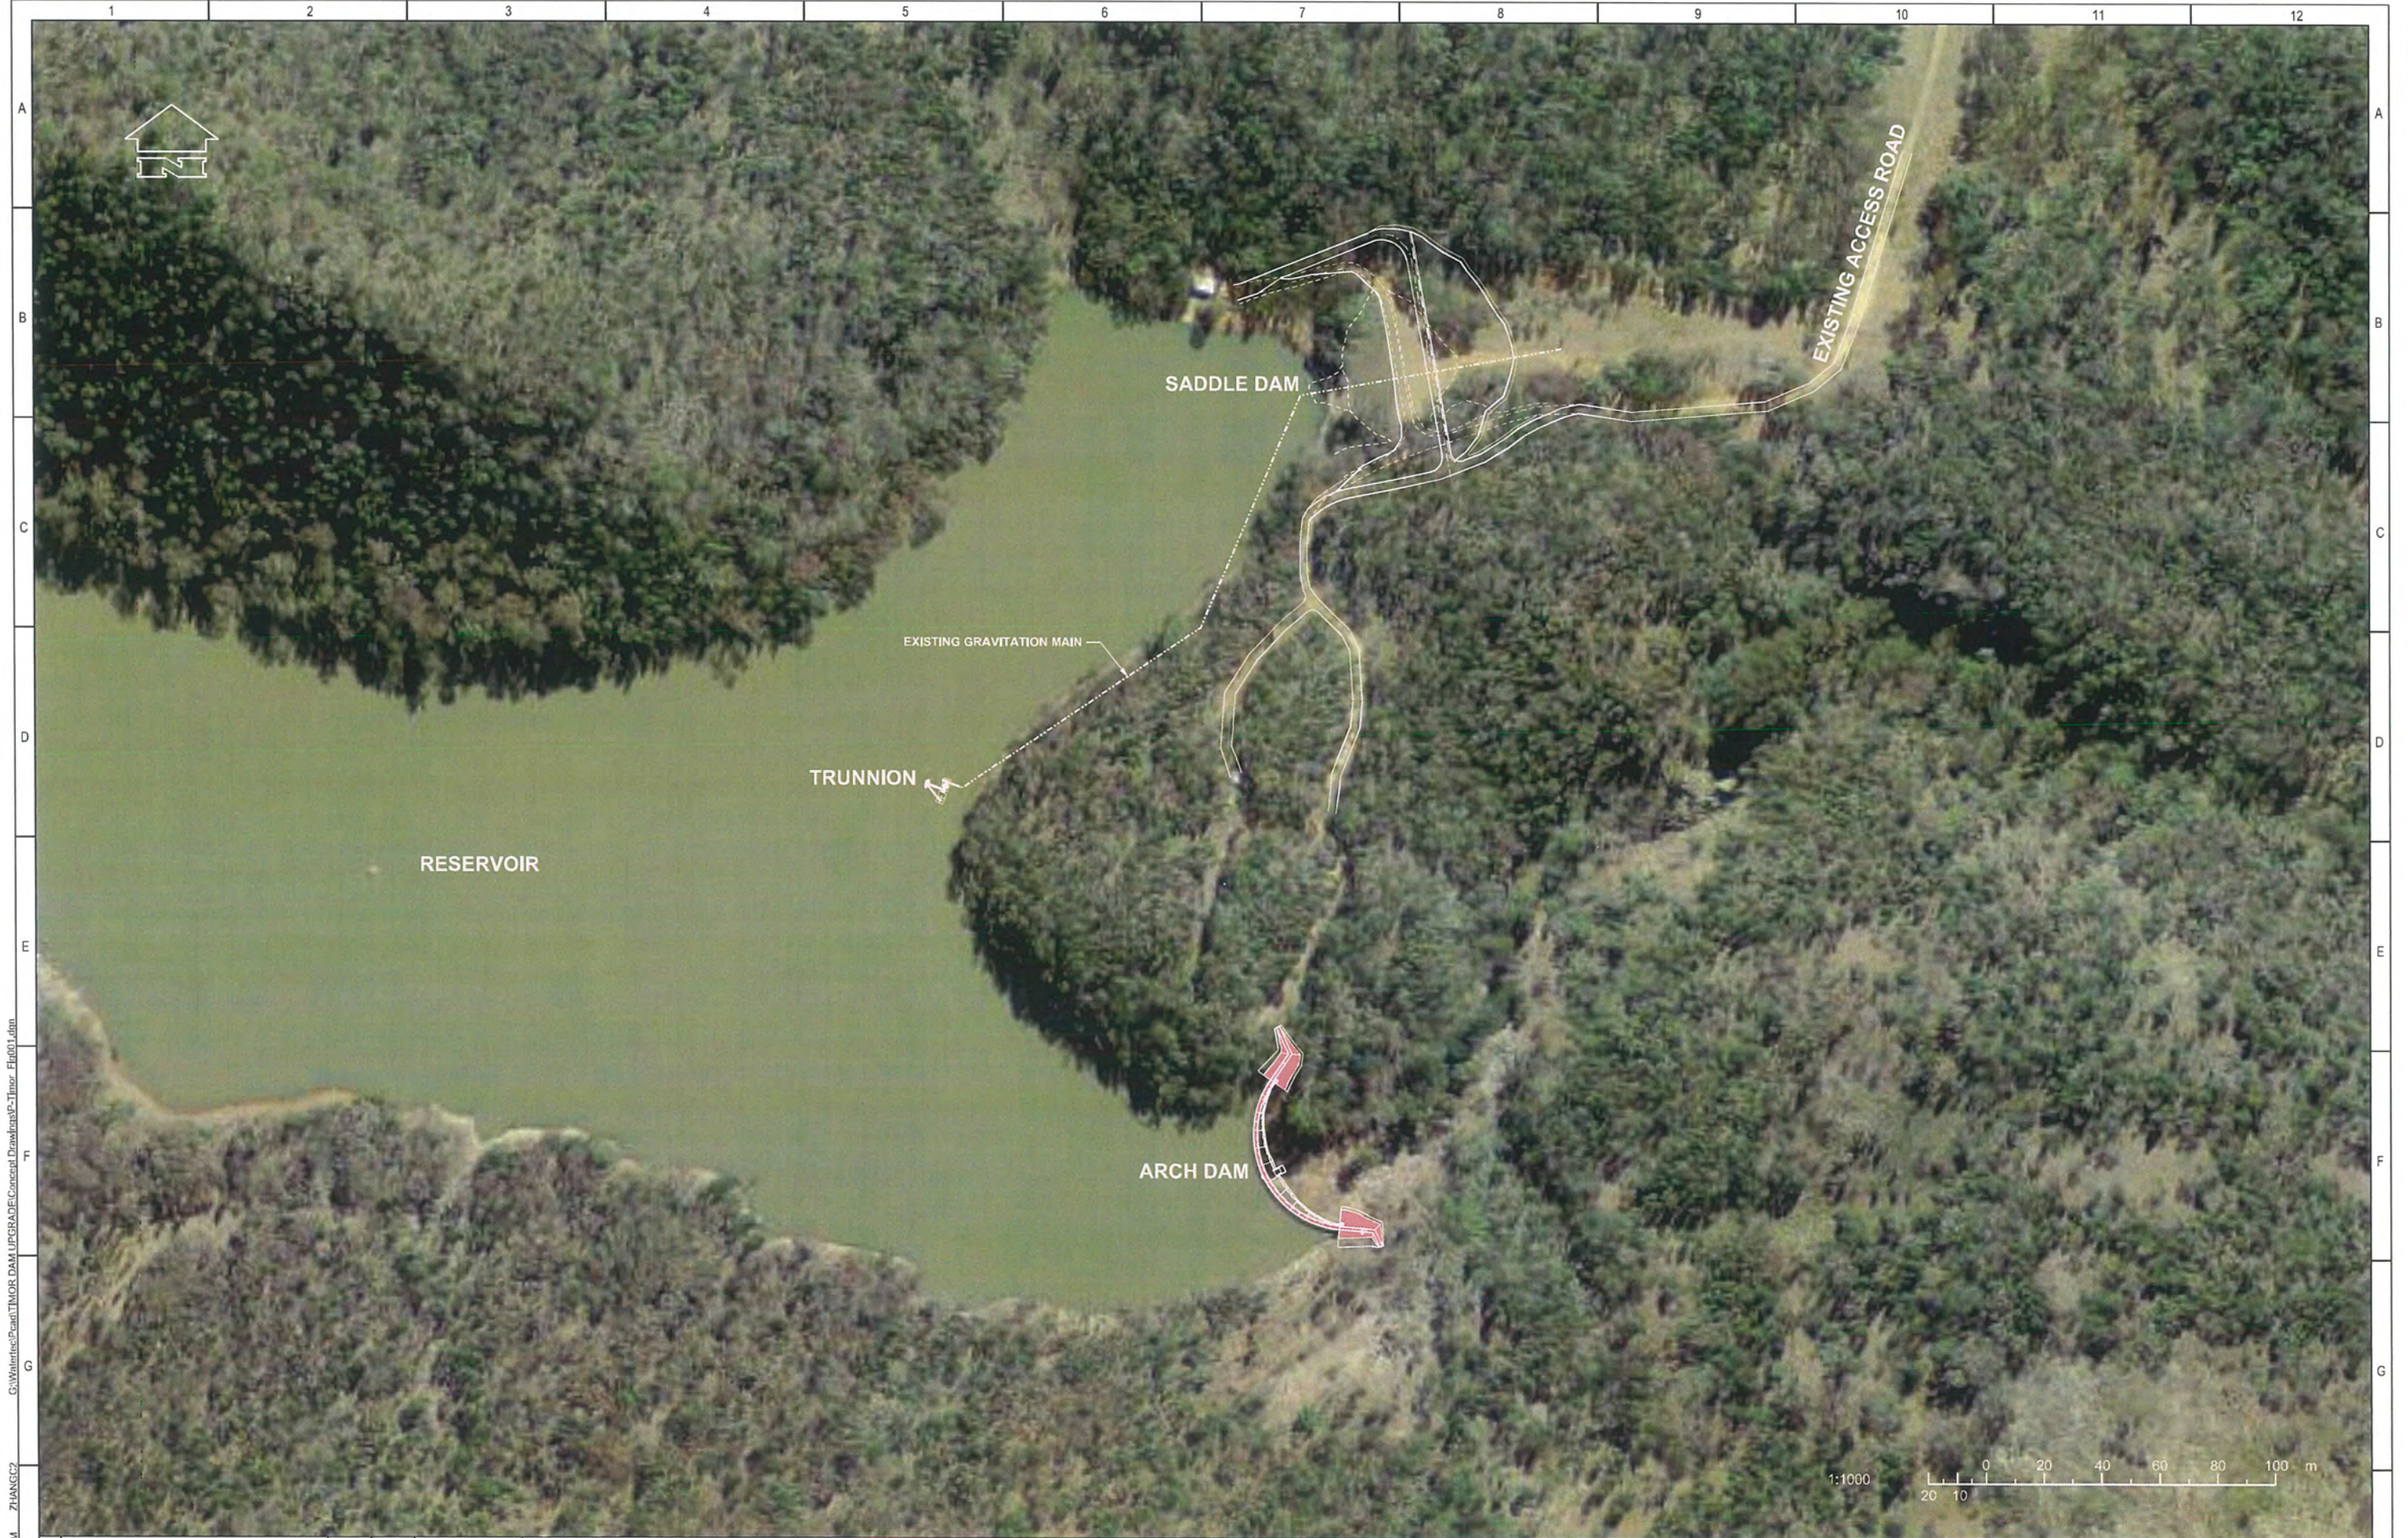
PROJECT/CONTRACT No.	-
SCALE @ A1	1:1000
DRAWING No.	FIG-001
REV	0

SITE PLAN

Current access roads around the dam will be paved and well drained to accommodate Council trucks and other traffic in the long term. Widening of current roads is not envisaged. Parking areas are to be provided adjacent to the main concrete wall (left abutment) and the saddle dam. Following completion of the raising works, vehicles will also need to travel across the raised saddle dam crest and to the boat ramp on the left bank of the storage. Refer also **Figures 1 and 5 at Appendix B**.

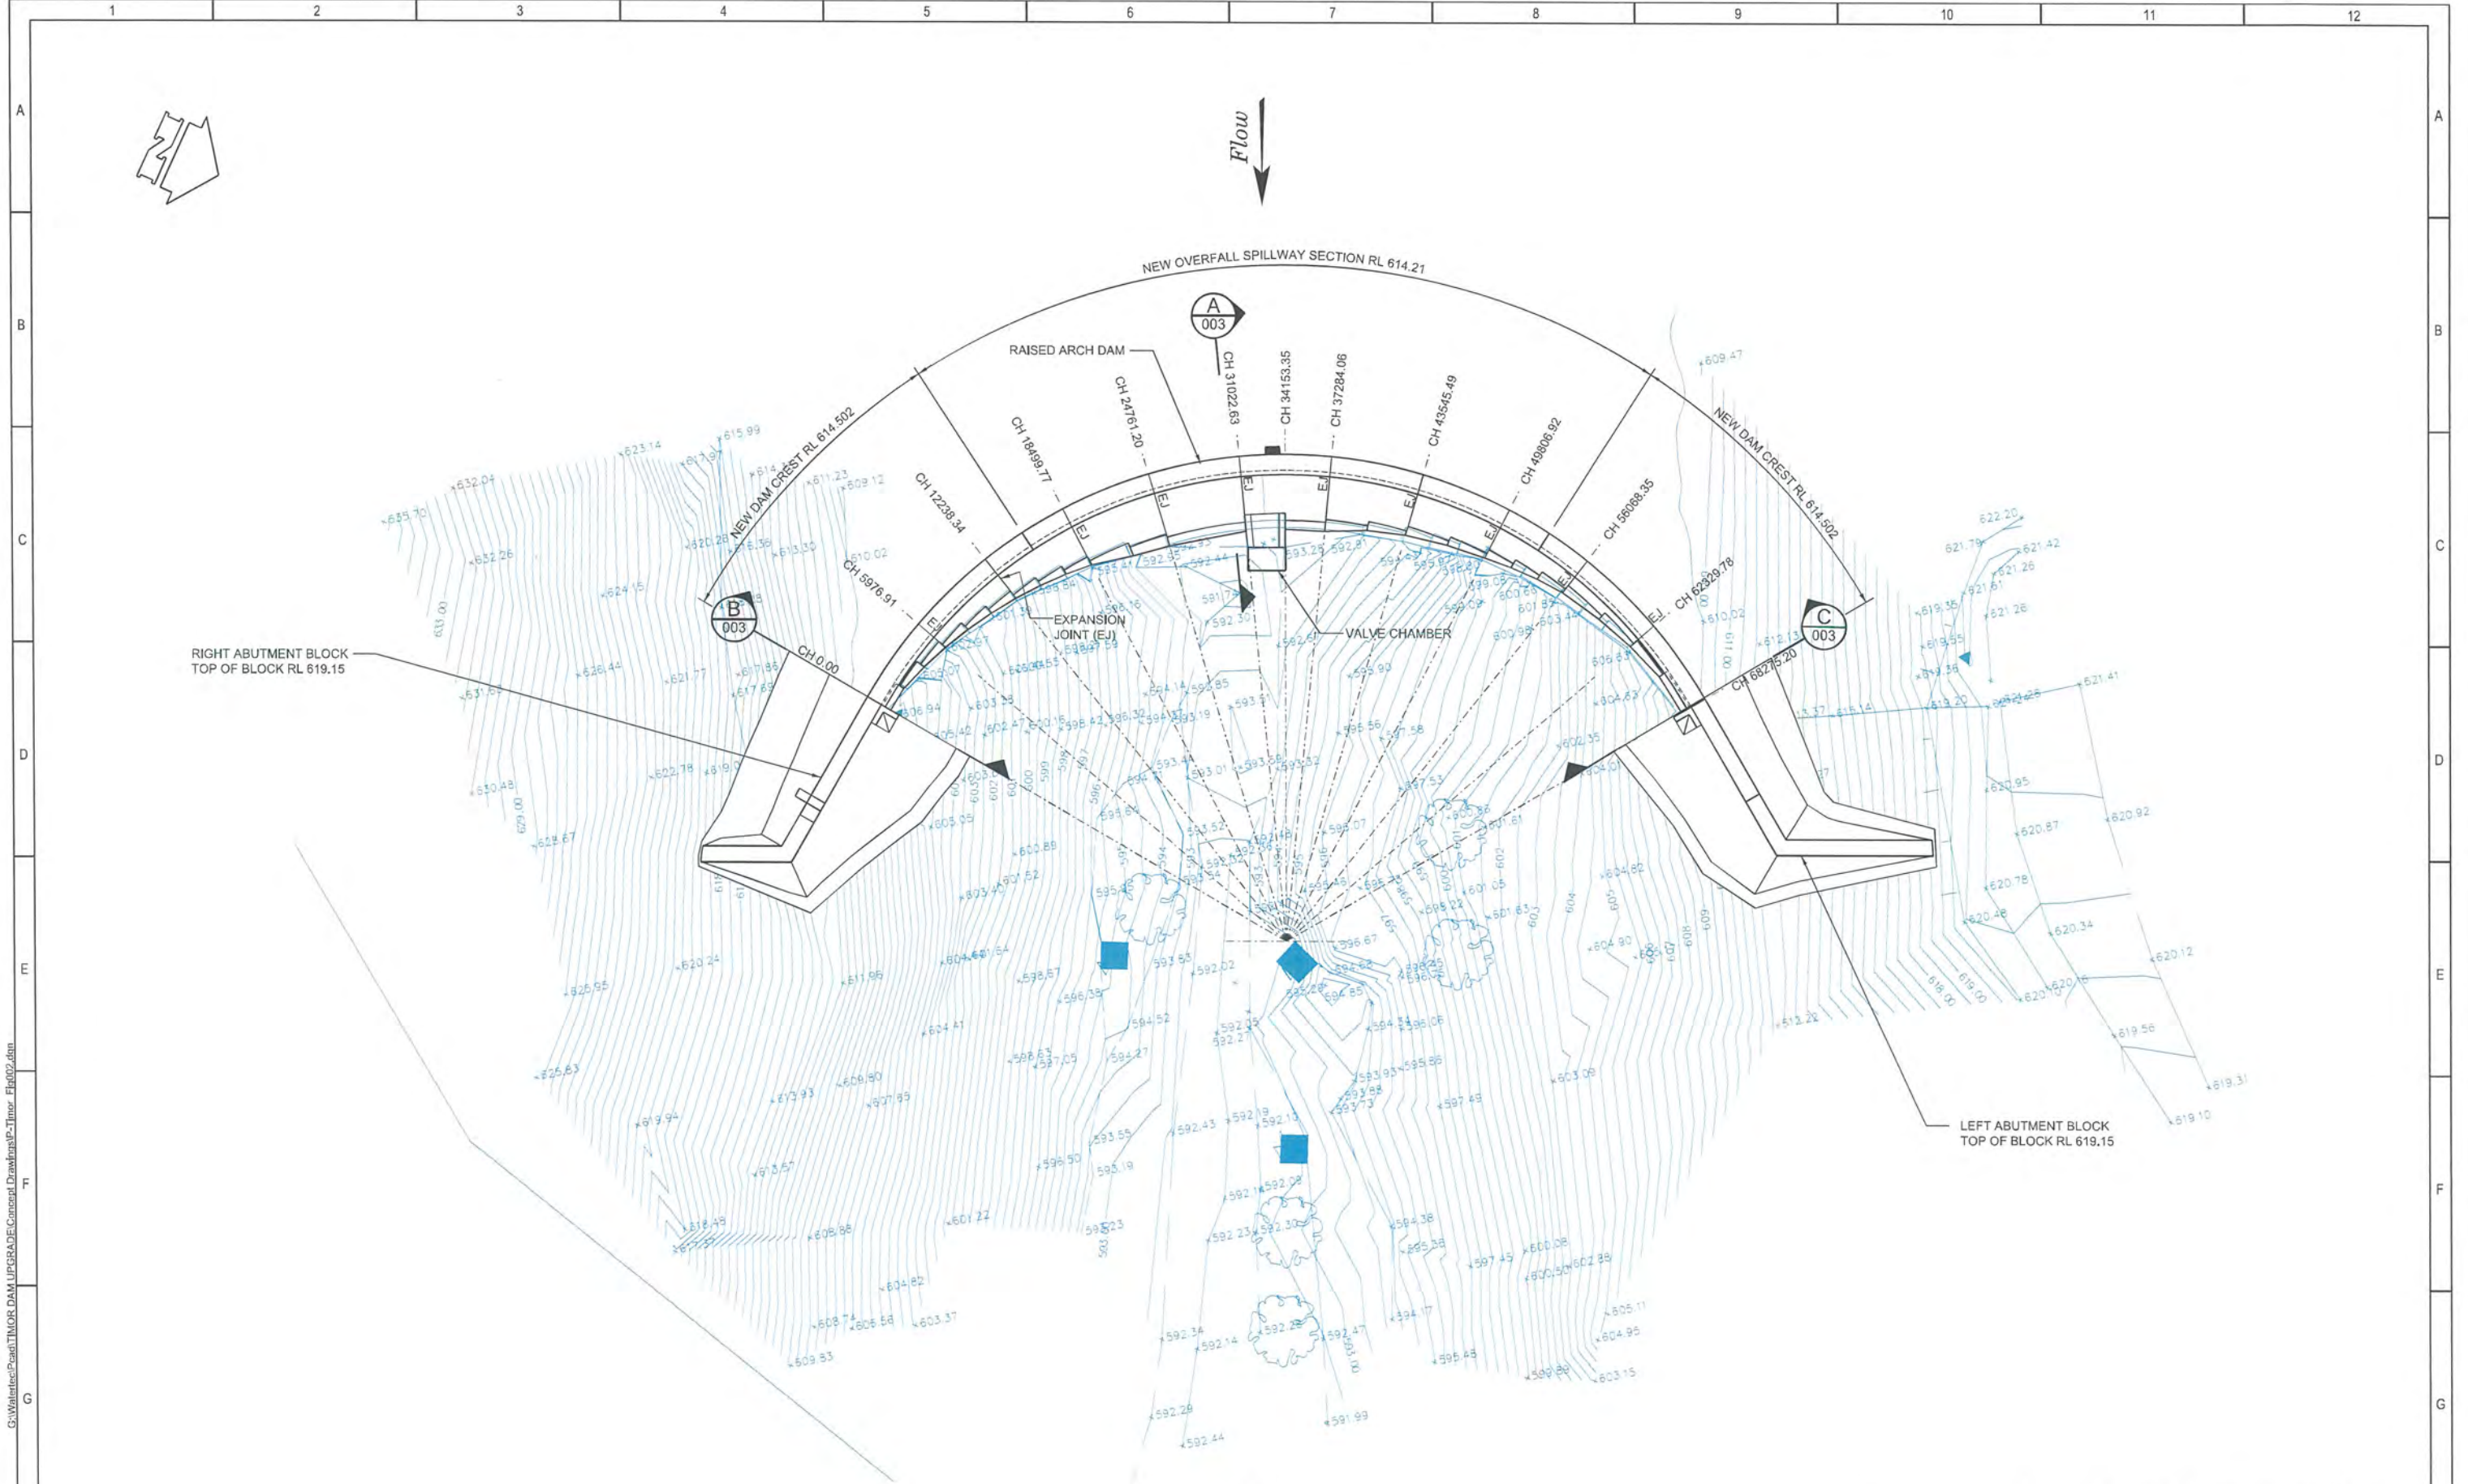
PROJECT/CONTRACT No.	
SCALE @ A1	1:200
DRAWING No.	FIG-002
REV	0

PLAN
SCALE 1:200

COONABARABRAN WATER SUPPLY
TIMOR DAM RAISING
ARCH DAM RAISING
GENERAL ARRANGEMENT
Sheet 1 of 3

The proposed raising involves a new arch above the existing arch which would be structurally independent from the existing structure. Refer **Figures 1 to 4 at Appendix B**. This ensures true arch action of the raised section. Such action (including shrinkage, creep and temperature effects) would be in doubt if the raised section was bonded to the existing dam. This concept has been successfully employed for the raising of a similar type dam in Victoria.

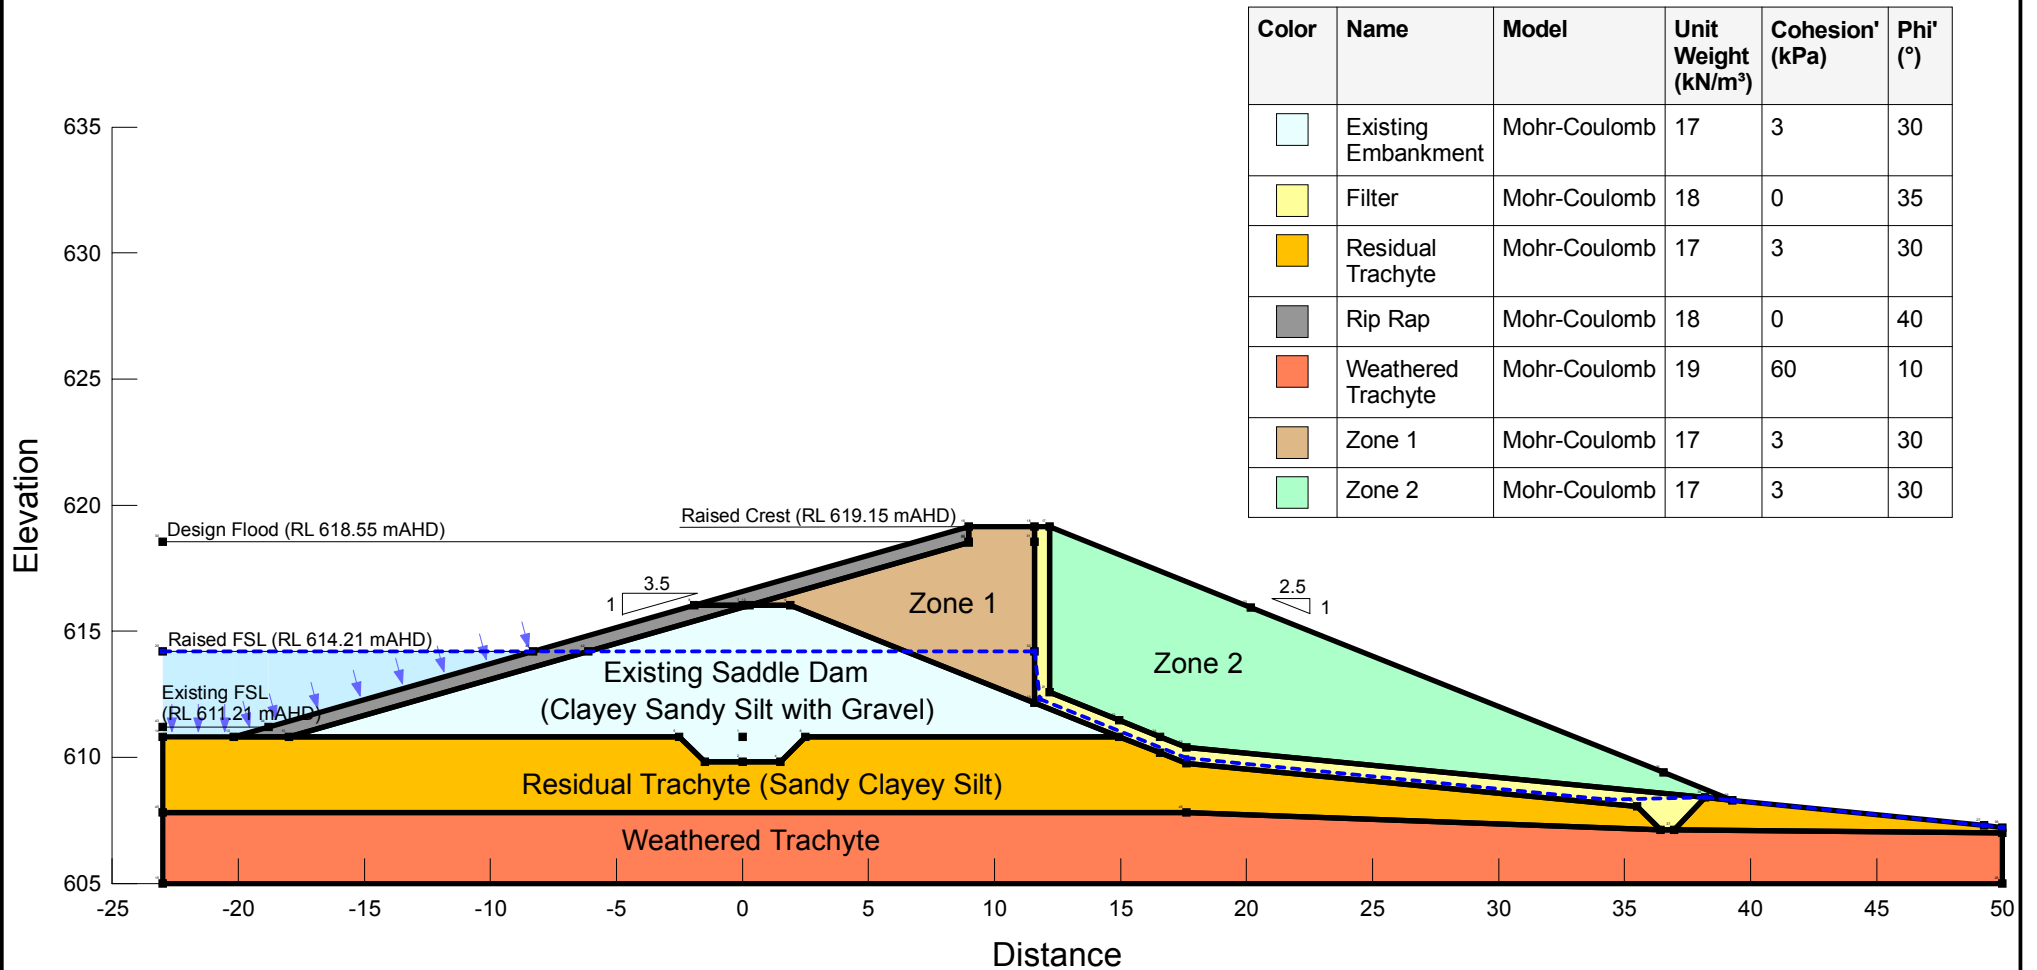
Timor Dam - Raised Saddle Dam Stability

00 Timor Dam - Raised Saddle Dam
 Timor Dam_Saddle Dam_2018 Raising.gsz
 26/07/2018 Scale: 1:300

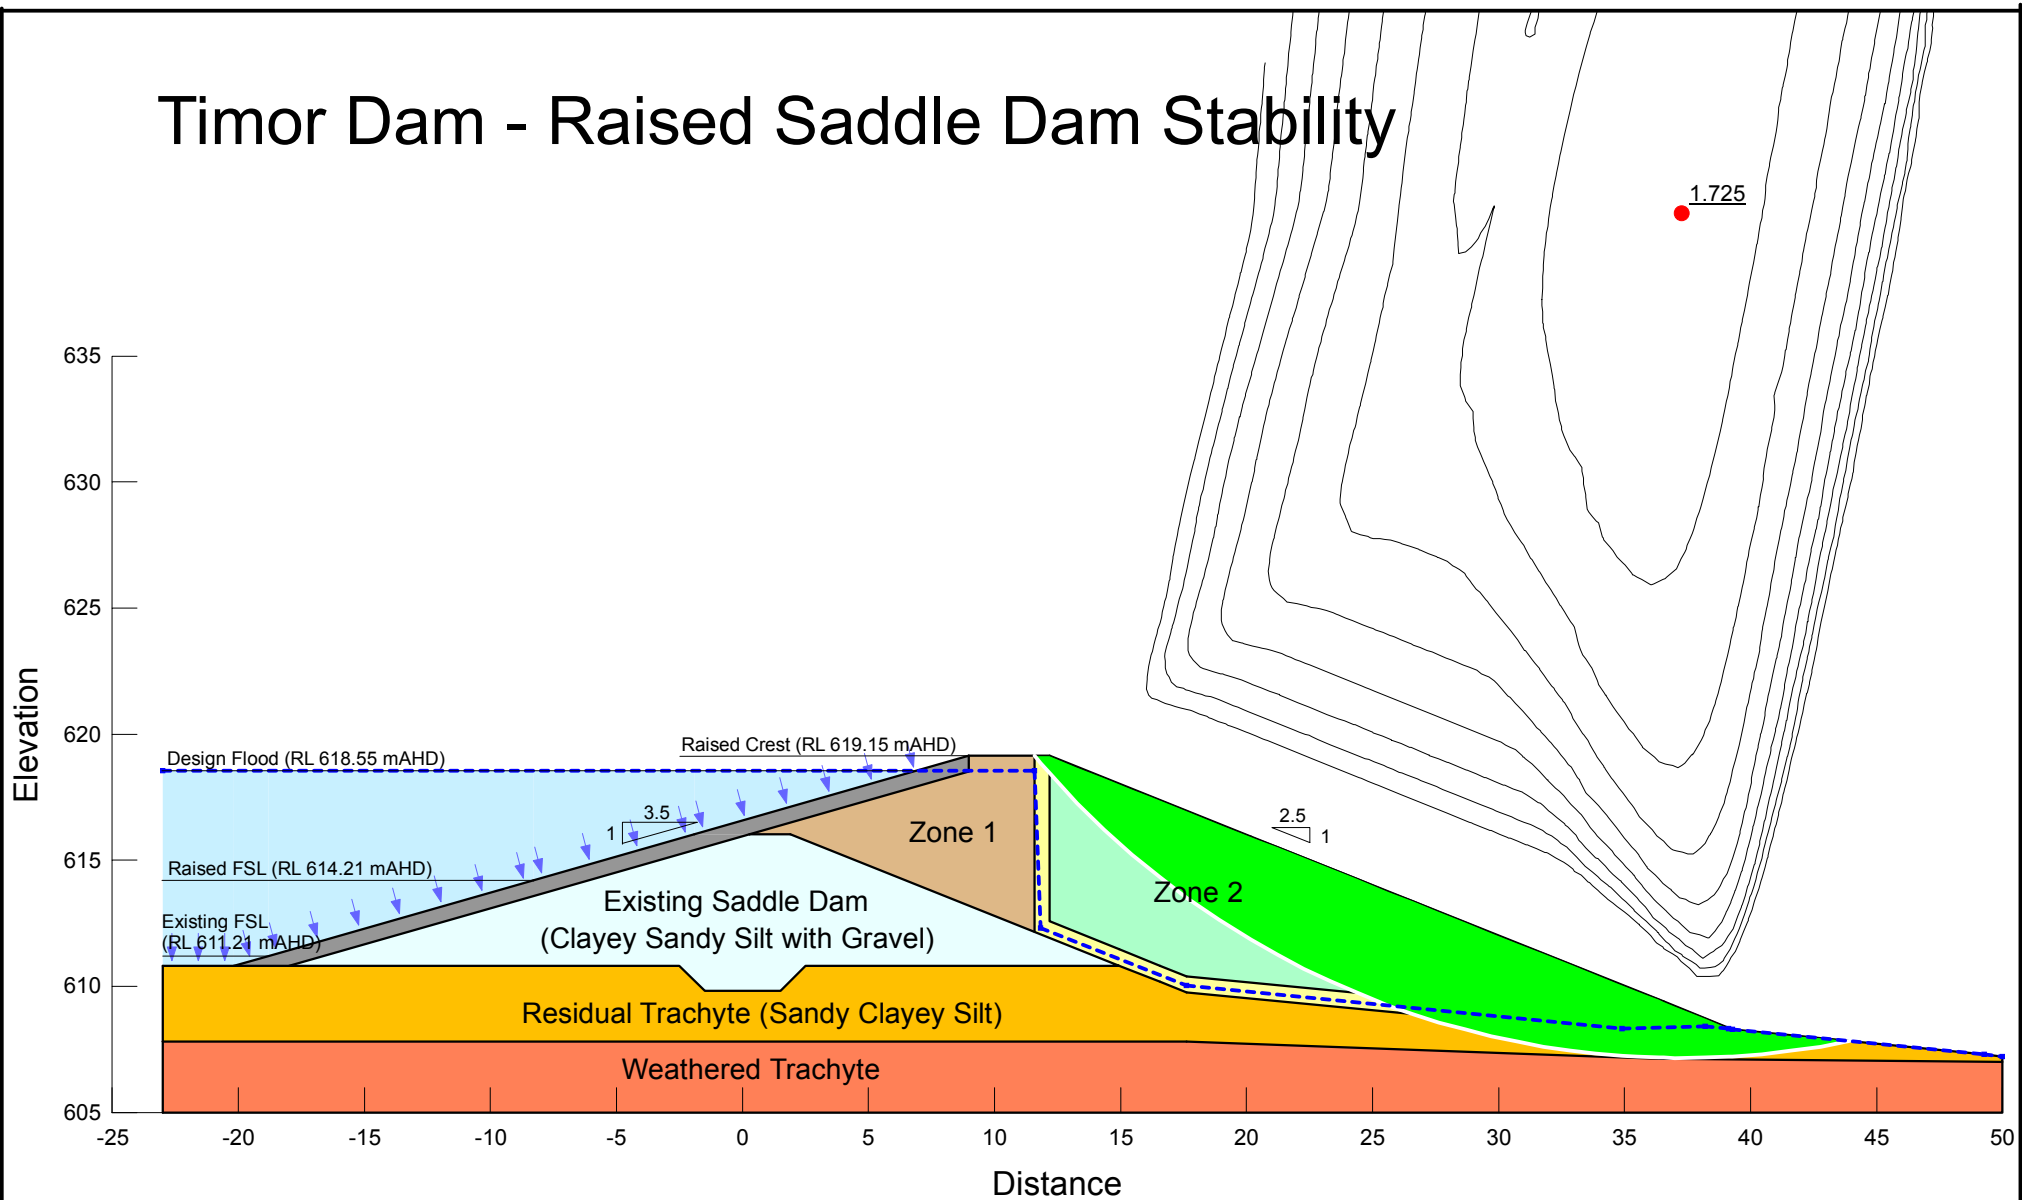
Timor Dam - Raised Saddle Dam Stability

02 Steady State FLOOD (downstream)	
Timor Dam_Saddle Dam_2018 Raising.gsz	
26/07/2018	Scale: 1:300

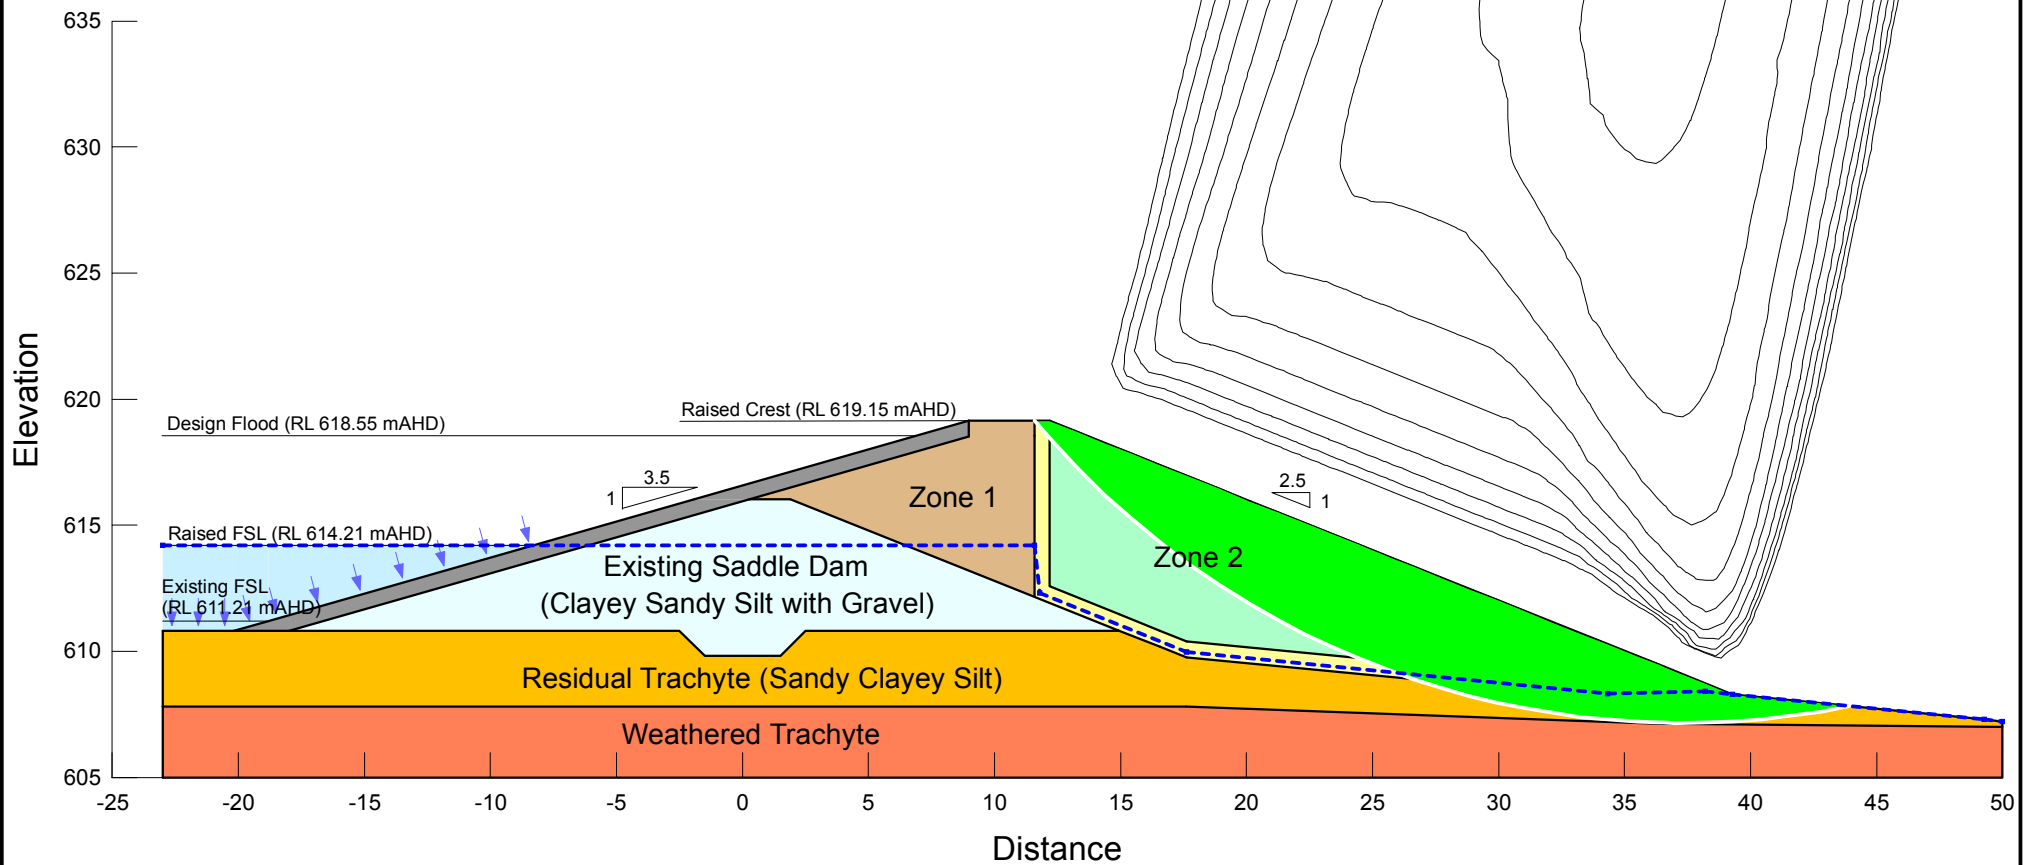
Timor Dam - Raised Saddle Dam Stability

05 Earthquake (downstream)	
Timor Dam_Saddle Dam_2018 Raising.gsz	
26/07/2018	Scale: 1:300

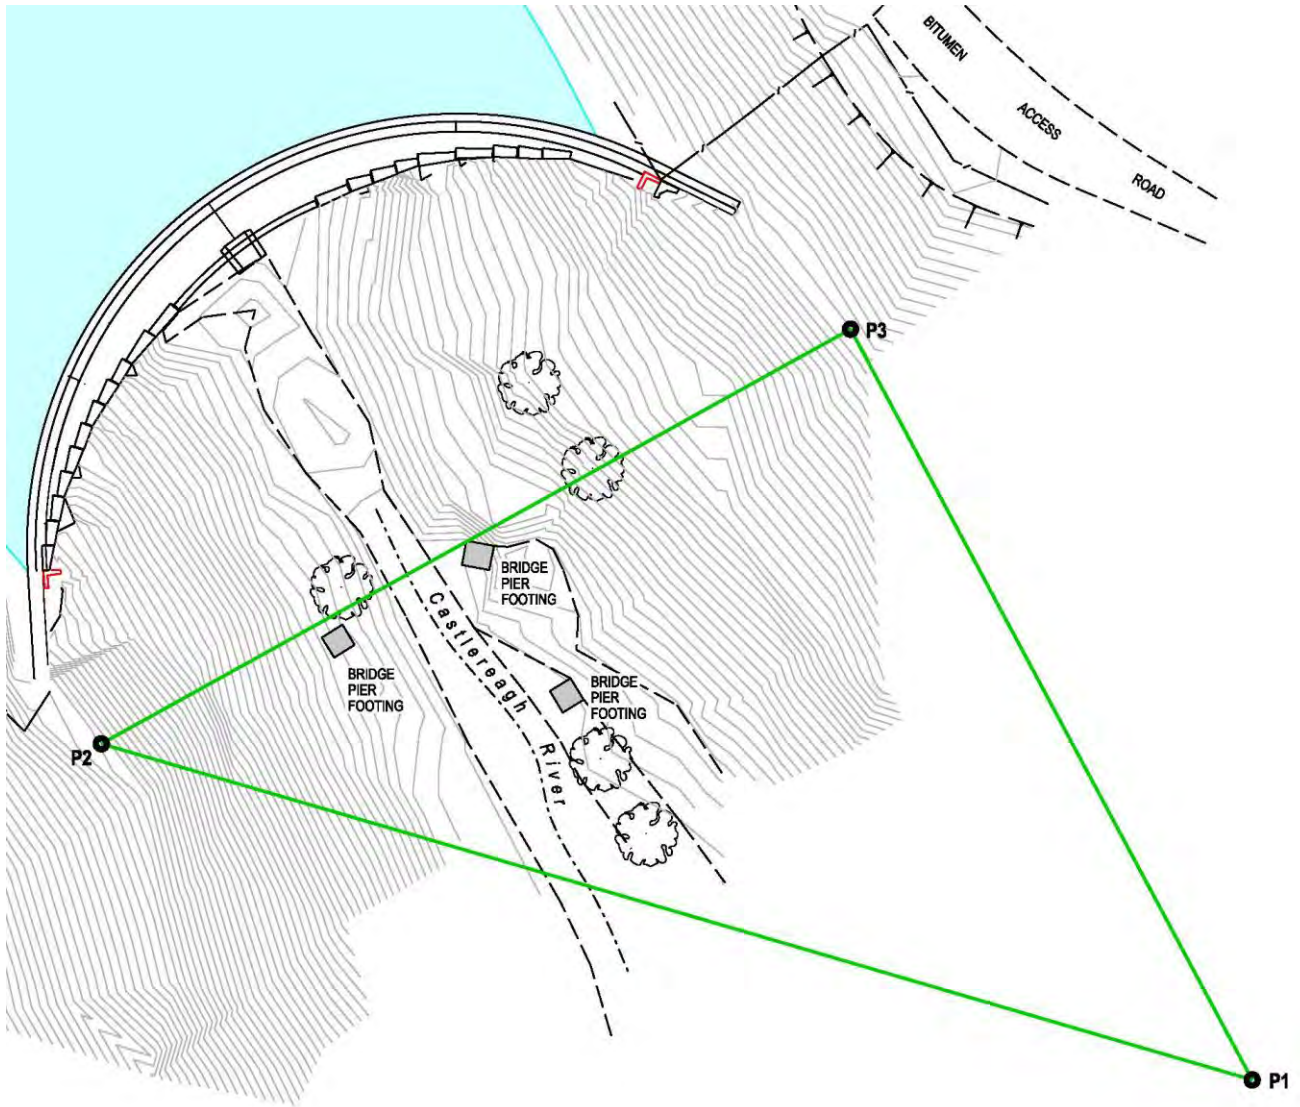
Figure 1 - Primary Control Network – proposed pillar locations

The proposed primary control network is comprised of three concrete pillars located beyond the extent of the concrete dam wall. These pillars will act as stable reference points against which the absolute movement of the wall can be measured. Table 1 and Figure 1 describe and show further details of the proposed pillar locations.

The steep embankments that exist at Timor Dam may prohibit the installation of pillars P2 and P3. If this occurs PWA will investigate other control station options such as stable instrument plates or stainless marks secured into the existing rock surfaces.
