Emergency Asbestos Management Plan 2013

(For Buildings Found to Contain Asbestos)

WARRUMBUNGLE SHIRE COUNCIL

The Emergency Asbestos Management Plan shall be used for the management of asbestos containing materials after the Wambelong January 2013 fires and covers all property damaged by fires within in the Warrumbungle Shire Council Local Government Area.

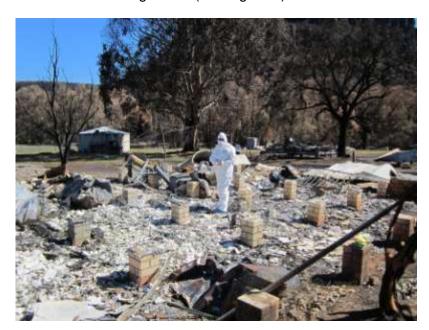
All Asbestos Containing Materials (ACMs) that has been damaged by fire is considered to be Friable under the WHS Regulation (see Figure 2)

Figure 2 - Burned Down Building within the WSC Local Government Area

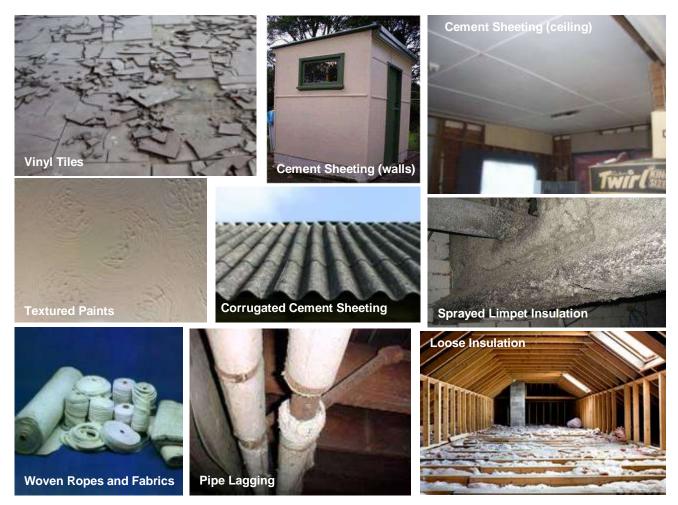
Figure 4 – Typical Asbestos Containing Materials (ACMs) from Bonded Vinyl Tiles to Friable Insulation

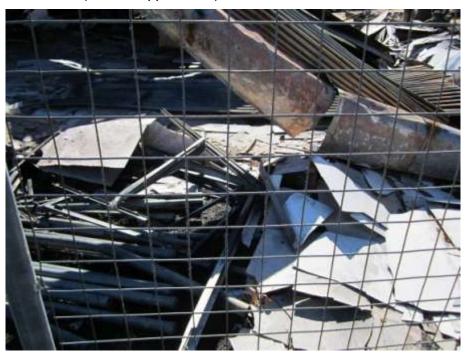
Figure 6 – Example of building collapsed due to structural fire damage. Collapsed ACM that has been reduced to a powder form or that can be crumbled or pulverised or reduced to a powder by hand pressure when dry is defined as friable asbestos.

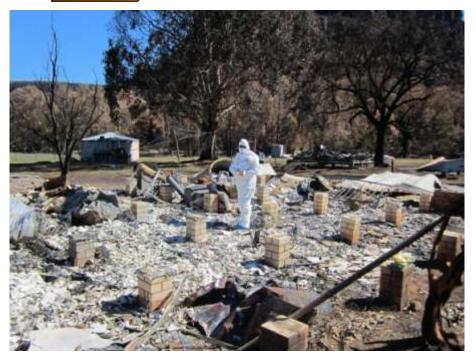
Figure 7 – Example of Fire Damaged Asbestos Cement that is considered friable asbestos.

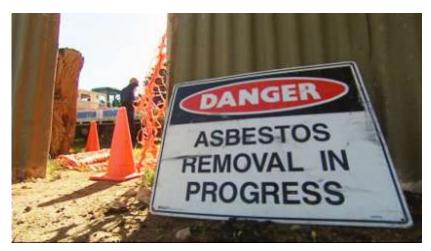
Figure 8 - Specified Asbestos Removal Signage

- 1) Specified Asbestos Warning Signage on front property gate;
- 2) A risk assessment should be undertaken to assess the requirement for fencing, as remote regional locations have low risk of public access. If a site fence is required, it must be established no less than 10m from the building foundation where possible;
- 3) Specified Asbestos Warning Signage and site contact number on front of site fence or front property gate;
- 4) Sealing with Pink dyed PVA dust suppressant glue of presumed asbestos contaminated areas;
- 5) Water retention area for wash down of building and demolition waste and recyclable waste
- 6) Waste segregation bays have shade cloth on fences to stop recontamination;
- 7) Onsite Storage for Building and Demolition Waste.

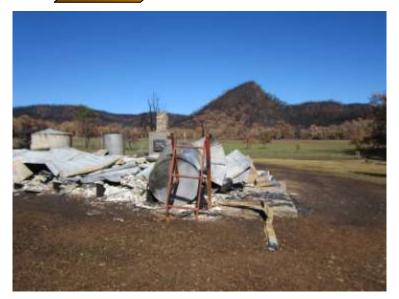
Figure 9 – Example of Fire Damaged property with Friable Asbestos and Soil to be removed

Fire damaged friable asbestos and building ash are likely to be on the surface of the soil and will therefore require the removal of impacted soil. Following the removal of fire damaged friable asbestos and building ash, the area must be inspected by an Occupational Hygienist and a clearance certificate issued. All such material must be handled, transported and disposed of as asbestos contaminated waste. All asbestos contaminated waste must be transported to landfill under sealed conditions as summarised below:
